**A report of an Inquiry into the collision  
that occurred on 21 July 1991  
at Newton Junction**

November 1992

On Sunday 21 July 1991, just before 10 pm, two suburban electric passenger trains collided violently head-on at Newton West Junction in the Scottish region of British Railways, killing both drivers and two passengers and injuring twenty-two other passengers.

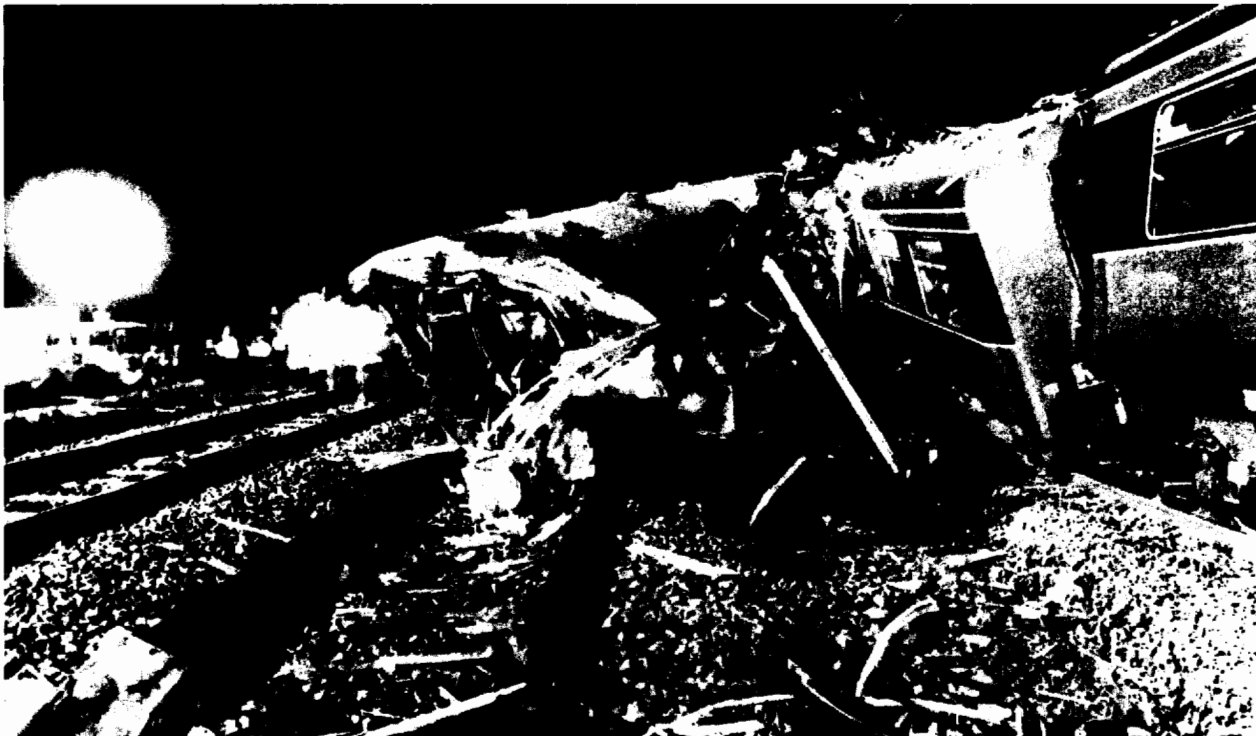
The wrecked trains at Newton

104 The leading vehicles of both trains were almost completely destroyed in the collision and had to be wrenched apart for the recovery of casualties, thereby making detailed examination of the drivers' cabs and their controls almost impossible. Mr Thompson described the testing of the two vehicles from each train still in running condition after the incident. The only significant fault found was during one test with the Electro Pneumatic Brake Unit on the driving trailer taking longer to release than called for in its specification. No other significant problems were discovered during extensive tests following the collision. Only one Automatic Warning System indicator (from the Class 314 unit) had been recovered but Mr Thompson explained that the evidence displayed on an AWS indicator after a collision was not regarded as reliable, especially if the mechanism had become detached from the unit.

106 With colleagues of the Research Department of British Rail, he had examined the main structural members of the two vehicles severely damaged in the collision and they had reached the conclusion that the combined impact velocity was between 55 and 69 miles/h. It was apparent from other tests regarding the closing speeds that the collision impact velocity could have been as high as 76 mile/h but in his opinion the speed quoted from their tests was more realistic.
