HM Railway Inspectorate

## **RAILWAY ACCIDENT IN THE SEVERN TUNNEL**

A report on a collision that occurred  
on 7 December 1991

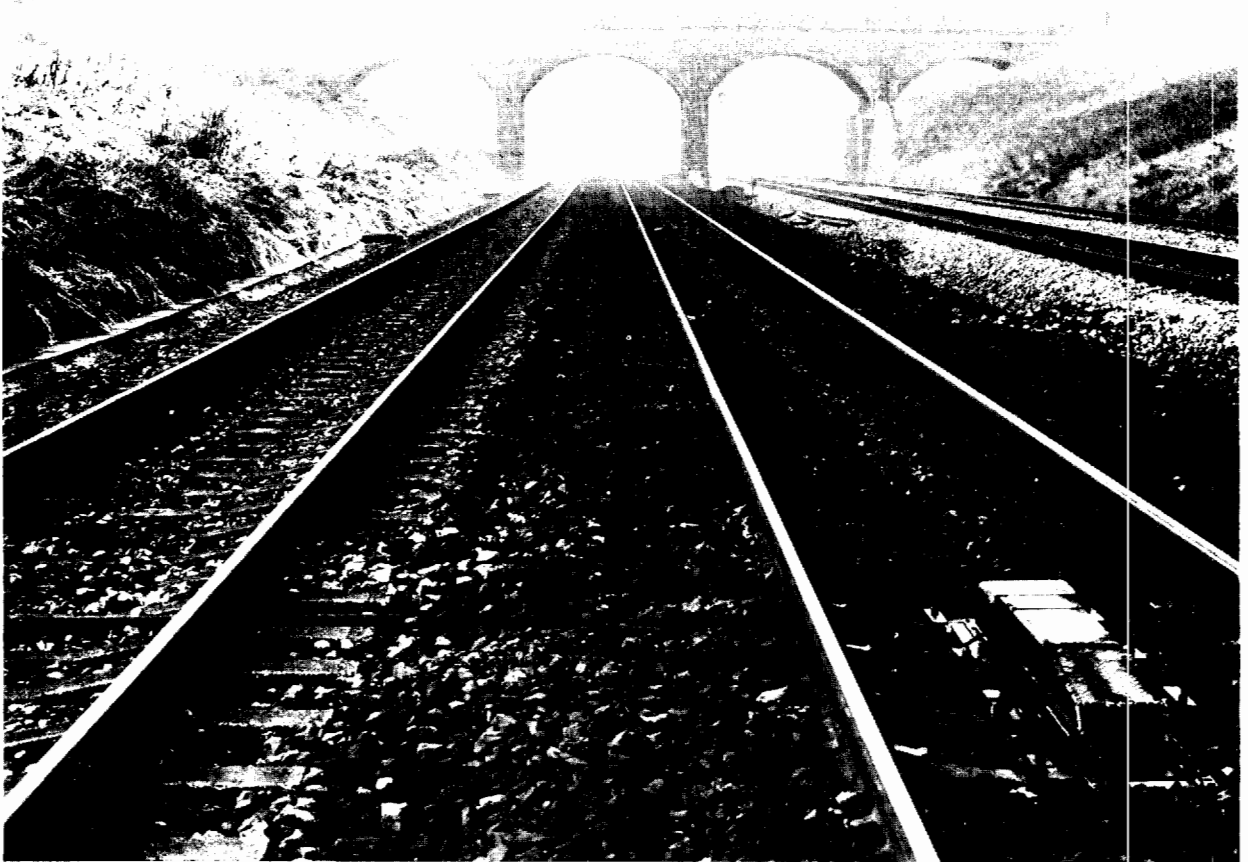
**Figure 1** Sighting of Signal N164. From 200 yards, on a misty morning. In the foreground is the Automatic Warning System magnet for the signal (photograph courtesy of BRB)

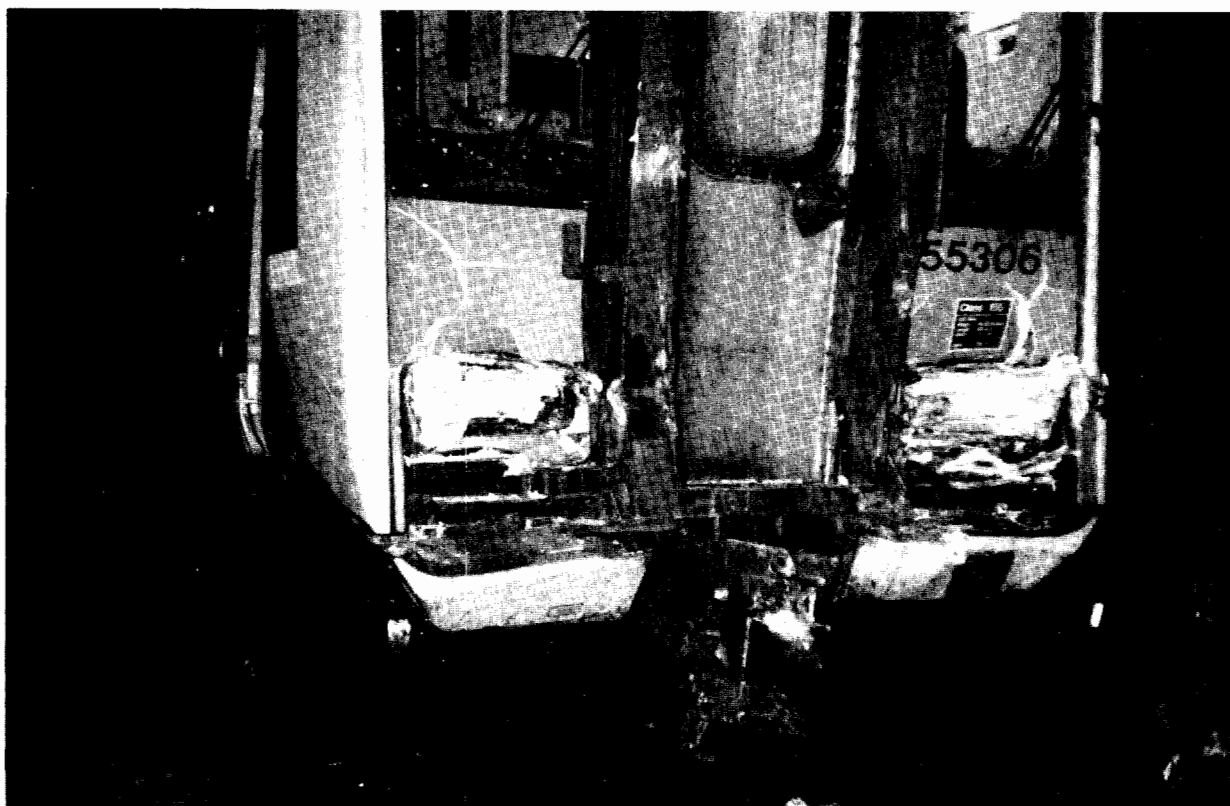
**Figure 3** Leading car of Sprinter train (photographs courtesy of BRB)

43 The sliding door leading to the Driver's cab was about half an inch open, but jammed due to buckling of the floor. Mr Carroll called to the Driver who replied in a quiet voice that he was all right. Mr Carroll enlisted the help of two passengers to force the door open about 18 inches. He squeezed into the cab and found the Driver bleeding badly from facial injuries. He located the Driver's bag and took out the high visibility vest, handlamp and small first-aid kit. He put on the vest and gave the first-aid kit to the two passengers who were helping him, asking them to treat the Driver. On looking through the cab window he could see the rear of the HST about 10 to 15 yards ahead.

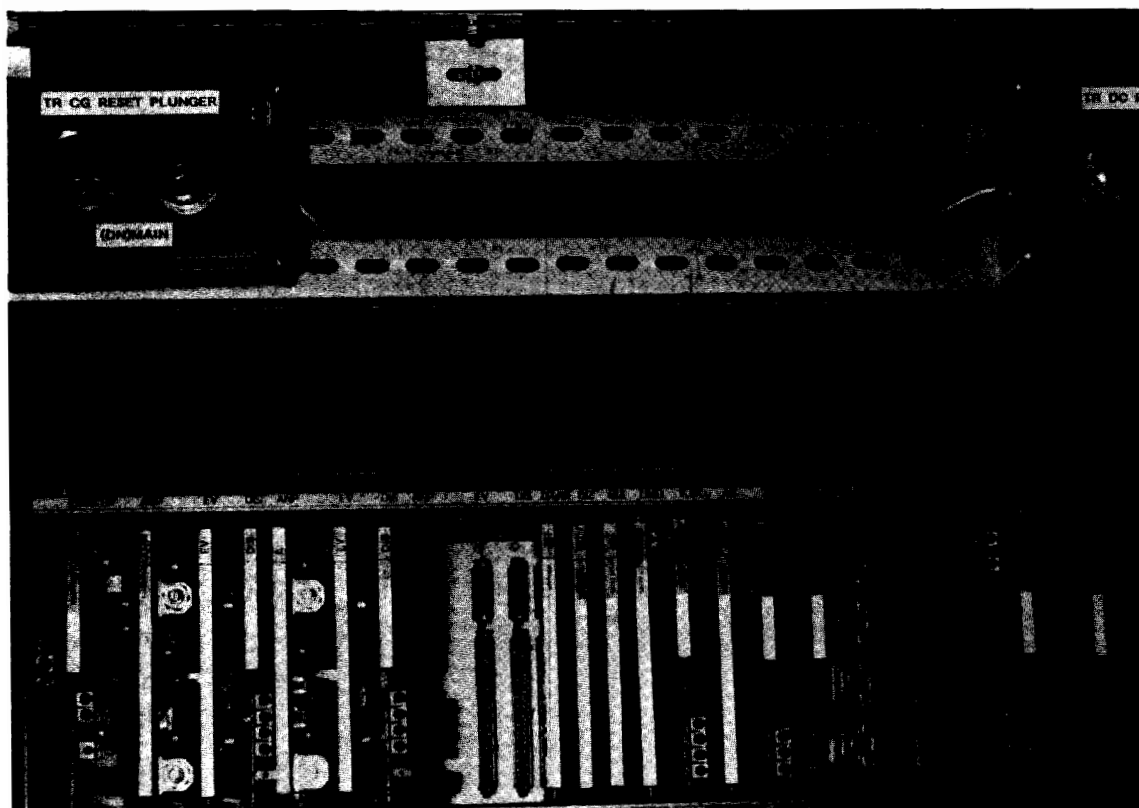
**Figure 6** Axle counter evaluator and reset plunger. A photograph of the Down Main Line axle counter evaluator with its reset plunger above it, to the left (photograph courtesy of BTP)

him that the axle counter had failed, since the count was too high for a single train. He asked the Signaller for permission to clear the counter and on receiving word that the Tunnel was clear, he took the cover off the green button and pressed it, but nothing happened. He then took the cover off the evaluator, pressed the black button and then the green button. The counter cleared but did not reset, so he replaced the covers and told the Signaller he would not touch the evaluator again without letting him know. He didn't look at the indicator lights and could not say what their condition was.

111 Mr Cattle said he pressed the black button first, and then the green, in the hope of getting the axle counter back into sequence and clearing the fault. He understood that on through routes, a successful re-set would have caused the signal to clear to green, but he was satisfied from the Signaller that both roads through the Tunnel were clear. Having tried without success to re-set the counter he didn't touch it again. He confirmed that the WDH fuse was in position at that time - had it been removed there would have been no need to contact the Signaller before attempting to re-set.

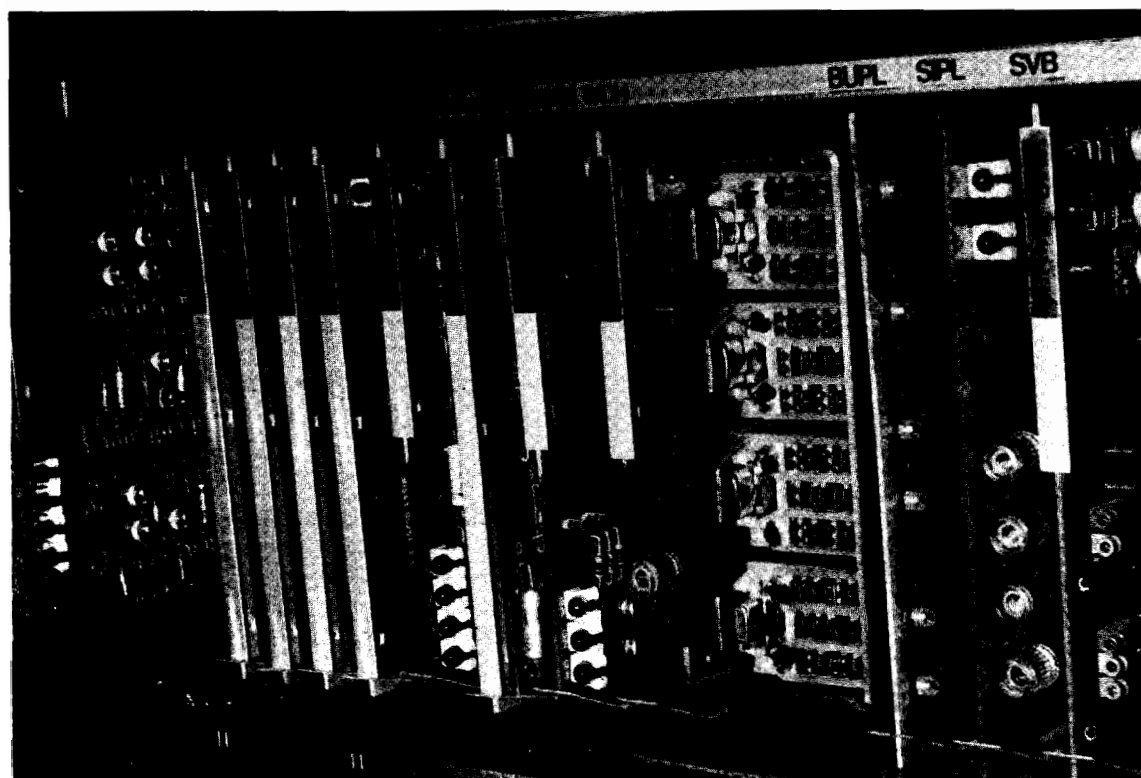
105 He demonstrated how with the front cover removed, the fuse can readily be removed from the WDH card to disconnect the evaluator from the signal interlocking. With the WDH fuse removed, Signal N164 will remain at Danger. He agreed that intermittent faults could occur without being explained or even identified, but said he had never come across an axle counter giving an inadvertent output allowing the signalman to set a route, nor any wrong-side failure of an axle counter, either intermittent or permanent.

106 He visited the STJ Relay Room on the morning after the accident to carry out tests on the Down axle counter. When he arrived the Relay Room was locked and sealed. On gaining access he found that the front cover was off the evaluator and the cover provided for the re-set button was undone. He could not recall whether the WDH fuse was in or out when he got there.

**Figure 7** Axle counter evaluator. This photograph of the Down Main Line evaluator shows detail of the fuse location on the WDH card and the LED count-in/-out display on the ZIANZG card (photograph courtesy of BTP)
