HM Railway Inspectorate

RAILWAY ACCIDENT AT WATFORD

A report of the investigation into
the collision that occurred on
8 August 1996 at Watford South
Junction on the line from
Euston to Crewe in the
Railtrack Midlands Zone

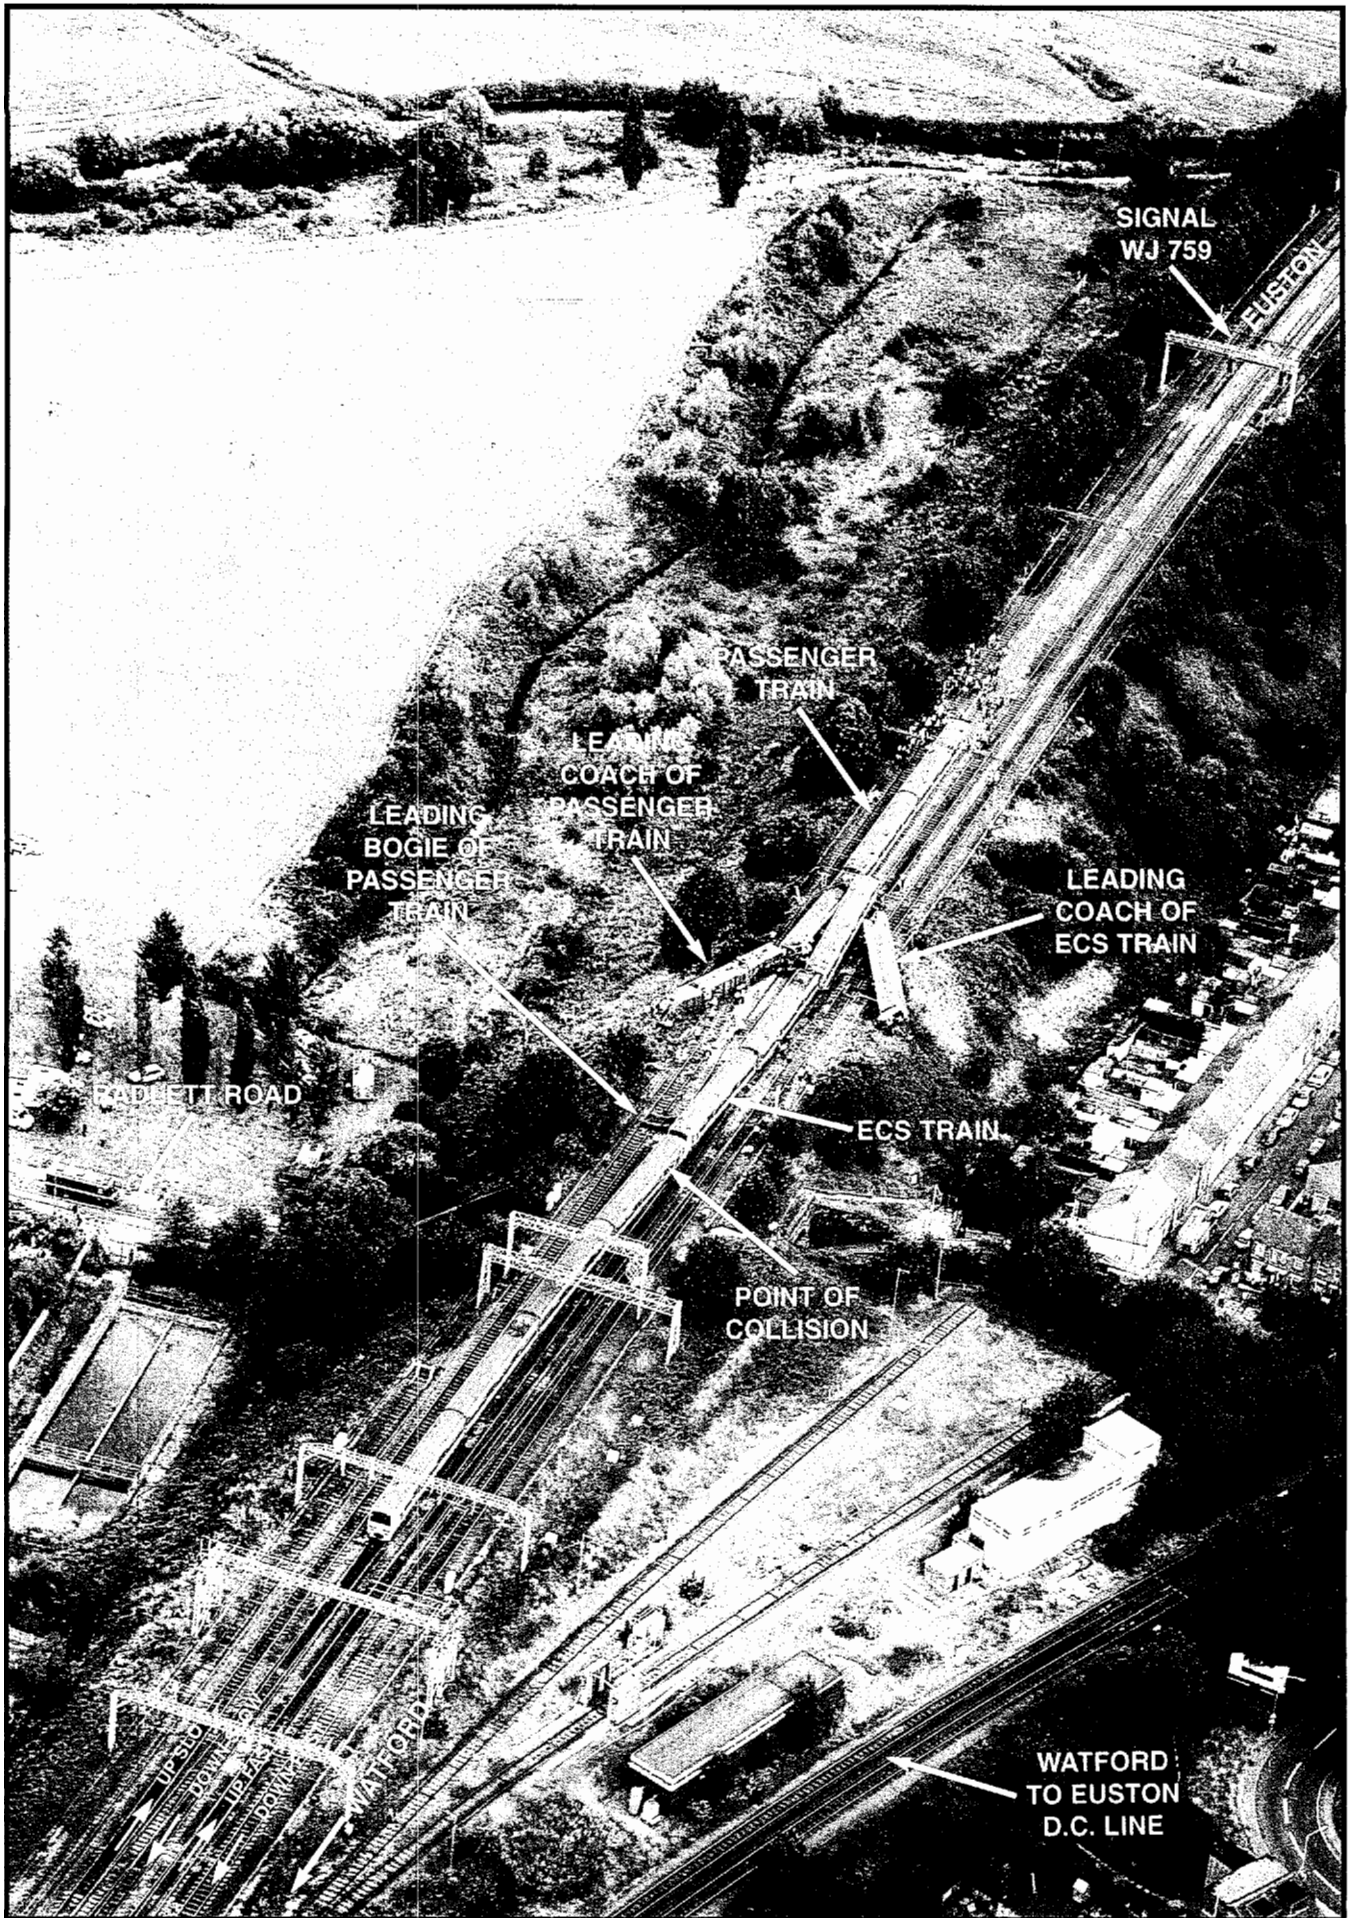
PHOTOGRAPH 1
Aerial view of collision scene
 (Courtesy of Hertfordshire Constabulary)

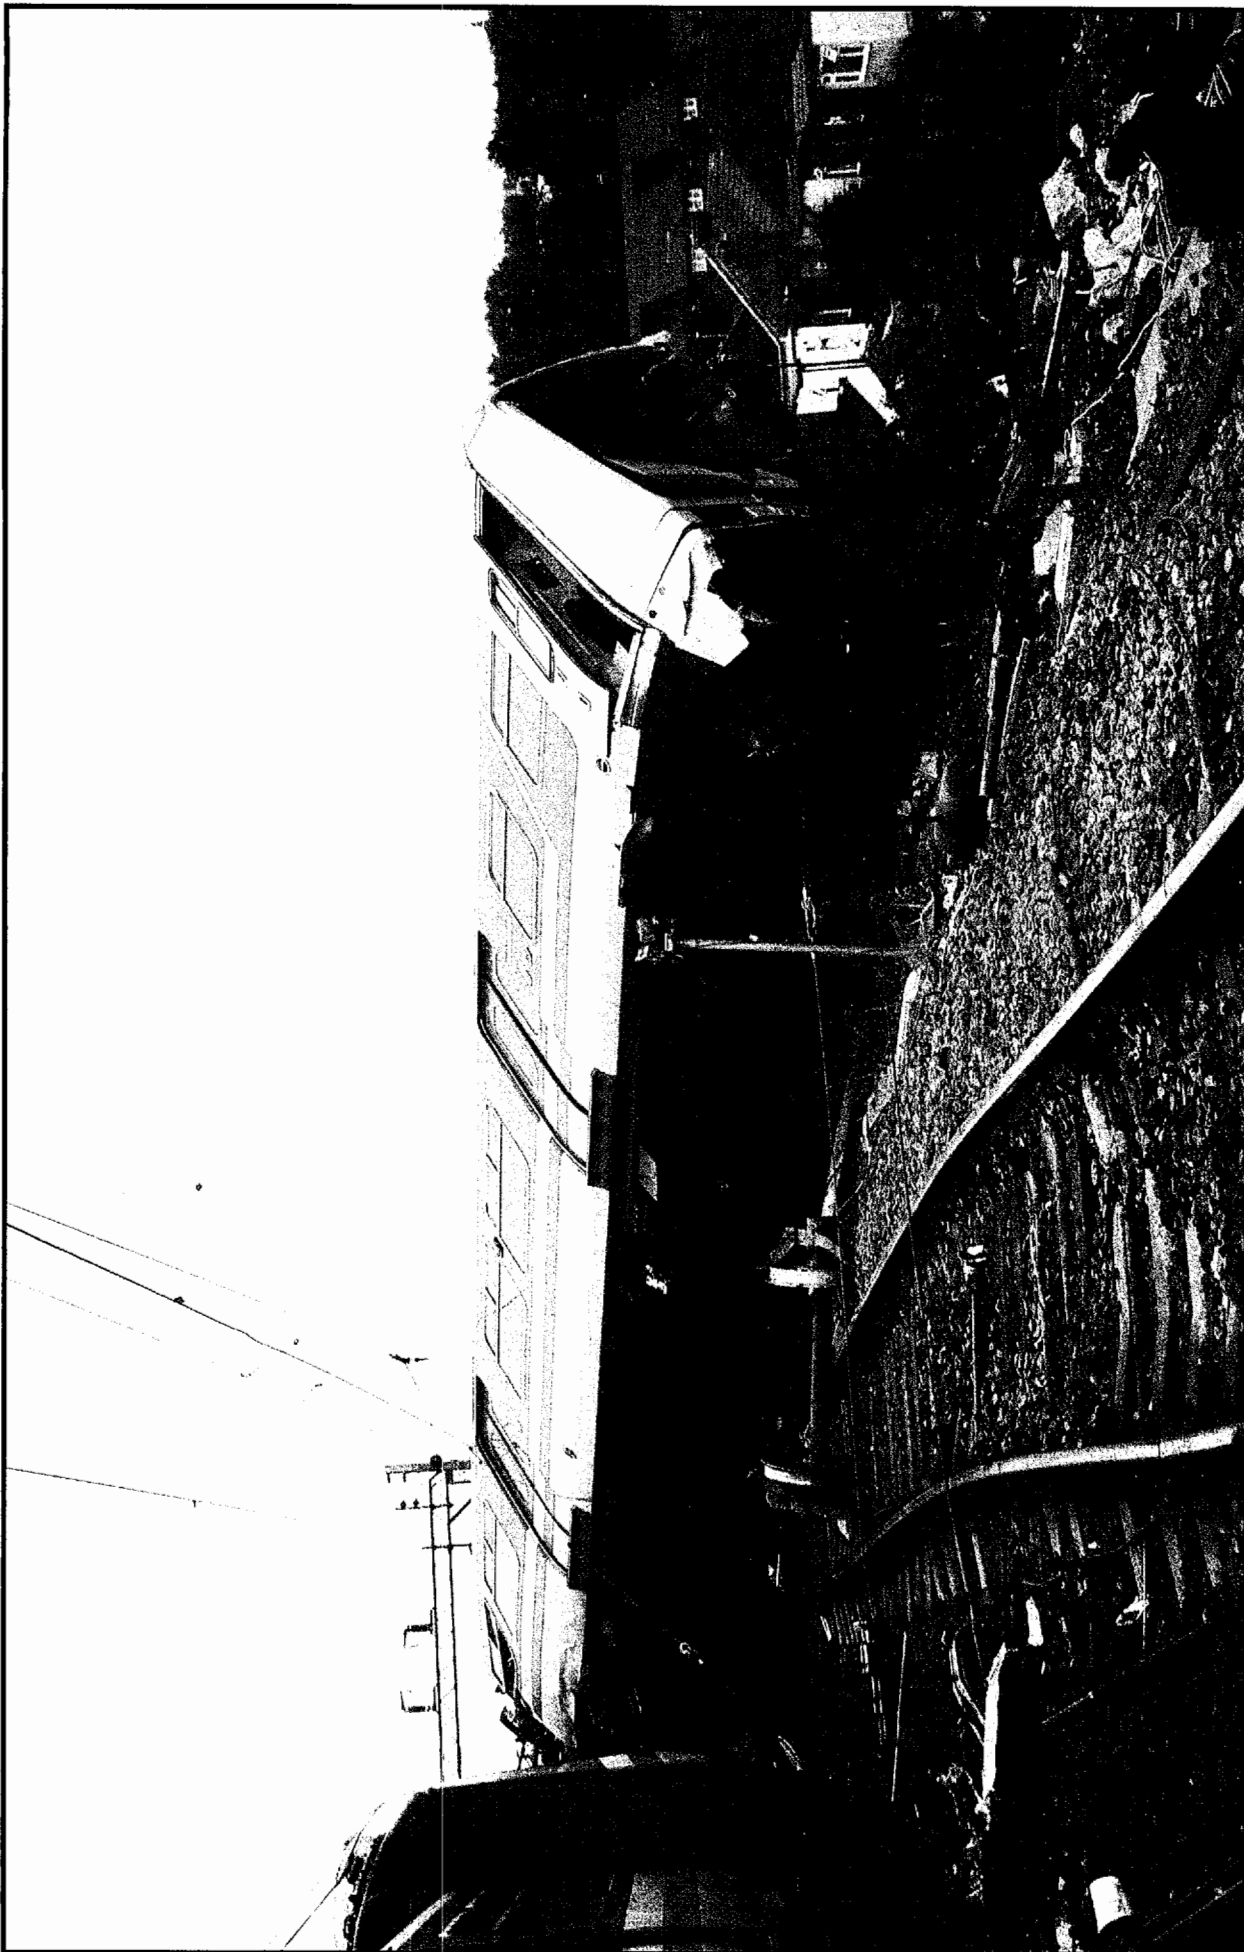
123. The driving cab suffered similar damage to that of 78114 in that the driver's side collapsed by about 1.5 metres, as far back as the rear door pillar of the driver's access door.

(See photo no 3). The solebar, bodyside and cantrail were completely crushed. The headstock was bent backwards by about 300 mm at its lower end. The vehicle floor and roof were badly buckled over the leading 2.5 to 3 m but there was little damage to the underframe or superstructure on the right hand side of the vehicle. The drawbar between this and the second coach fractured and there was severe distortion and tearing of the headstock at the trailing end of the coach. The remainder was largely undamaged apart from displaced seat cushions, light fittings and waste bins. The leading wheelset of the leading bogie became detached and the remainder of the bogie had buried itself in the down cess ballast having become detached from the coach underframe following failure of the centre pivot assembly. The trailing bogie remained attached to the coach.

PHOTOGRAPH 3
Leading coach of empty coaching stock train.
(Courtesy of North London Railways)

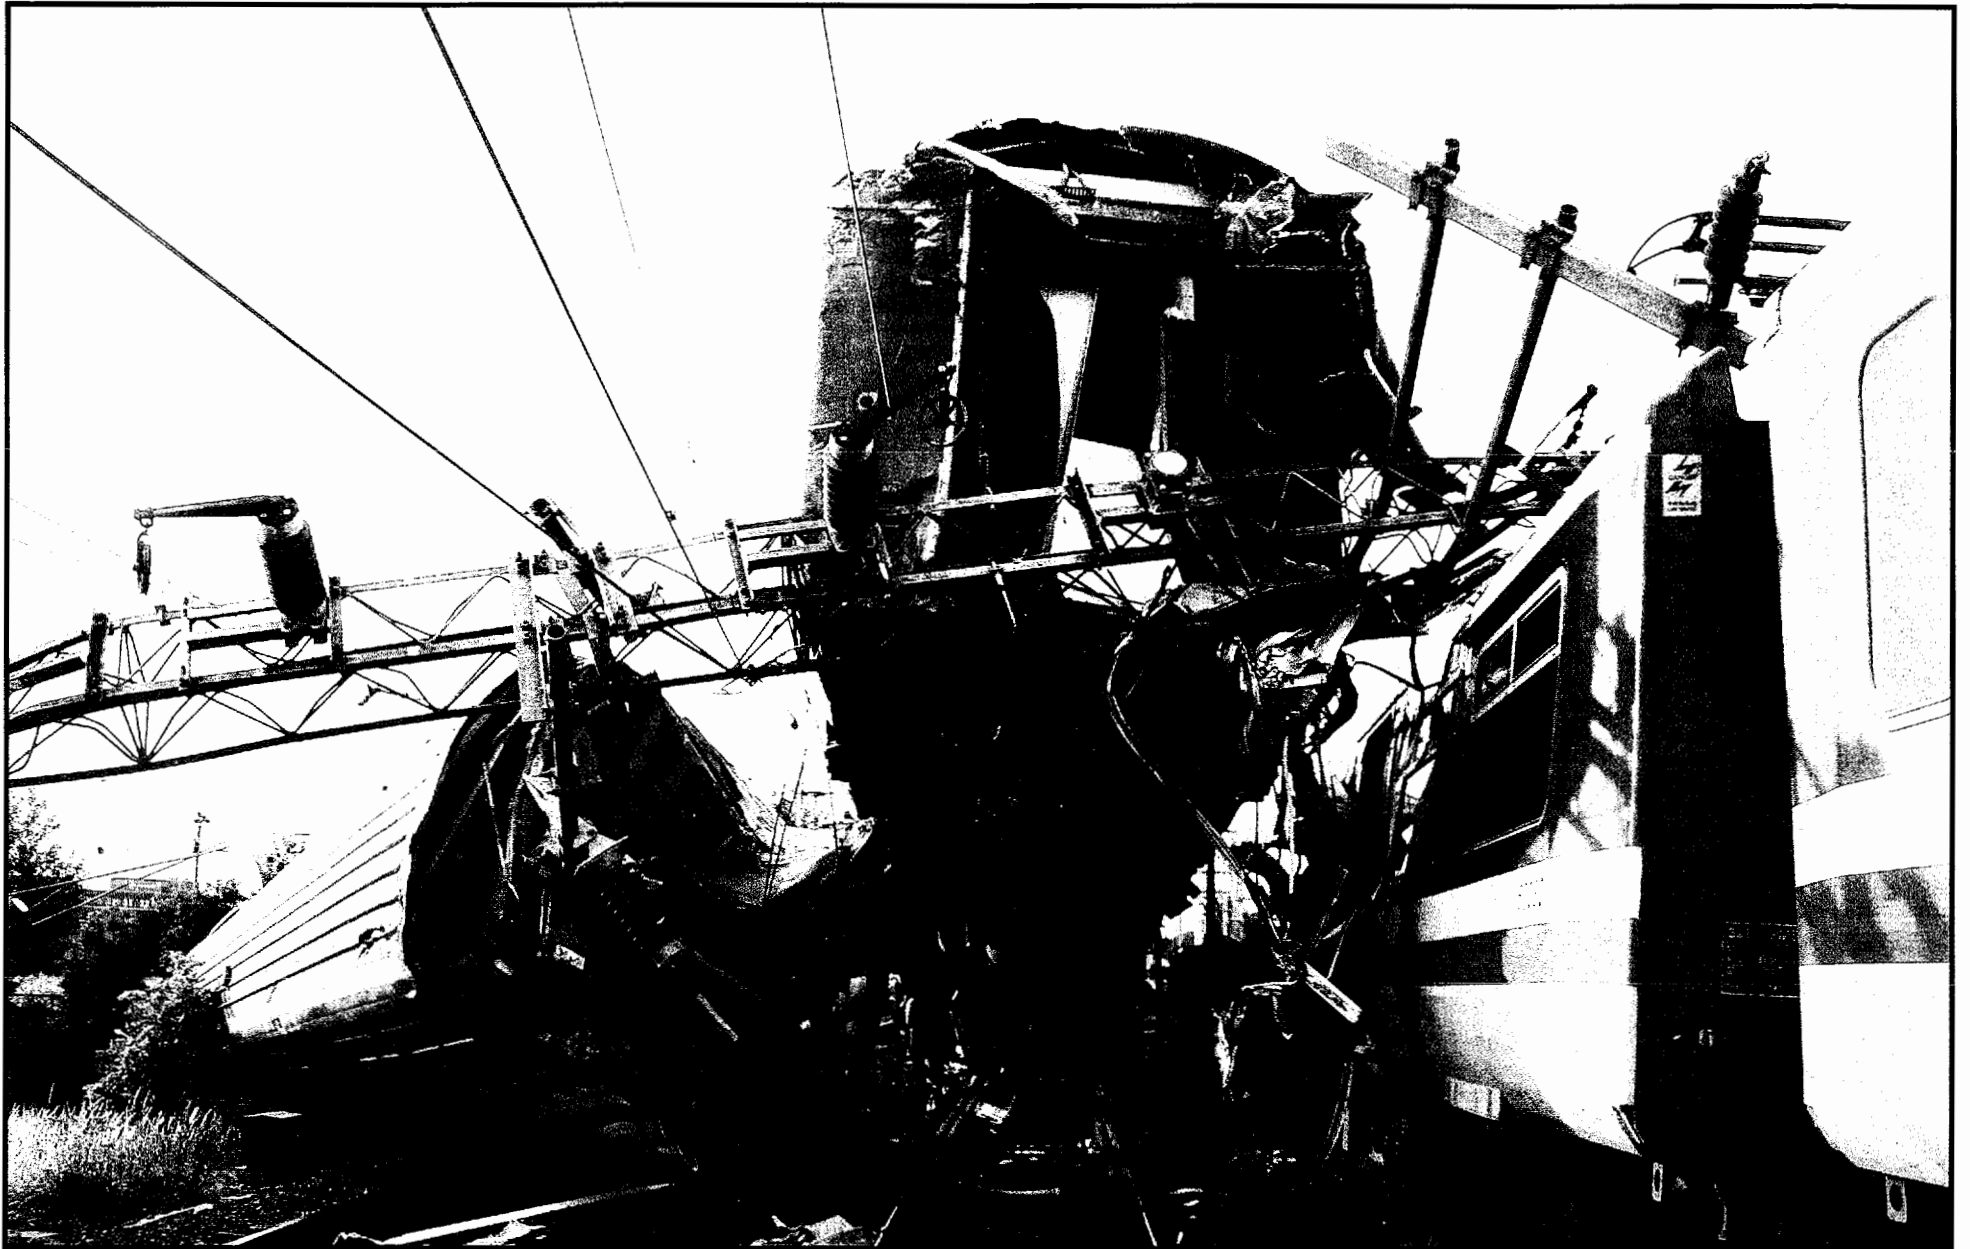
124. The left hand side was severely damaged with the solebar suffering considerable crushing. Assorted debris from the torn bodyside of the second coach of the passenger train was found hanging from the solebar indicating that 71966 had ploughed into 63082 and ripped out its side. The left hand side lower body panel was crushed and the leading left hand side seating was torn out. There was minor damage to the trailing end of this vehicle and seat cushions and light fittings were detached throughout. The leading bogie was detached, but the trailing bogie was still attached to the underframe by the anti-rollbar connection.

PHOTOGRAPH 4
Second coach of empty coaching stock train, after collision showing result of overriding with first coach at left of photograph.
(Courtesy of North London Railways)

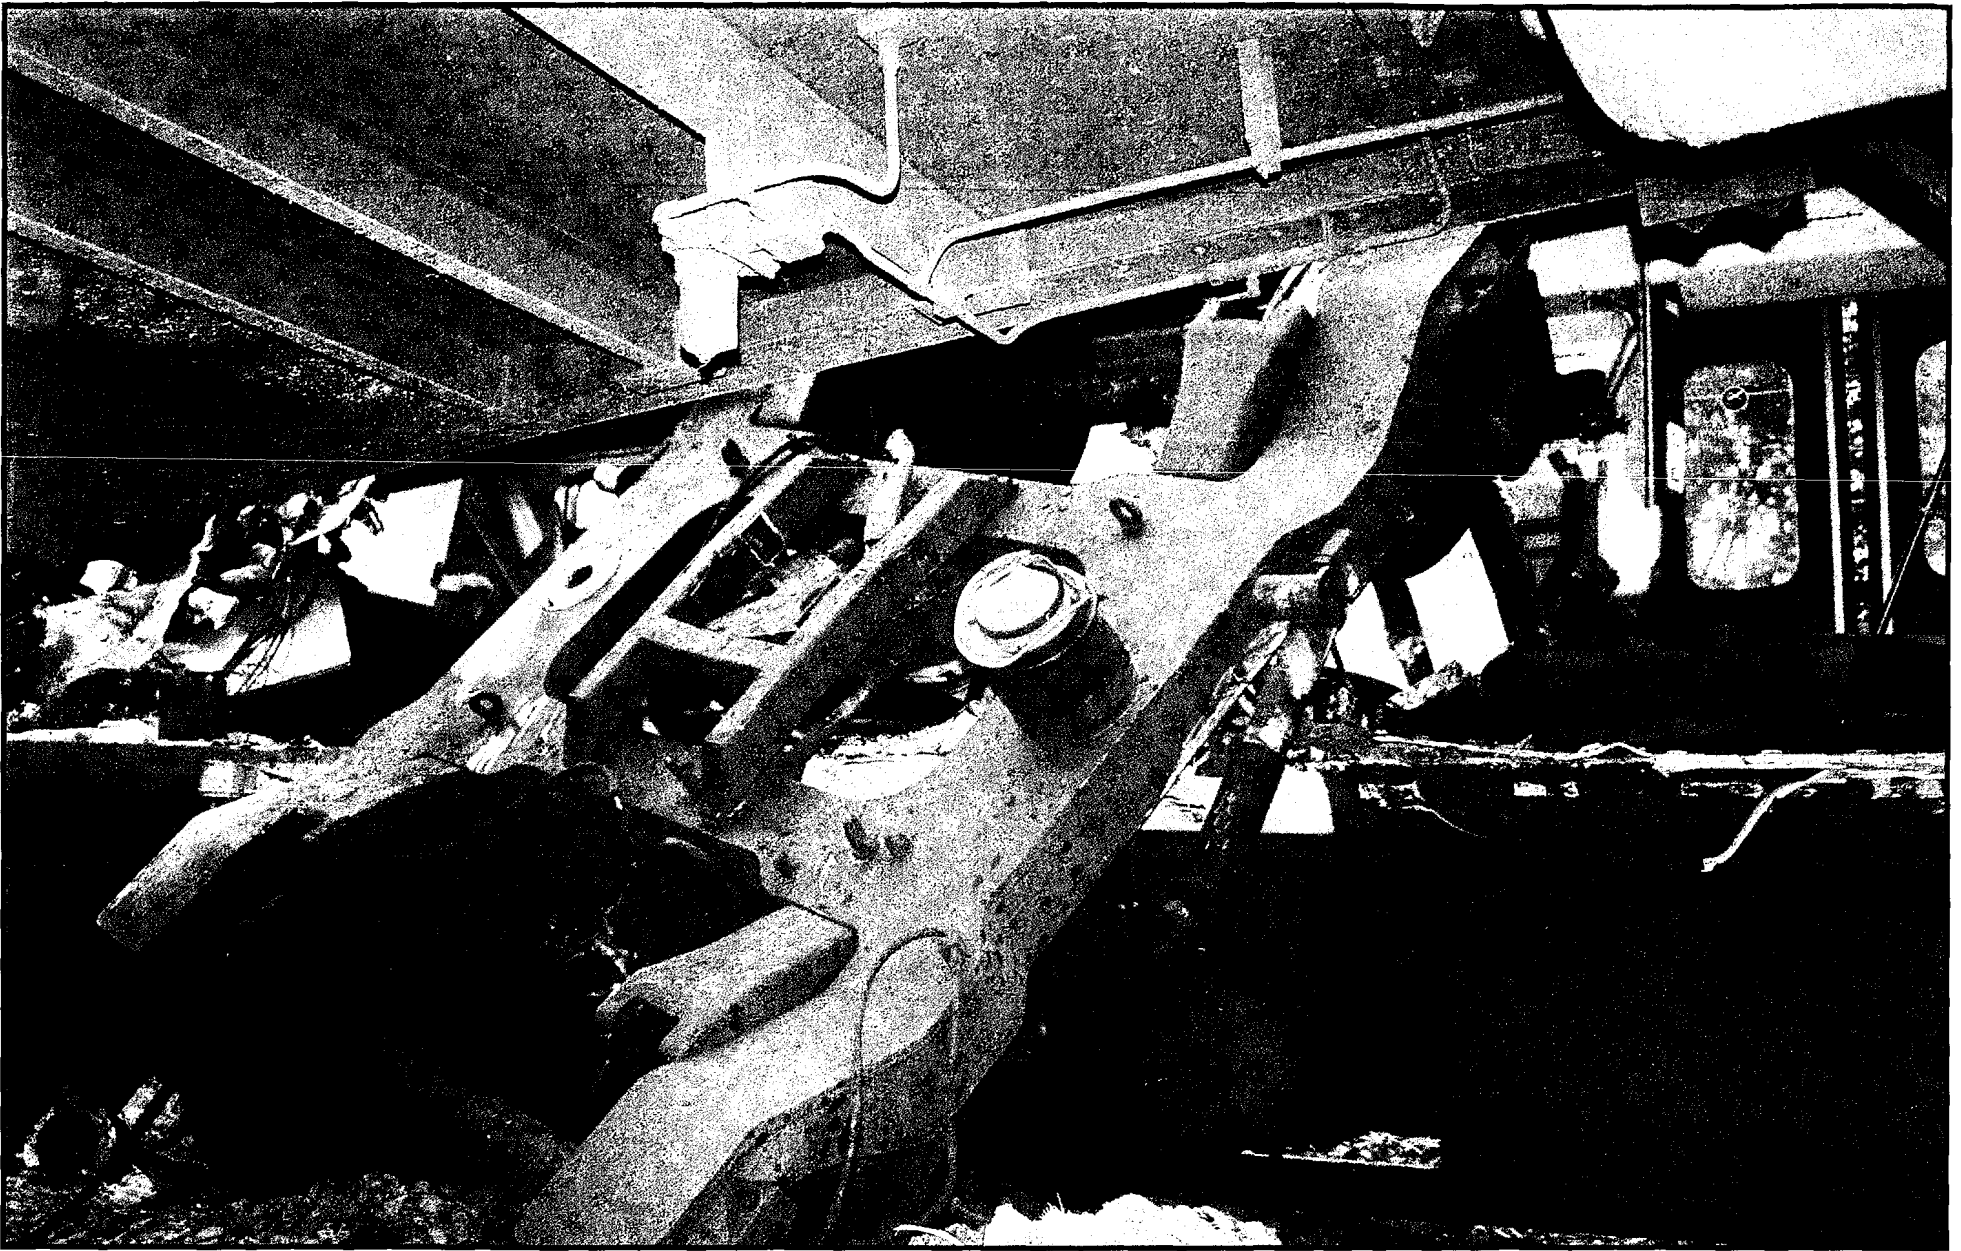
PHOTOGRAPH 5

**Displaced bogie from empty coaching stock train at rest within
passenger space of second coach of passenger train**

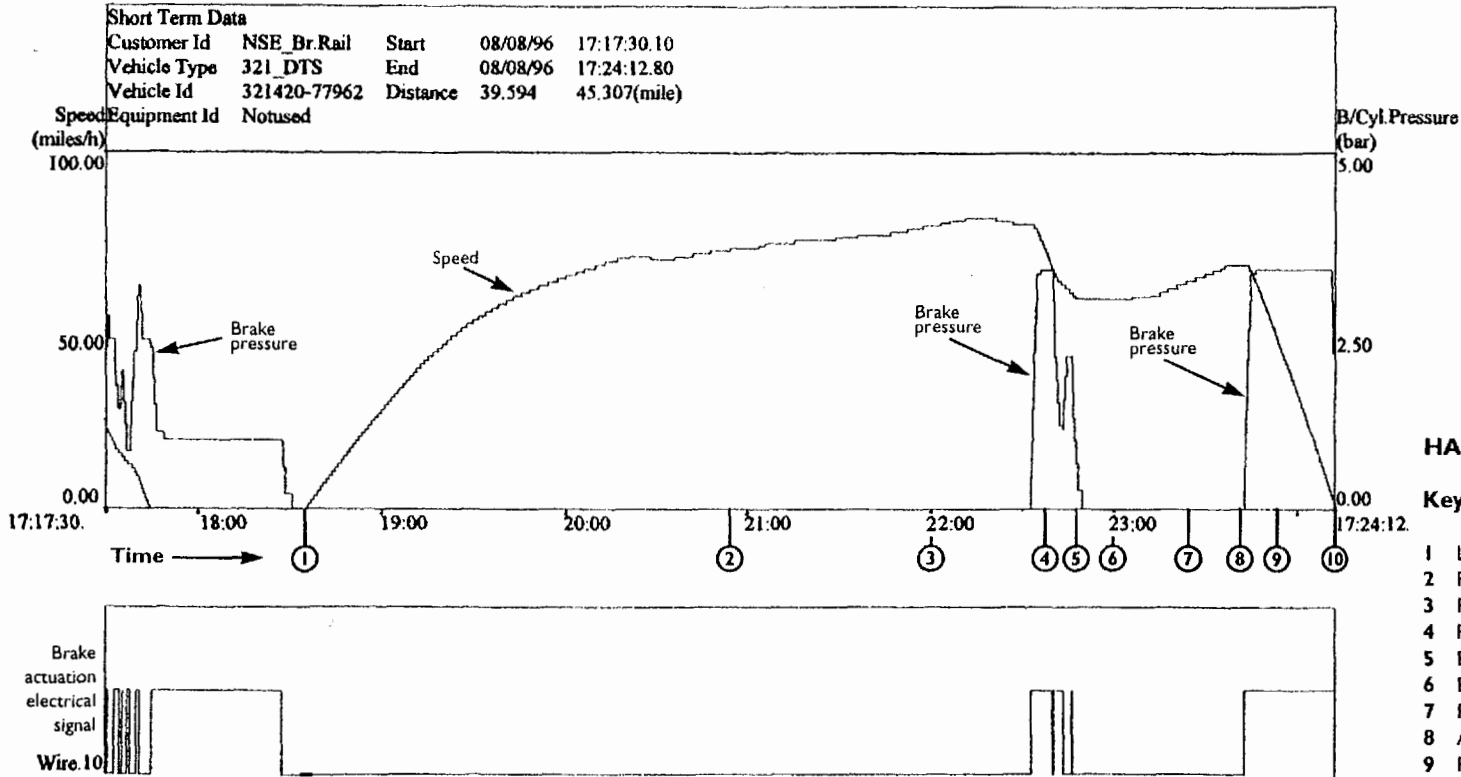
DIAGRAM 2: HASLER RECORDER TRACE FOR JOURNEY FROM HARROW AND WEALDSTONE STATION UP TO POINT OF COLLISION

62. The data recorder for the leading car (78114) of the passenger train was found to have stopped recording at 0708 on 8 August 1996, just over 10 hours before the accident occurred. Unfortunately, the failure of this data recorder resulted in the loss of the cab specific data that would have shown whether or not the driver of the passenger train received an AWS bell or warning horn. The failure of this piece of equipment is dealt with in paras. 70 to 75 below. The recorder for the trailing car (77962) of the passenger train stopped at the time of the collision, however a full set of data up to the moment of impact was downloaded graphically and digitally and compared with the route topography. (See appendix 4 and appendix 6, diagram No 2)
