RAILWAY ACCIDENTS

REPORT ON THE COLLISION

26th October 1959

ARDSLEY STATION

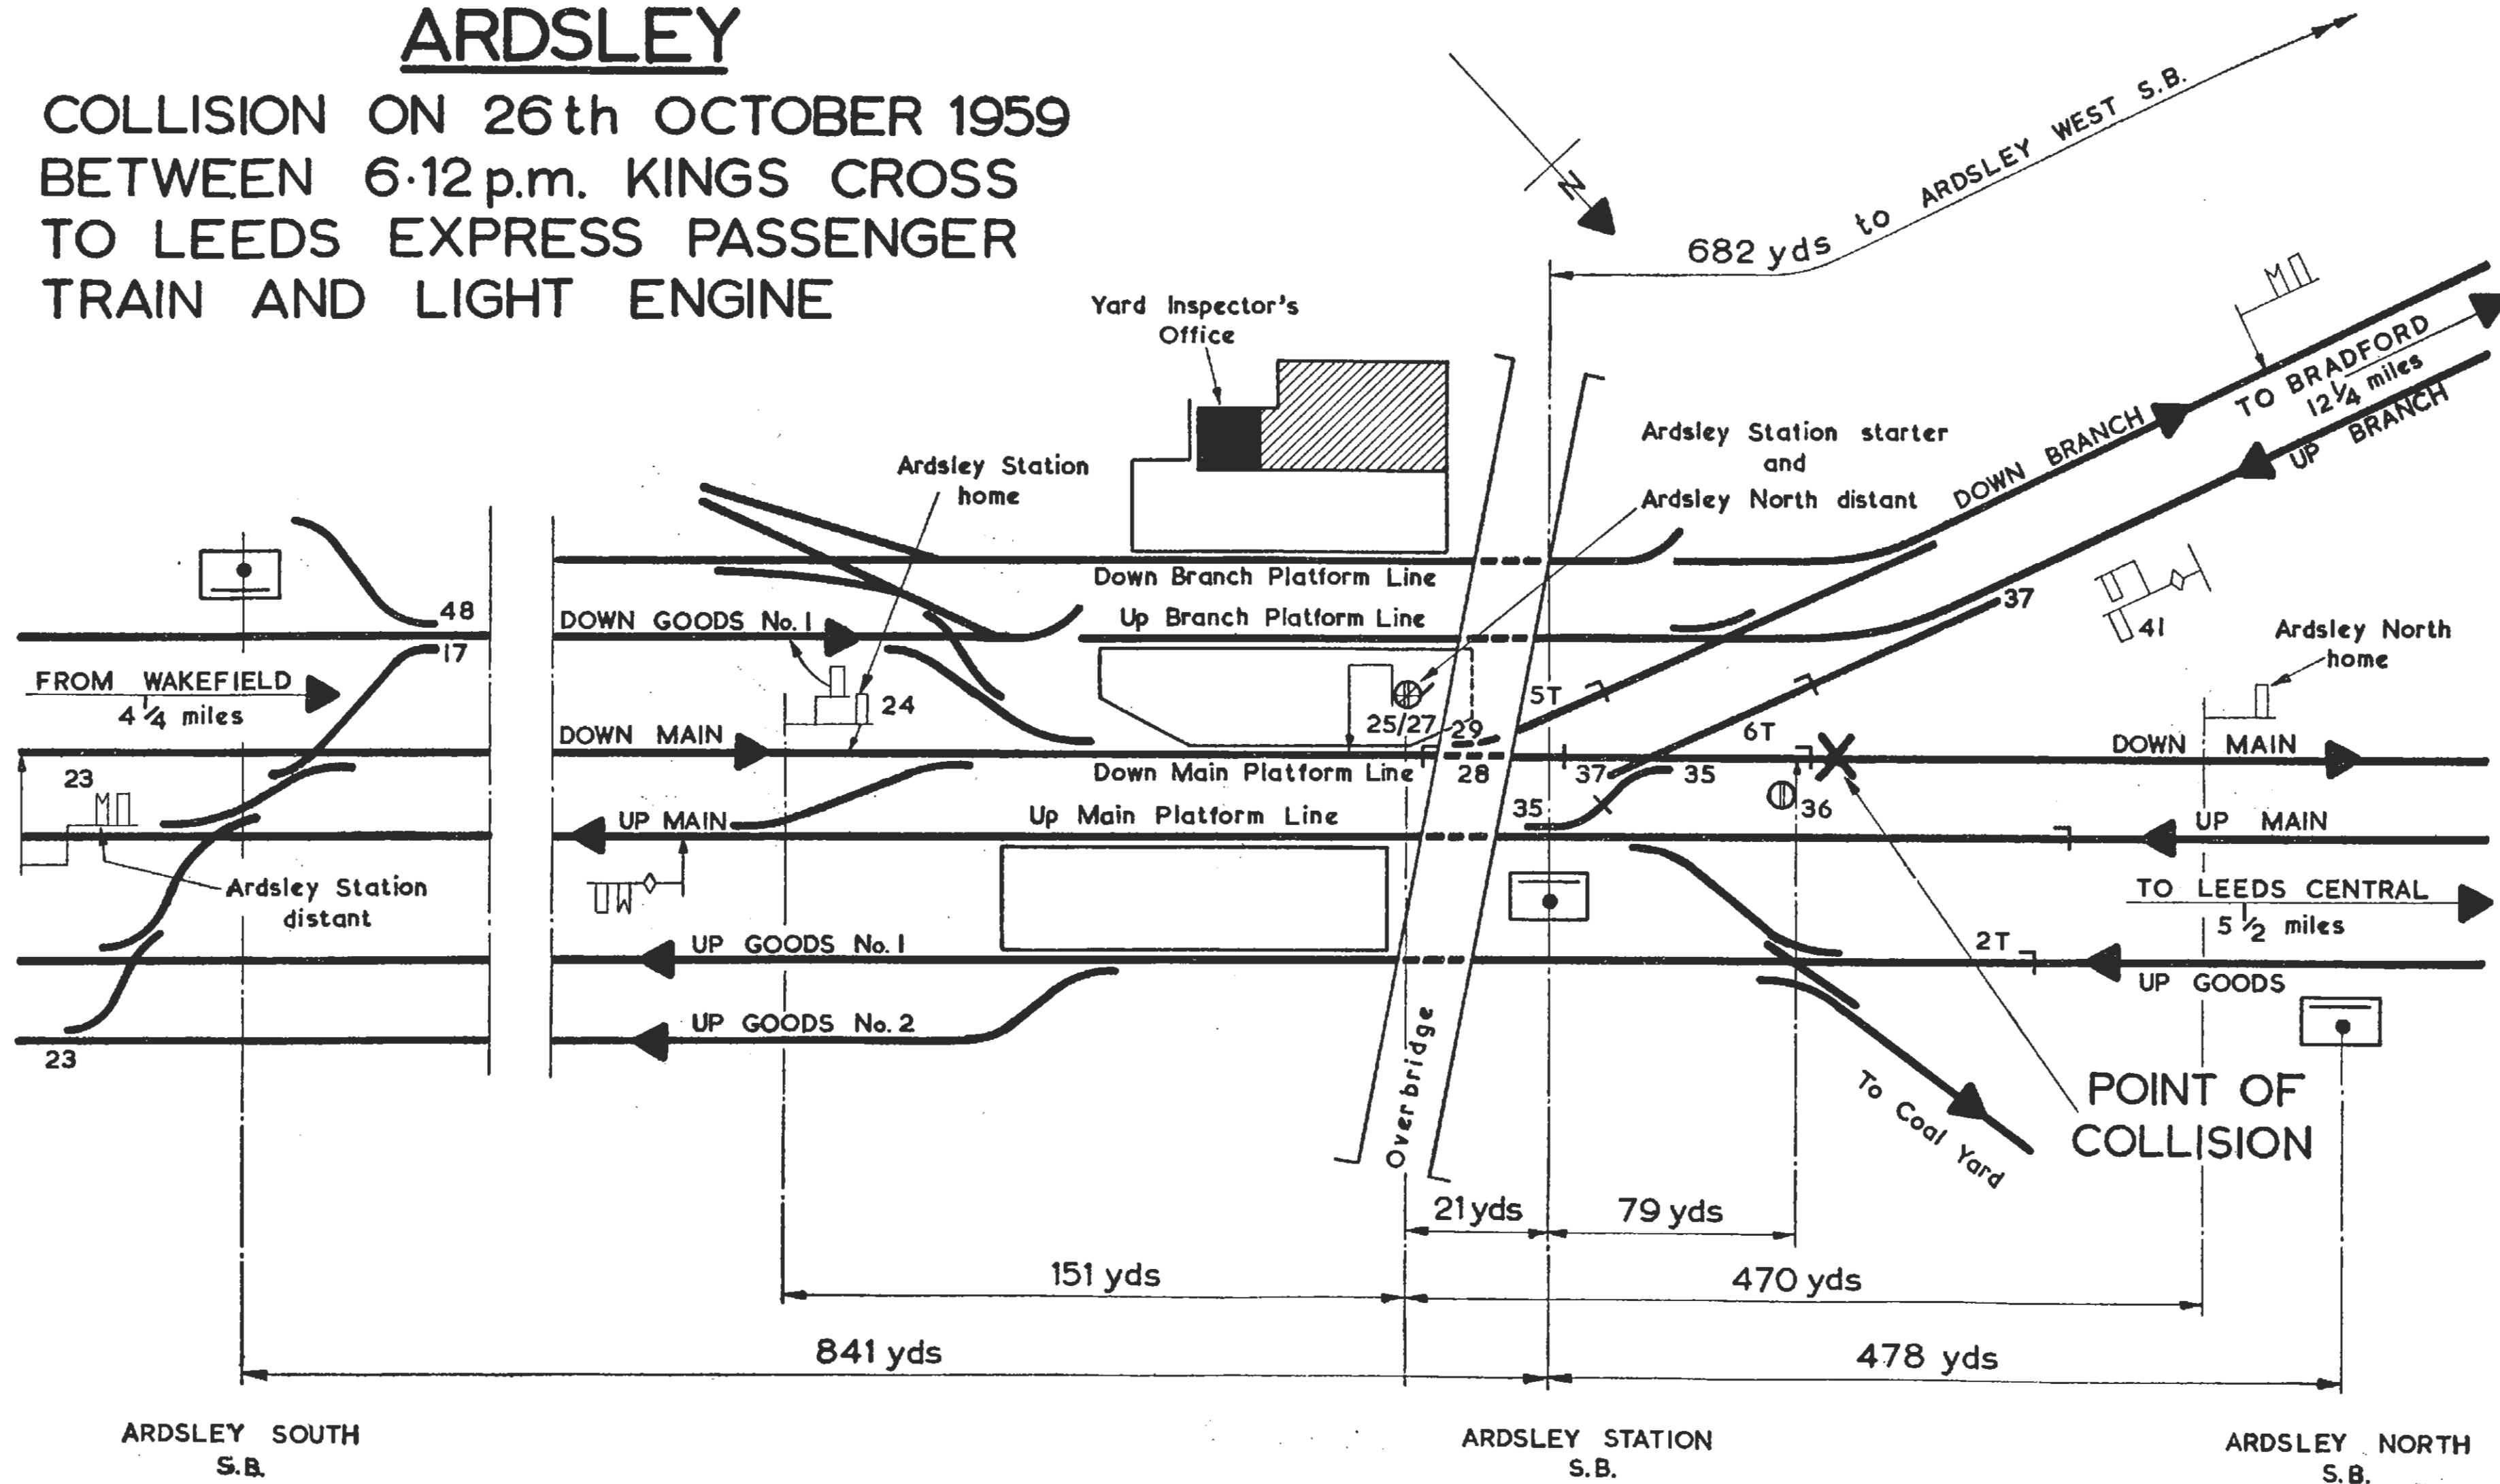
ARDSLEY

COLLISION ON 26th OCTOBER 1959
BETWEEN 6.12 p.m. KINGS CROSS
TO LEEDS EXPRESS PASSENGER
TRAIN AND LIGHT ENGINE

As shown on the sketch opposite, Ardsley Station is situated on the main line between Wakefield and Leeds Central, at the junction with the branch line to Bradford. In the Down direction the main lines rise almost continuously from Wakefield and the gradient approaching Ardsley Station is 1 in 117; through the station the lines are on a slight left-handed curve. The adjacent signal boxes are Ardsley South, 841 yards towards Wakefield, Ardsley North, 478 yards towards Leeds and Ardsley West, 682 yards towards Bradford.

The branch line junction is on the Leeds side of the station. The signal box is opposite the junction and there is a road overbridge between it and the platforms.
