## **RAILWAY ACCIDENTS**

## **REPORT ON THE COLLISION**

20th May 1958

ARKLESTON JUNCTION SIGNAL BOX

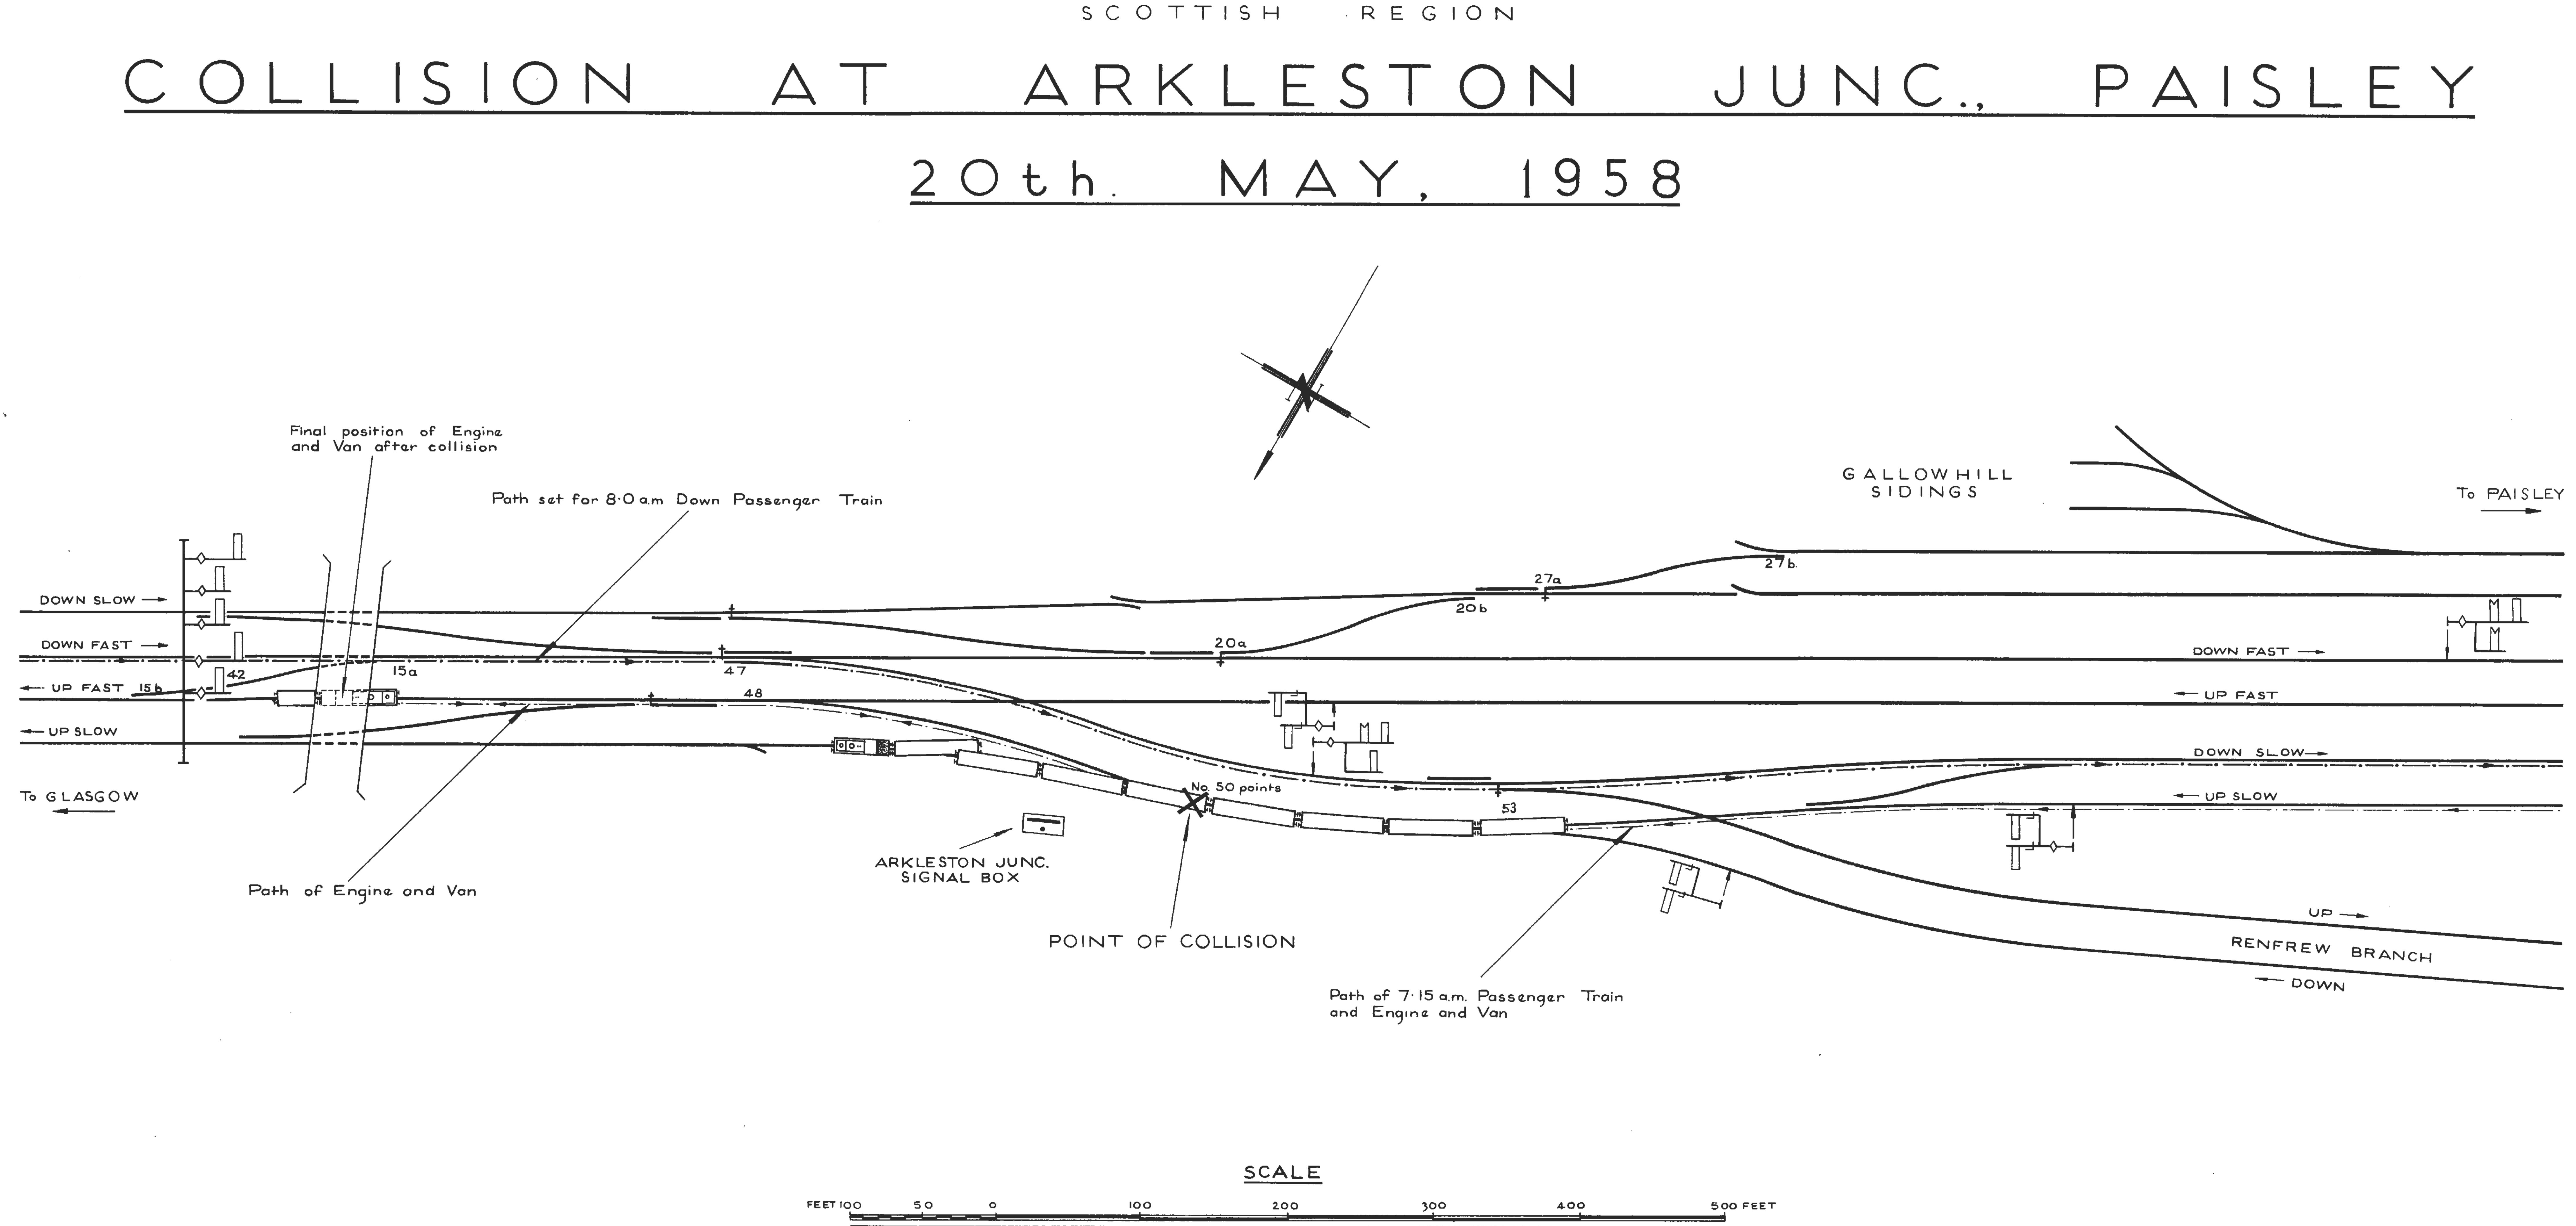
6. The drawing attached shows diagrammatically the arrangement of the lines and the relevant signals, which are all semaphores, and the route followed by the engine and van and the passenger train. It also shows the route set by the signalman for a Down passenger train which had been accepted at the same time; this affected the lie of the facing points over which the engine and van travelled into the path of the passenger train. It will be noted from the diagram that the direction of running changes at the signal box; on the Glasgow side the two Up lines are to the North and the two Down lines to the South, whereas on the Paisley side the direction of running from North to South is Up Slow, Down Slow, Up Fast and Down Fast.
