MINISTRY OF TRANSPORT & CIVIL AVIATION

REPORT ON THE COLLISION

which occurred on
2nd December 1955

BARNES STATION

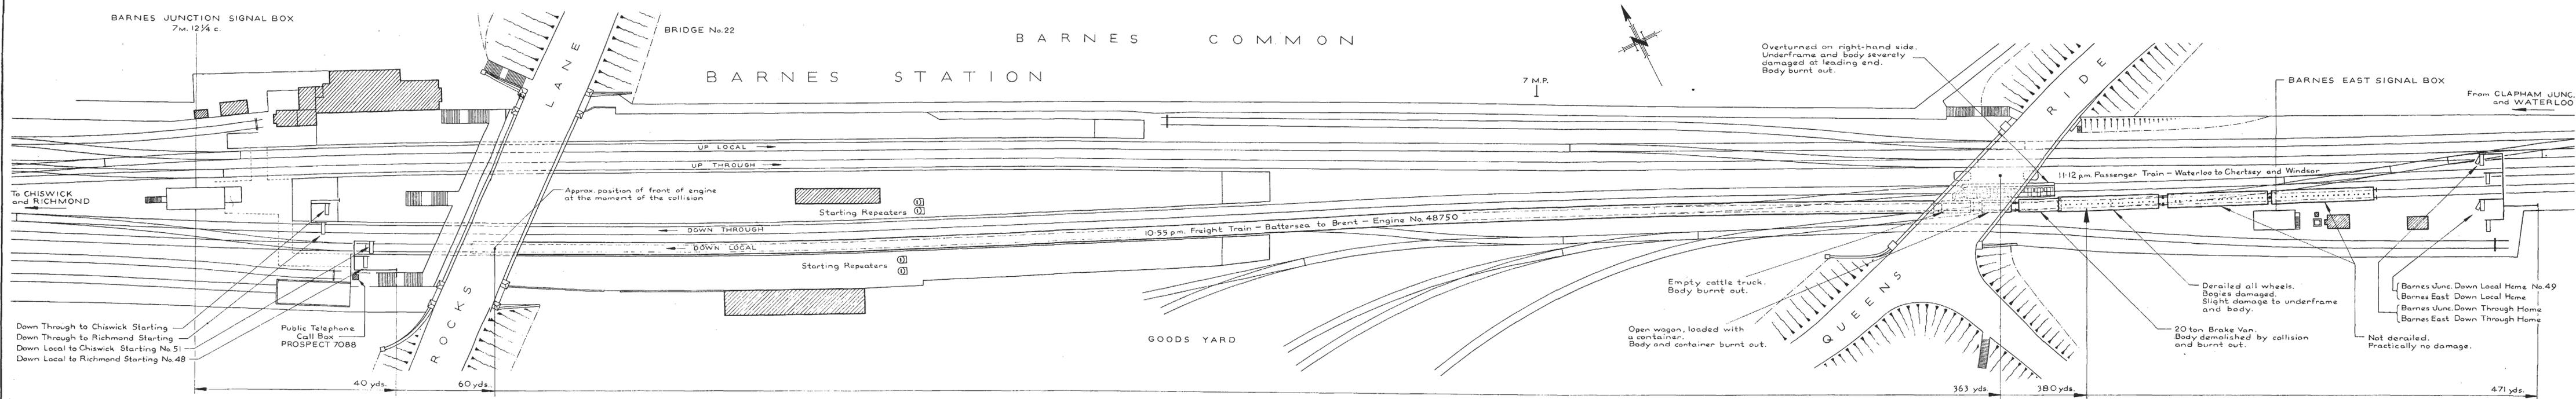
FIG. 2 GENERAL SITE PLAN
 SHOWING THE APPROXIMATE POSITION OF THE TWO TRAINS AFTER THE COLLISION

4. As has been stated, the leading coach mounted the underframe of the brake van, leaving its derailed and badly damaged bogies jammed together against the wheels of the van, which was also derailed. The wooden van body was swept away and the end of a container loaded on the low-sided wagon next to the van was smashed. The coach then turned over to the right clear of the freight train and came to rest on its side on the alignment of the Down Through line under the bridge, and alongside the van and the two rearmost wagons, which had been driven forward for a few yards.

The coach underframe was severely crumpled in front of the main bogie pivot cross member, which is approximately 10 ft. from the headstock, and it is probable that the motorman's and the first passenger compartment were destroyed by the impact. The underframe had retained its general shape behind this cross member, though there was some buckling of the solebars, and it is probable that the eight passenger compartments over this length were not very seriously damaged at this stage, though some doors may have been jammed. Damage to the 2nd coach of the leading (Chertsey) unit was mainly superficial, and it came to rest upright in close contact with the underframe of the brake van, with both its bogies derailed. The two coaches of the rear (Windsor) unit were undamaged and remained on the rails. There was very little structural damage to the massive steel underframe of the freight train brake van, or to the steel frames of the next two wagons. The rest of the freight train was undamaged and was drawn away later by its own engine.
