RAILWAY ACCIDENTS

**REPORT
ON THE DOUBLE COLLISION**

28th January 1960

BOROUGH MARKET JUNCTION

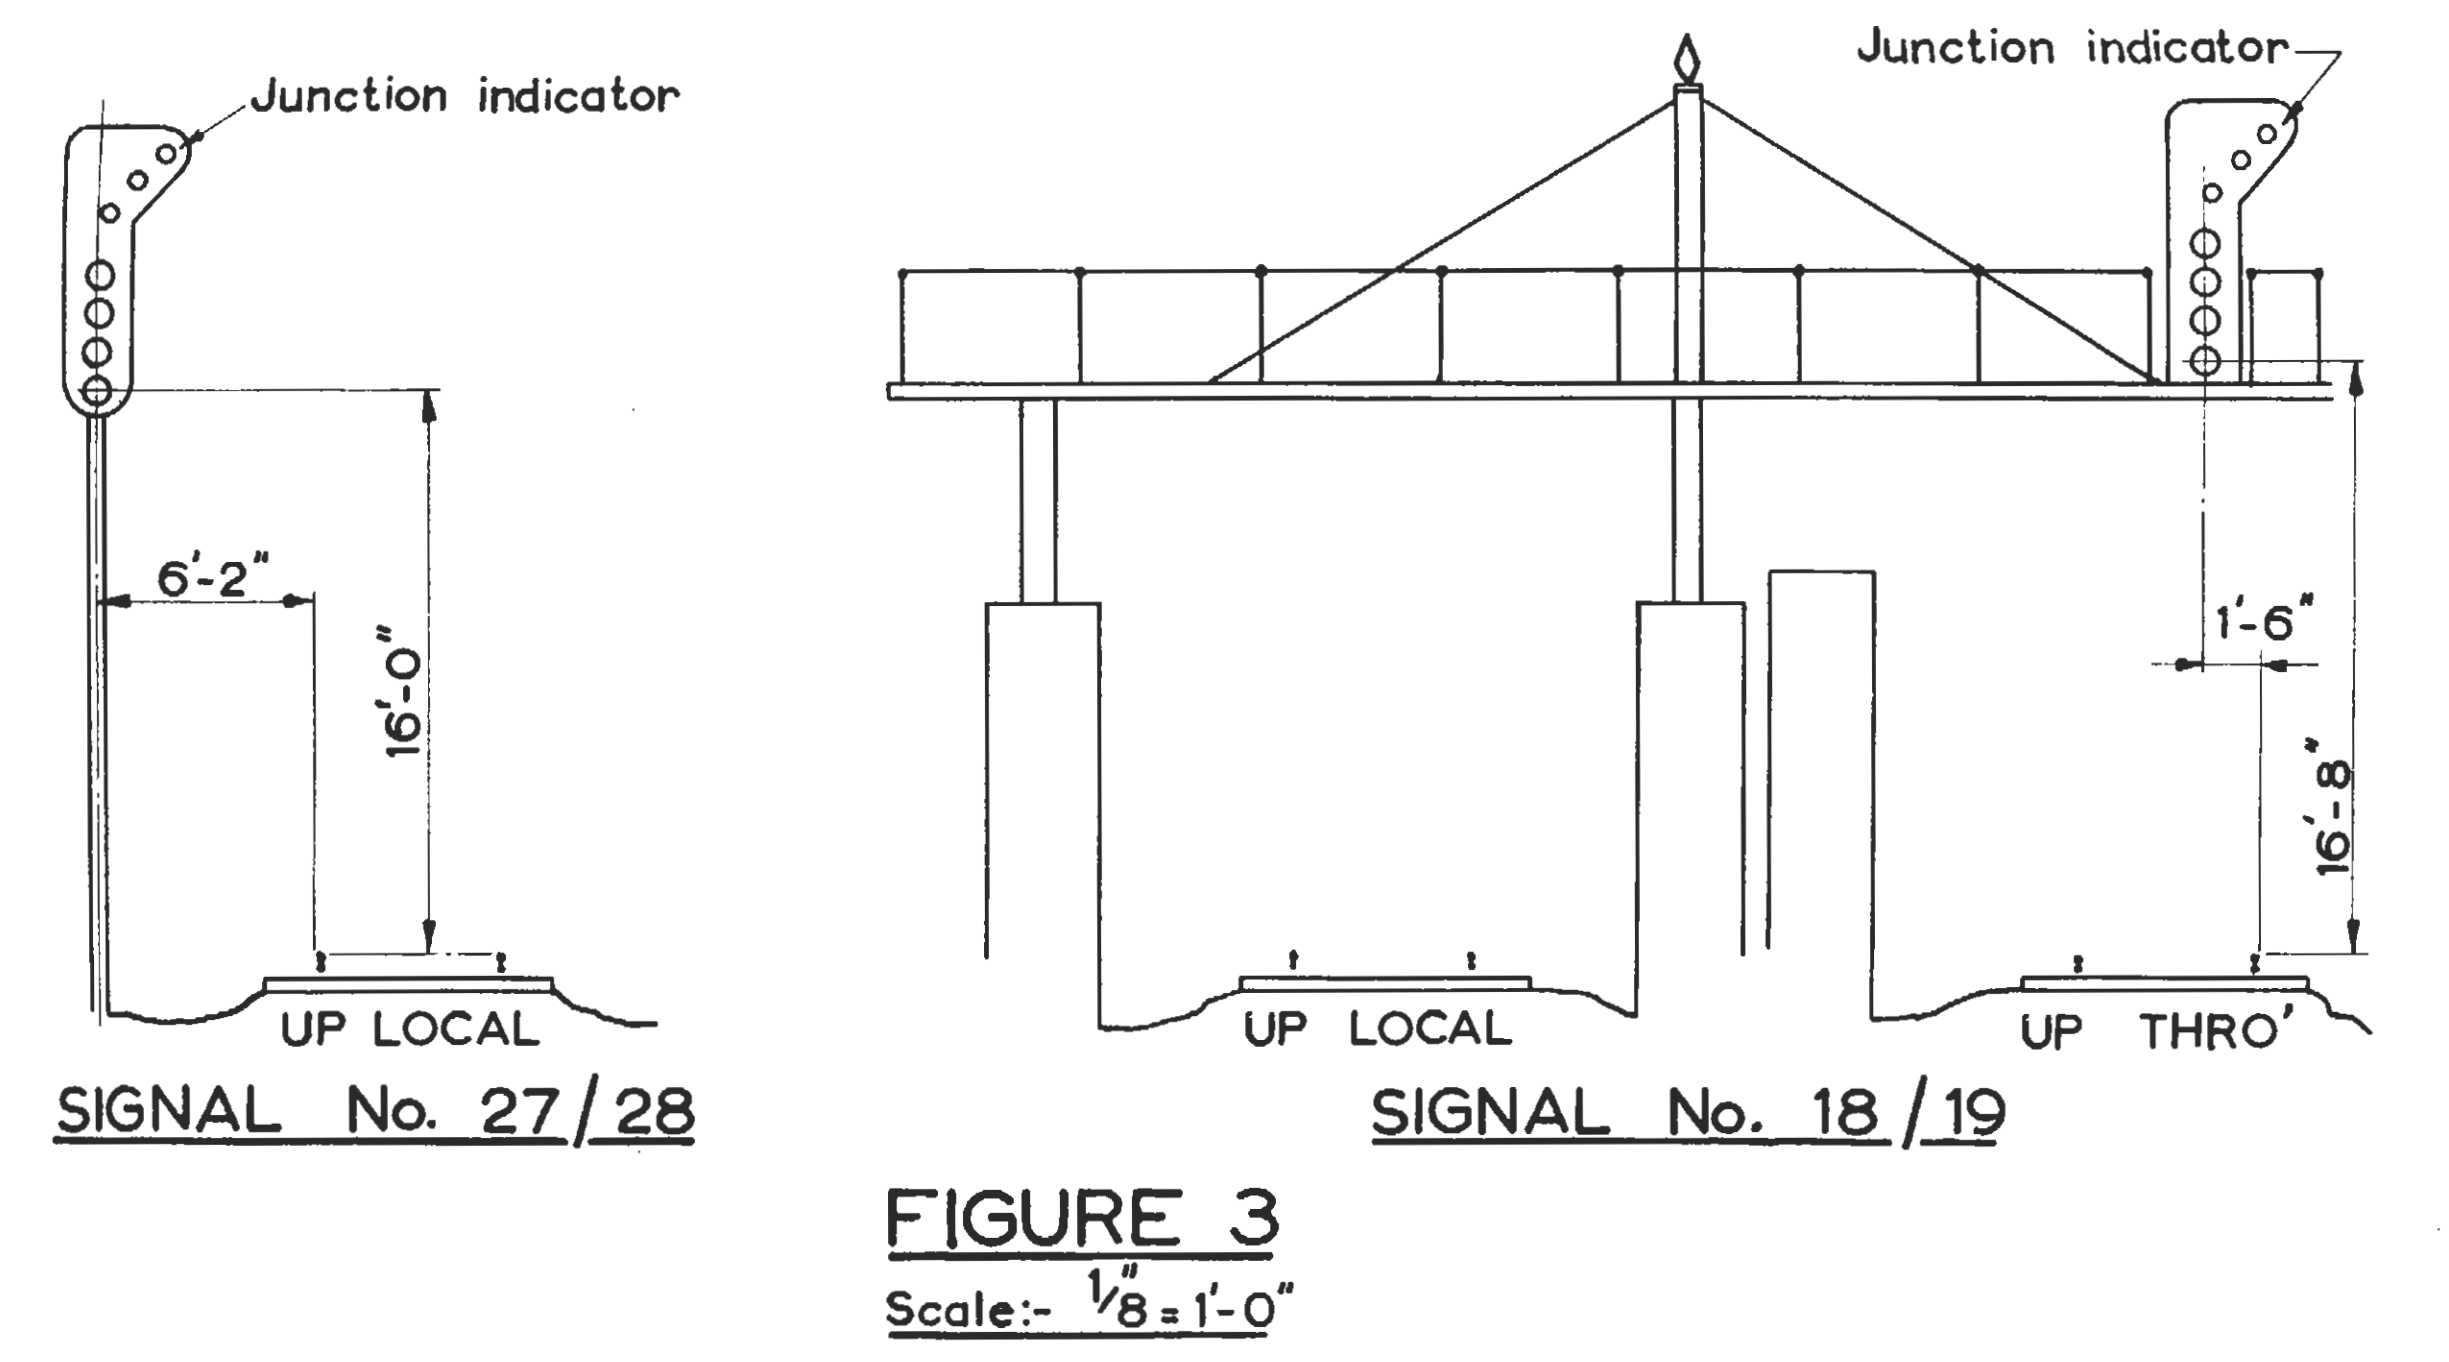
As shown in Figure No. 1 of the attached plan, Borough Market Junction is the point where the 4-track route from London Bridge diverges to Cannon Street and to Waterloo (Eastern) and Charing Cross. It is a most important junction and the traffic through it is extremely heavy. The junction is mainly on viaducts.

Figure No. 2 shows the layout of the tracks in the area and the position of the relevant signals on the Up Through and Up Local lines and on the Down line from Charing Cross. In the Up direction from London Bridge the lines run generally westwards and are mainly on sharp left-handed curves to Borough Market Junction signal box which is about 260 yards beyond the platforms. The 4-track route to Cannon Street then takes a sharp right-handed curve to the North, while the double track route to Charing Cross continues westwards for a short distance before swinging to the left. The Up lines rise at 1 in 109 through London Bridge to a point roughly halfway between the platforms and the signal box, and then fall at 1 in 128 through the junction. Metropolitan Junction is the next box towards Charing Cross.

Signal No. 18/19. This signal can first be seen by the driver of a train on the Up Through line at a distance of 200 yards to the left of a bridge girder between the Up Through and the Up Local lines (i.e. from point A on Figure No. 2); it remains in view for 57 yards till he reaches point B and is then obscured by the girder. It again comes into view beyond the girder at a distance of 80 yards (point C) and it remains in view until it is reached. The signal is focussed towards point C and consequently its light aspect is not brilliant when seen from between points A and B.

It can also be seen by a driver of a train on the Up Through line at a distance of 165 yards from signal No. 18/19 (point D). It remains in view for a distance of about 22 yards (up to point B) and is then obscured by the bridge girder. It again comes into view just beyond point C. Signal No. 27/28 is focussed towards the Up Local line and its aspects are not brilliant when seen from the Up Through line. A train on the Up Local line a coach length or more ahead of the train on the Up Through line does, however, obstruct the view of this signal from the train on the Up Through line.

When the two signals are both in view from between points D and B and again beyond point C, No. 27/28 is considerably to the left of and less brilliant than No. 18/19.

could have seen it at clear during the short time (probably 6-8 seconds) which elapsed while the train was travelling the distance of 54 yards between point A and the block joint just short of point B on Figure No. 2, and if its lever had been replaced during that period he could have seen the aspect change.

Signal No. 18/19 at Borough Market Junction is not easy to adjust for the most advantageous sighting by drivers. Its beam must be focussed at a point not too far from the signal to ensure that the aspect will be seen in fog, and then, on account of the severe curvature, it is not brilliant when seen at a greater distance. I recommend, therefore, that consideration should be given to providing the signal with a wide angle lens. In view of the slow speed of trains through the junction, the small reduction in brilliance of the wider beam should not make it difficult for the signal to be seen at close range during fog.

As mentioned earlier, the overlaps beyond some signals at Borough Market Junction are very short. On account of this and of the intensity of the traffic, an overrun of a signal creates a considerable risk of a collision. I recommend, therefore, that additional detonator placers should be provided which should be made to co-act with the aspects of signals—in other words, when a signal is red the detonator placer at it should automatically place the detonators on the line and should remove the detonators when the signal is clear. Because speeds through the junction are slow this arrangement might well avoid a collision resulting from an overrun or, at the least, cause the speed of the train and consequently the severity of the collision, to be reduced.

I have said that I am satisfied that the route ahead of the Hayes train was not changed. Nevertheless, I recommend that consideration be given to extending the approach locking track circuits of the signals so as to ensure that the approach locking operates from the time that the signals come into view; this is a principle which is applied in all modern installations.
