DEPARTMENT OF TRANSPORT

RAILWAY ACCIDENT

**Report on the Collision that
occurred on 11th September 1975
at Bricklayers Arms Junction**

IN THE
SOUTHERN REGION
BRITISH RAILWAYS

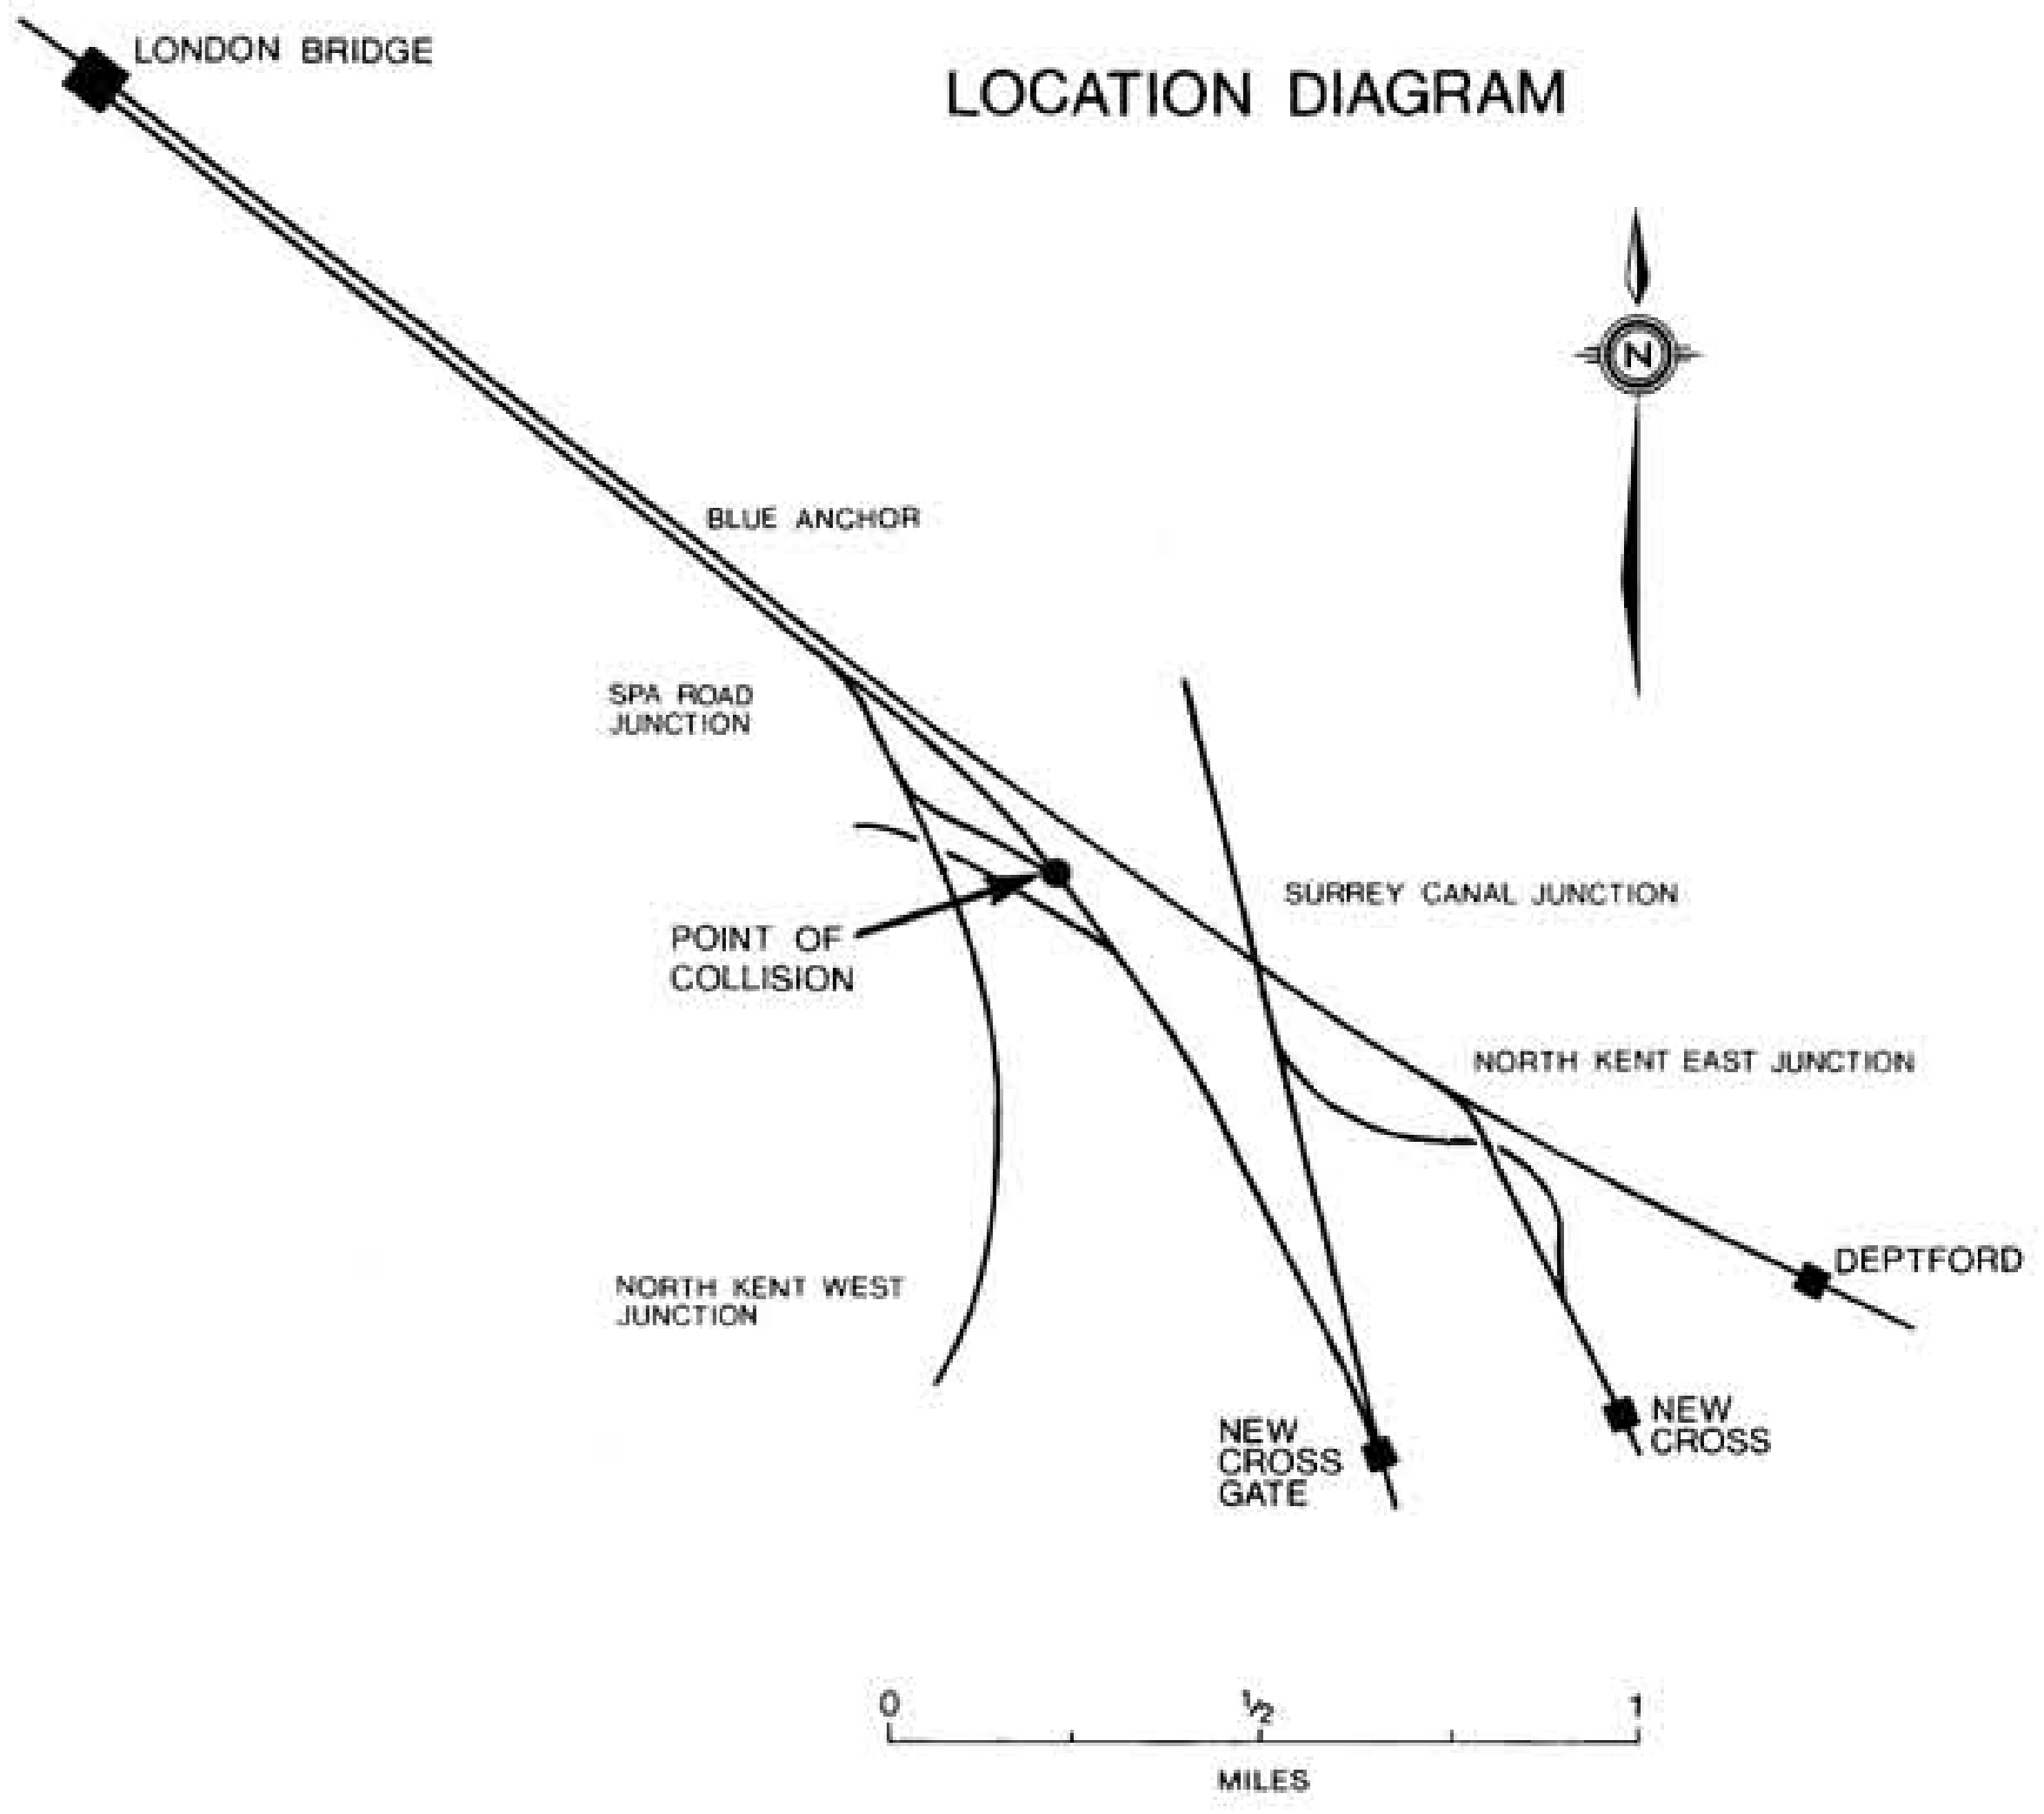
Plan of line between New Cross Gate and Blue Anchor showing
 derailment and routes of train

1. To the north of New Cross Gate Station, travelling in the Up direction towards London Bridge, there are four lines of railway, with the Up lines on the west side. At Bricklayers Arms Junction, where there are crossovers between the Up and Down Fast and Slow lines, the lines towards London diverge to run on three separate formations, with the Up and Down Goods lines to the left leading from the Up Slow line to North Kent West down a falling gradient; to the right the Up Fast and Down Fast and Slow lines continue curving to the right on a slightly rising gradient towards Blue Anchor; and on the centre formation curving to the left before becoming straight on a rising gradient of 1 in 162 steepening to 1 in 106, the Up Slow line becomes the Up Spur line and there are connections from the Up Fast and the Up Slow lines to the Down Spur line and the Reversible line which lie to the east of the Up Spur line. The collision occurred where the connection from the Up Slow (Up Spur) line joins that from the Up Fast and the lines then divide to become the Reversible and Down Spur lines. At the point of collision the Spur and Reversible lines lie approximately south-east to north-west and are running on an embankment some 20-30 feet above land containing factories, houses and playing fields. Normal line speed over the Spur, Reversible and Up Slow lines is 60 mile/h; over the diverging route at a set of points the speed limit is 25 mile/h. The layout of the lines and signals in the area together with the routes of the two trains concerned is shown on the plan at the back of the report.

7. Having brought his train to a stand on the Down Spur line at Signal L545 the driver of 5D33, under the impression that the subsidiary position-light signal was exhibiting a proceed aspect for his movement to the Carriage Road, released the brakes and moved his train forwards. Almost immediately he became aware of the approach of 2H27 which was travelling towards him on the Up Slow line and then proceeded to cross his route from his right-hand to his left-hand side in order to gain the Reversible line. He applied the brakes, and with his secondman evacuated the cab by the side doors; the train was almost at a stand when a glancing head-on collision occurred. The driver of the EMU also made an emergency brake application when he saw the diesel locomotive coming towards him but could do no more than to reduce the speed of his train before the collision. The two trains met at a slight angle which resulted in the leading coach of the EMU being lifted up and pushed past the locomotive, coming to rest leaning over at an angle with the passenger accommodation effectively intact. The cab of the locomotive and that of the EMU were completely destroyed by impacting into one another. The front of the EMU was pushed back into the guard's van, the buffer beam was bent approximately at right angles from the mid-point, and the underframe rode up over the locomotive frame allowing the locomotive buffer beam to push the motor bogie back to a point near the trailing bogie. The under-frame equipment of the leading motor coach was extensively damaged but the remaining three coaches of the EMU were effectively undamaged. The front of the leading locomotive was pushed back approximately
