RAILWAY ACCIDENT

REPORT ON THE COLLISION

2nd September 1960

CASTLECARY

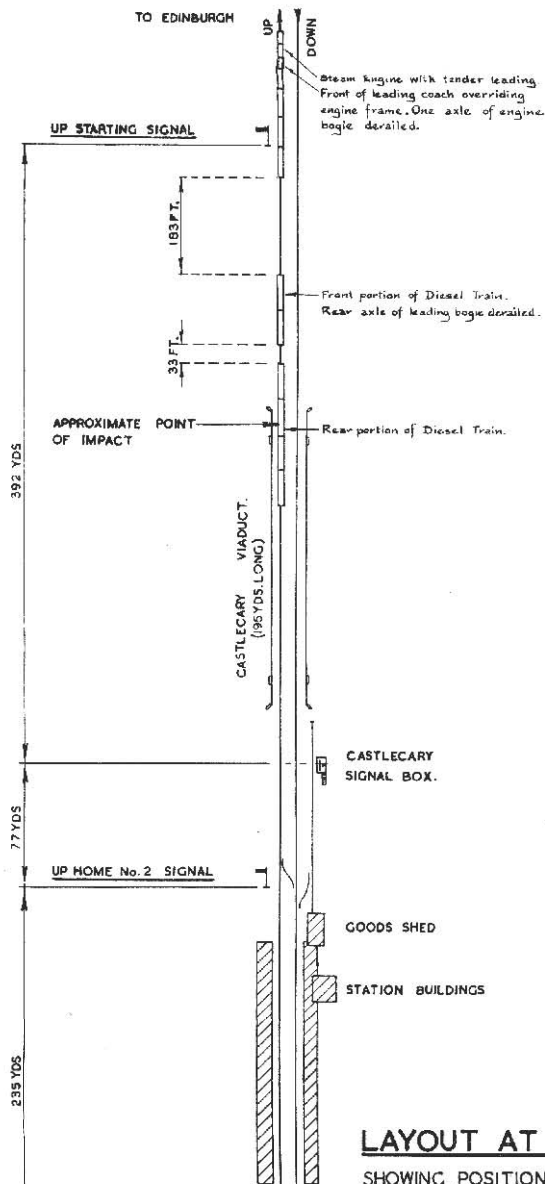
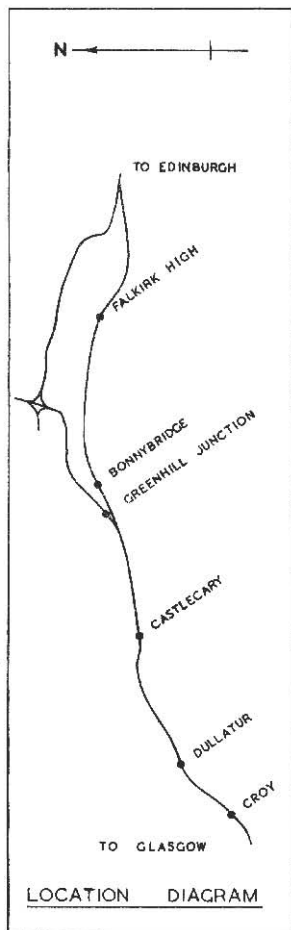
## LAYOUT AT CASTLECARY

SHOWING POSITION OF TRAINS AFTER COLLISION.

12. The distribution of the debris alongside the track showed that, at the moment of impact, the rear of the ECS train was some 65 feet short of the far end of the viaduct.
