LONDON PASSENGER TRANSPORT BOARD.

MINISTRY OF TRANSPORT,
Metropole Buildings,
Northumberland Avenue,
London, W.C.2.
22nd July, 1938.

I have the honour to report for the information of the Minister of Transport, in accordance with the Order dated 17th May, 1938, the result of my Inquiry into the accident which took place near Charing Cross station on the electrified "District" line of the London Passenger Transport Board, at about 9.55 a.m. on that day.

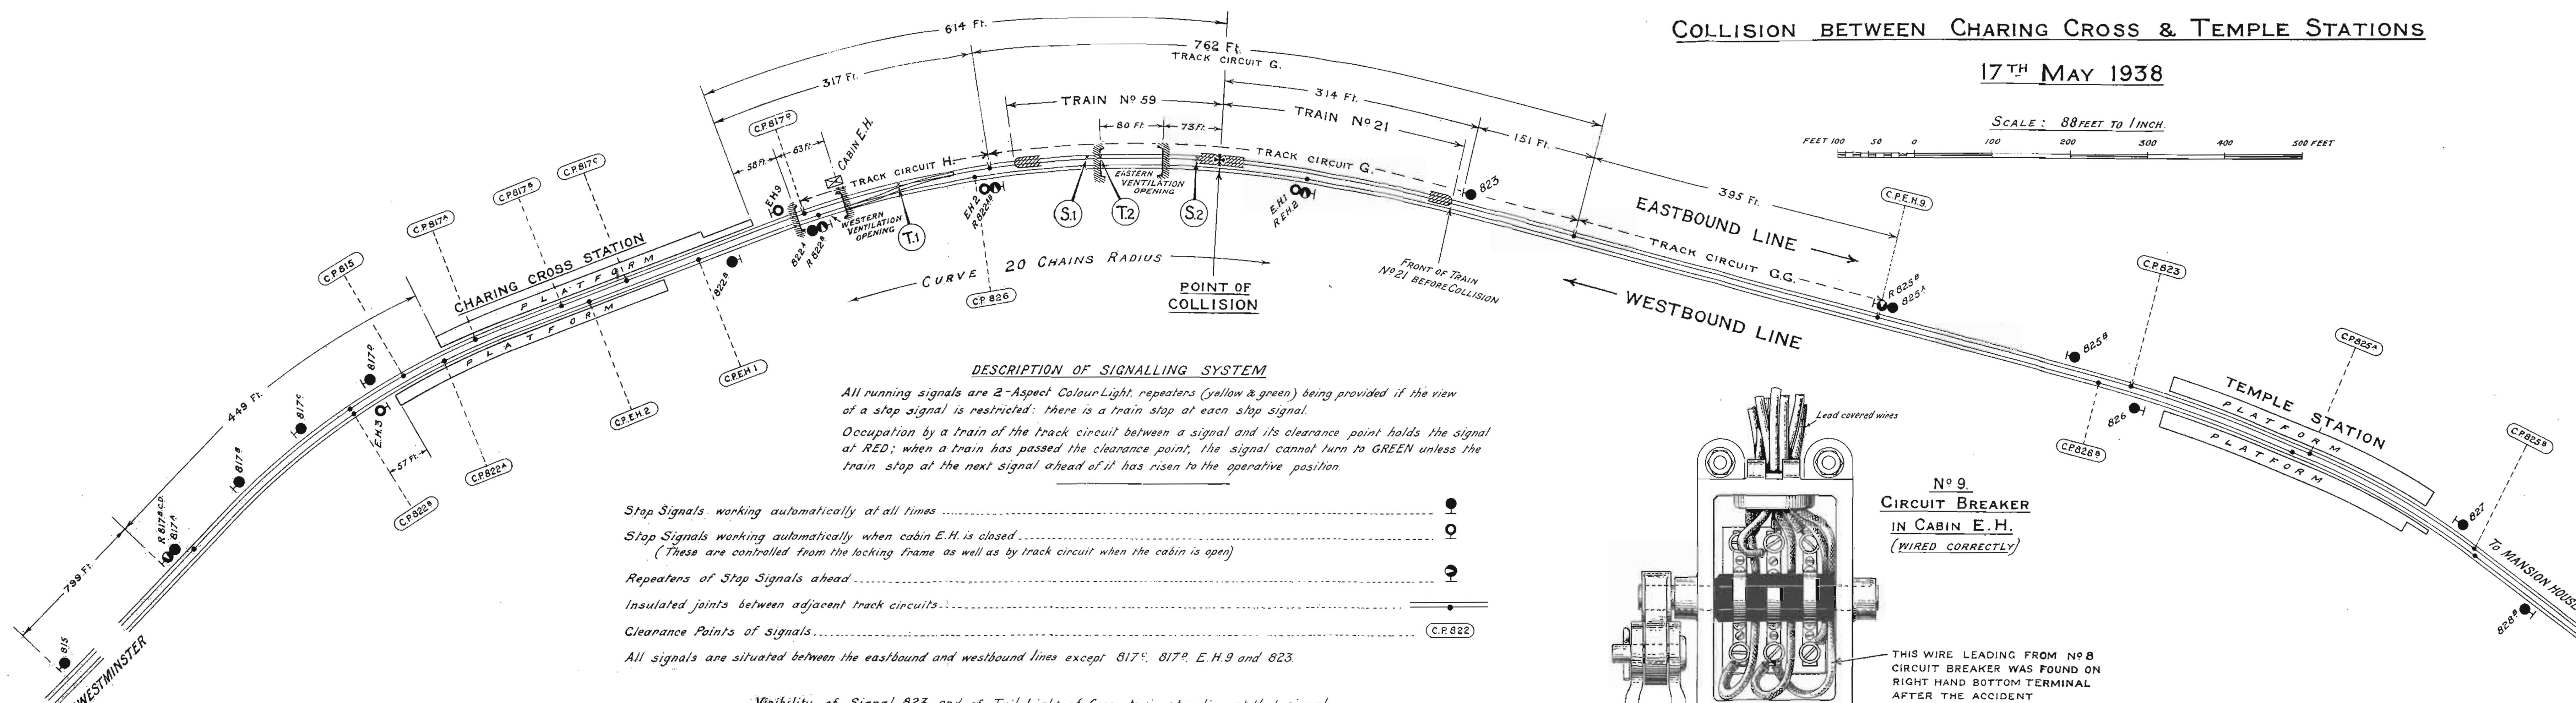
17TH MAY 1938

3. As shown on the attached plan, the accident took place on the eastbound line between Charing Cross and Temple stations, about 307 yards east of the former. The line between the two stations is level, and lies in tunnel, or more accurately in cut-and-cover; there are two ventilation openings which admit daylight to the line a short distance east of Charing Cross station. The point of collision was in the tunnel, about 73 ft. beyond the easternmost of these, and is approached by an eastbound train round a right-hand curve of 20 chains radius.

Visibility of Signal 823 and of Tail Light of 6 car train standing at that signal

If Westbound Train is passing:-
at S.1 Signal 823 can be seen 345 feet away, at S.2
" T.1 Tail Light " " " 153 " " " T.2
