# RAILWAY ACCIDENT

## **Report on the Derailment that occurred on 7th September 1972 at Clapham Junction**

IN THE  
SOUTHERN REGION  
BRITISH RAILWAYS

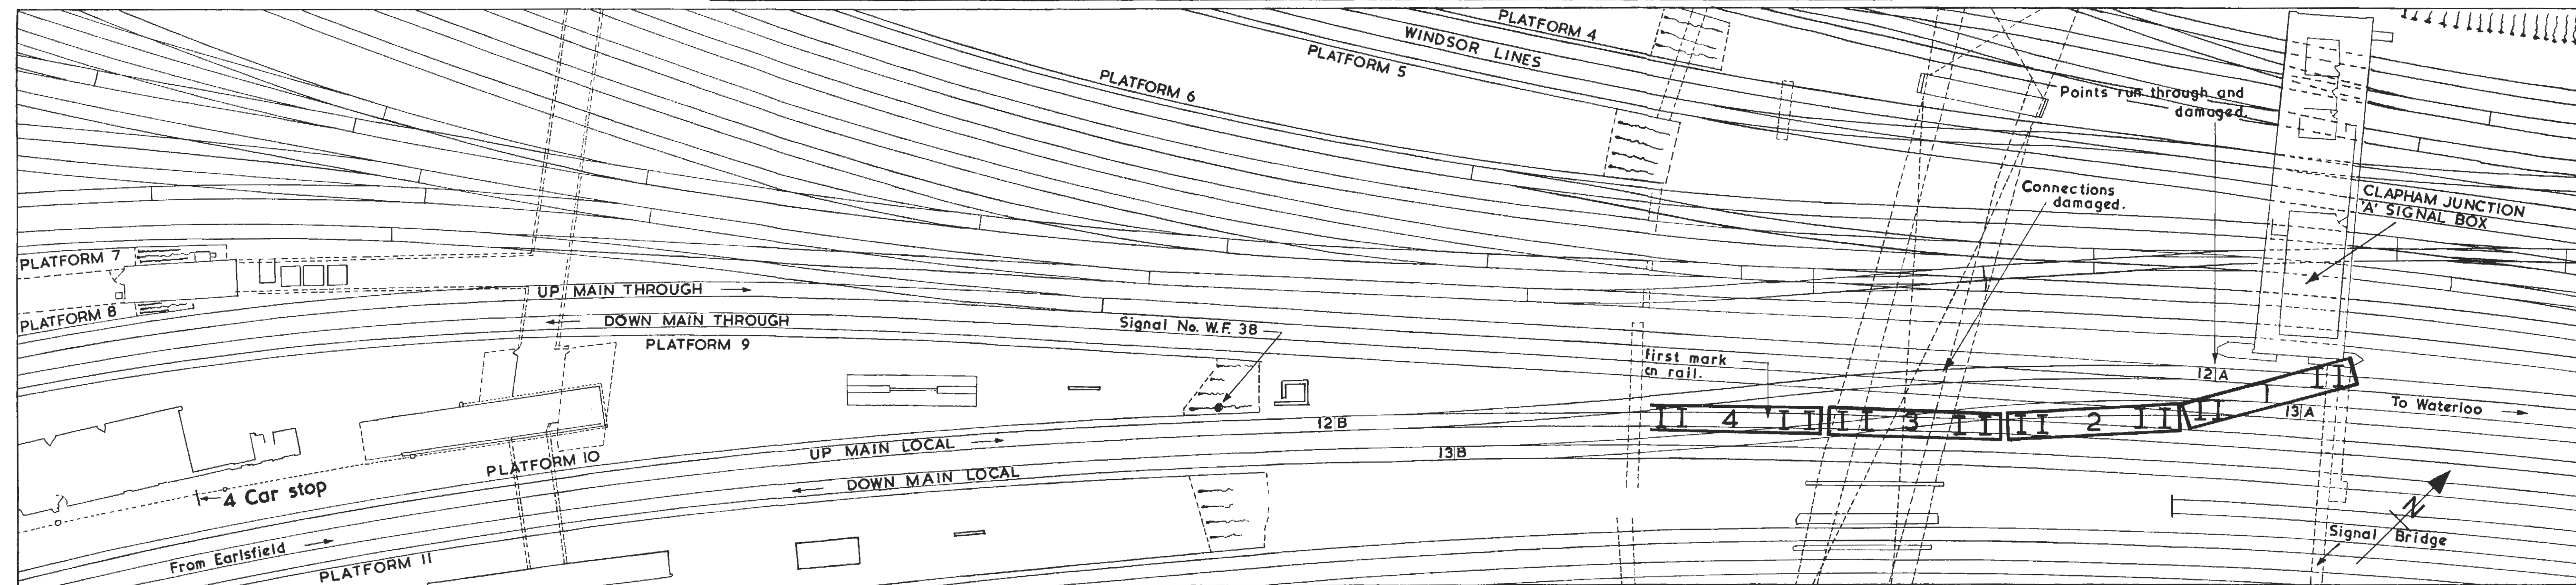
PLAN SHOWING THE POSITION OF THE TRAIN AFTER DERAILMENT

6. The facing points at the London end of platform 10 were in the reverse position when the train reached them, and the leading bogie of the first coach took the route leading towards the Up Main Through line. The points then moved to the normal position so that the remainder of the train continued along the Up Local line. About 140 ft beyond the switches the rear bogie of the leading coach became derailed and this was followed by derailment of the leading bogie of the second coach. The train came to a stand with the first coach leaning over at an angle and straddling the Up and Down Main Through lines just underneath the gantry carrying Clapham Junction "A" signal box. Damage to the train was confined to the first two coaches on which the wheel tyres were bruised, power and light conduits were broken, and damage was caused to springs, solebars, and axleboxes. The derailment caused moderate damage to the crossovers and to signal cables, and the London end of No. 12 points (12A) were run through and damaged.

21. The disposition of the vehicles after the derailment and the pattern of damage to the permanent way show clearly how the accident happened. Signalman Savage must have returned the lever controlling No. 12 points to normal just before the front of the train reached the insulated joint immediately in front of the points, and thus before the track locking became effective, so that although the point motor operating contacts were made the switches had not started to move, or had only just done so, when the leading wheels of the train arrived on them. It is possible that the switches did not actually start to move until the leading bogie had passed completely over them, but even had they done so the wheel flanges would have held them closed against the action of the point motor until the leading bogie had passed whereupon the switches would have moved to the normal position and would have completed their movement by the time the second bogie arrived on them. With the leading bogie taking the crossover and the rear bogie continuing along the Up Local line the leading coach slewed sideways until its rear bogie derailed on the diamond crossing of the Down Main Through to Down Main Local crossover. The leading bogie remained on the rails, running through and damaging the trailing switches of the other crossover, which by this time were in the normal position.

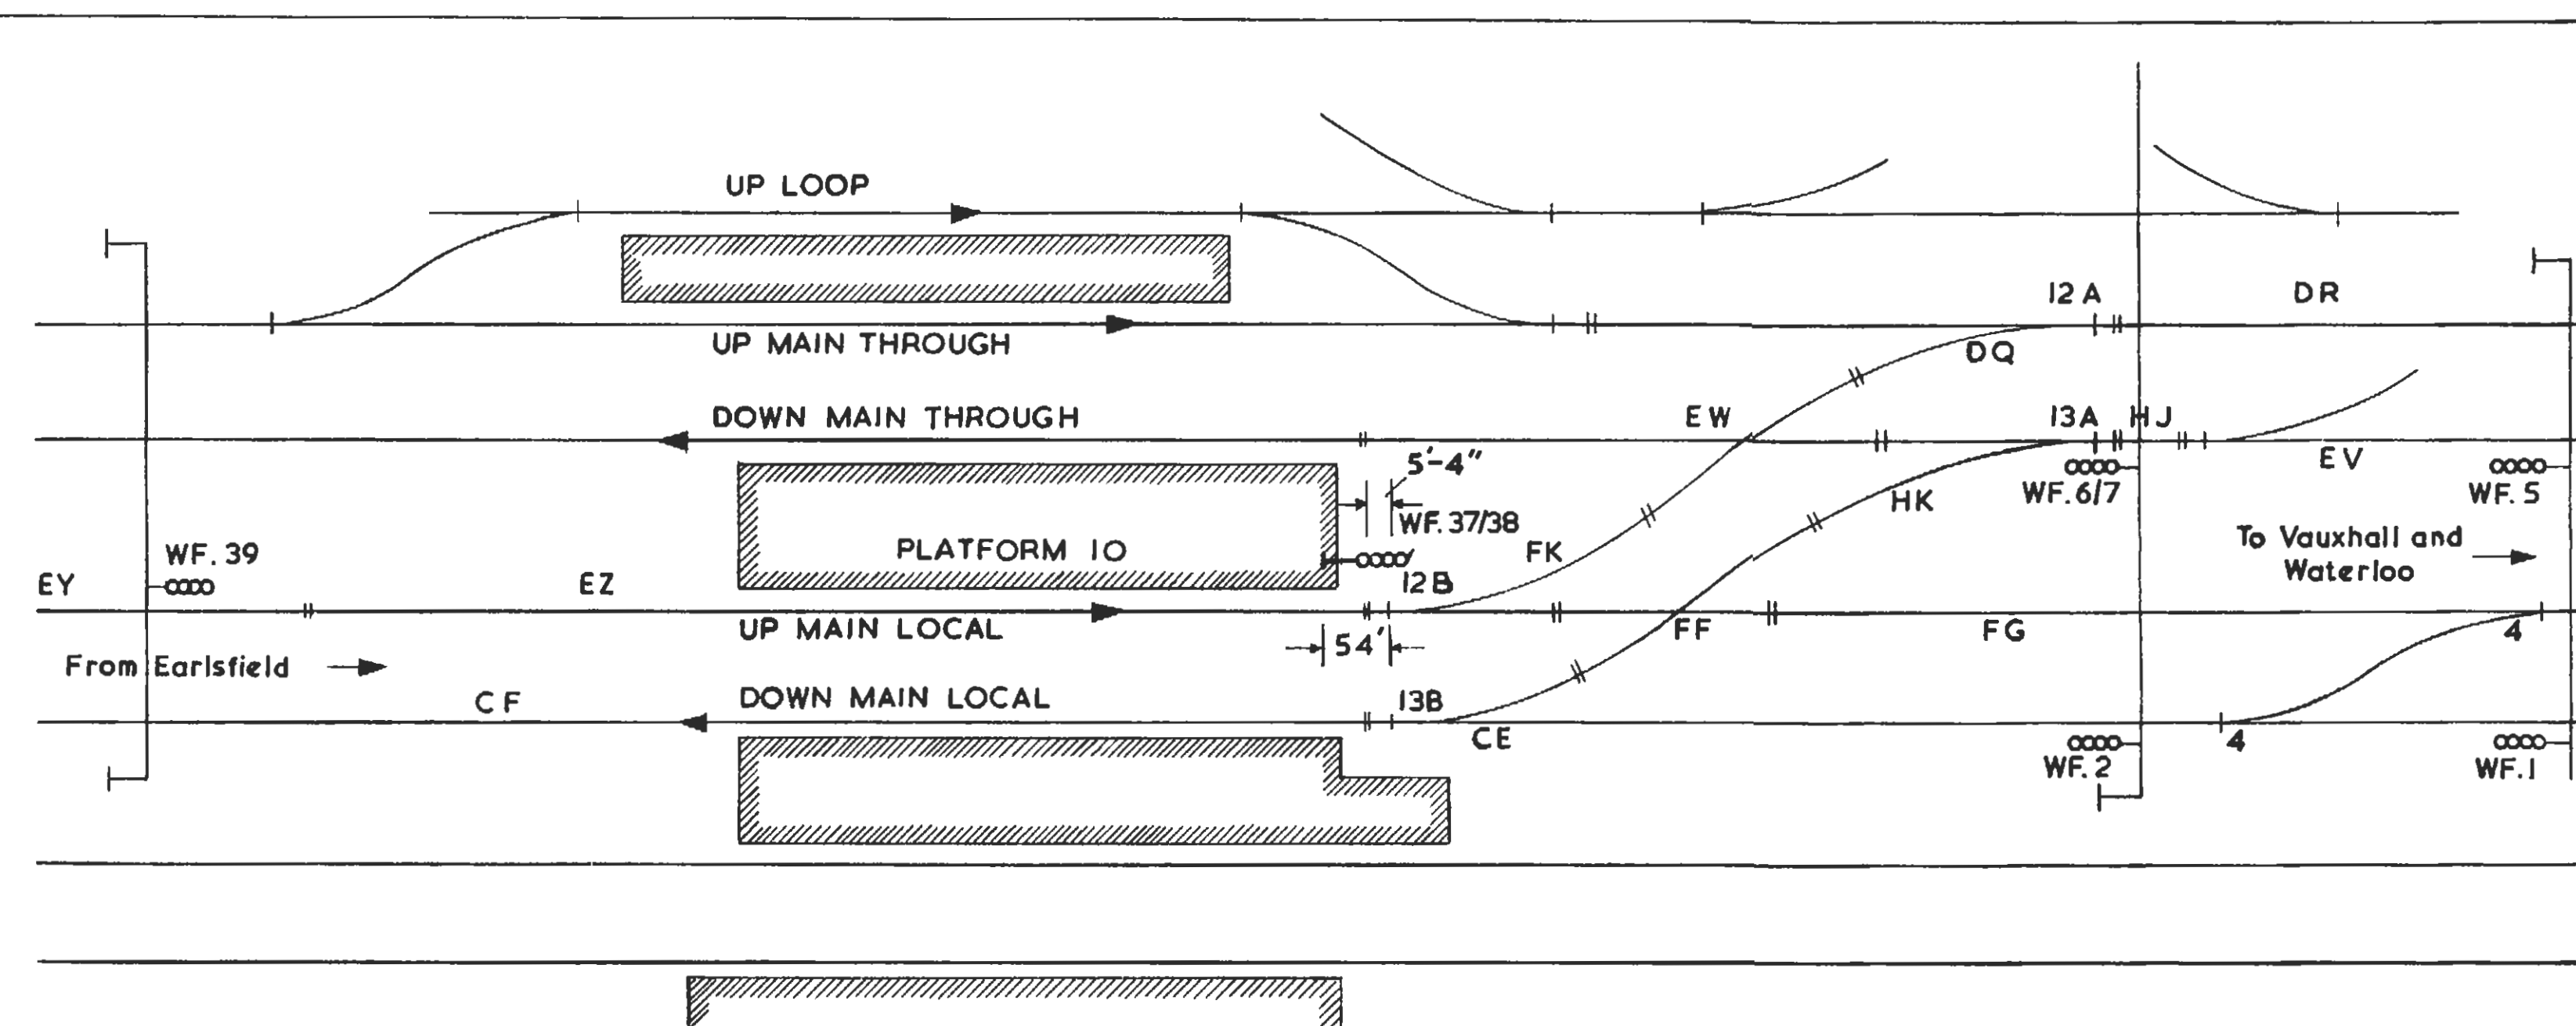
PLAN SHOWING THE SIGNALLING

4. The relevant controls on the signals and points concerned in the accident are as follows:
- a. Signal WF.39 (the Up Main Local outer home signal reading to Signal WF.38)  
Locks No. 12 points Normal and Reverse  
Locks No. 13 points when No. 12 points are Normal  
Approach locked by occupation of TC "EY"

- b. *Signal WF.38* (Up Main Local inner home—platform starting—signal)  
Locks No. 12 and 13 points Normal  
Approach locked by occupation of TC "EZ"
- c. *Signal WF.37* (Up Main Local to Up Main Through inner home—platform starting—signal)  
Released by No. 12 points reverse  
Approach controlled by occupation of TC "EZ"  
Approach locked by occupation of TC "EZ"
- d. *No. 12 points*  
Reversed locks *Signal WF.38*. Track locked by occupation of TC "FK" (the insulated joint between TCs "EZ" and "FK" is located 5 ft 4 ins from the toe of the facing points)
- e. *No. 13 points*  
Reversed locks *Signal WF.38*, and *Signal WF.39* when No. 12 points are Normal

22. I have no reason to believe that at the time of the accident there was any fault in the signalling system. It had functioned correctly before the accident, the thorough tests carried out by Mr. Gregory soon after the accident revealed no faults, and the equipment has continued to function properly since the accident. If the integrity of the signalling is accepted, as I think that it must be, certain important facts must also be accepted. Firstly, Signalman Savage could not have cleared signal WF.38 as long as No. 12 points were reversed, and these points *were* reversed at the moment when the front of the train passed the signal. Secondly, if Signalman Savage had cleared the signal for the crossover route (WF.37) the junction indicator lights would have been illuminated and he would not have been able to restore the points to normal, as in fact he did, unless he had first replaced this signal to Danger. Thirdly, the reversal of No. 13 points locks signal WF.38 at Danger and Signalman Savage would thus have had to return these points to normal, as well as No. 12, before he could have cleared the signal for the Up Local line.

32. The signalling system at Clapham Junction is basically of 1936 design, although many individual items of equipment are of much more recent date. When plans are prepared for the resignalling of the area I recommend that consideration be given to extending the track locking at No. 12 points, and at other points where the track locking is very short.
