MINISTRY OF TRANSPORT

REPORT ON THE COLLISION

21st January 1952 at

CLYDEBANK STATION

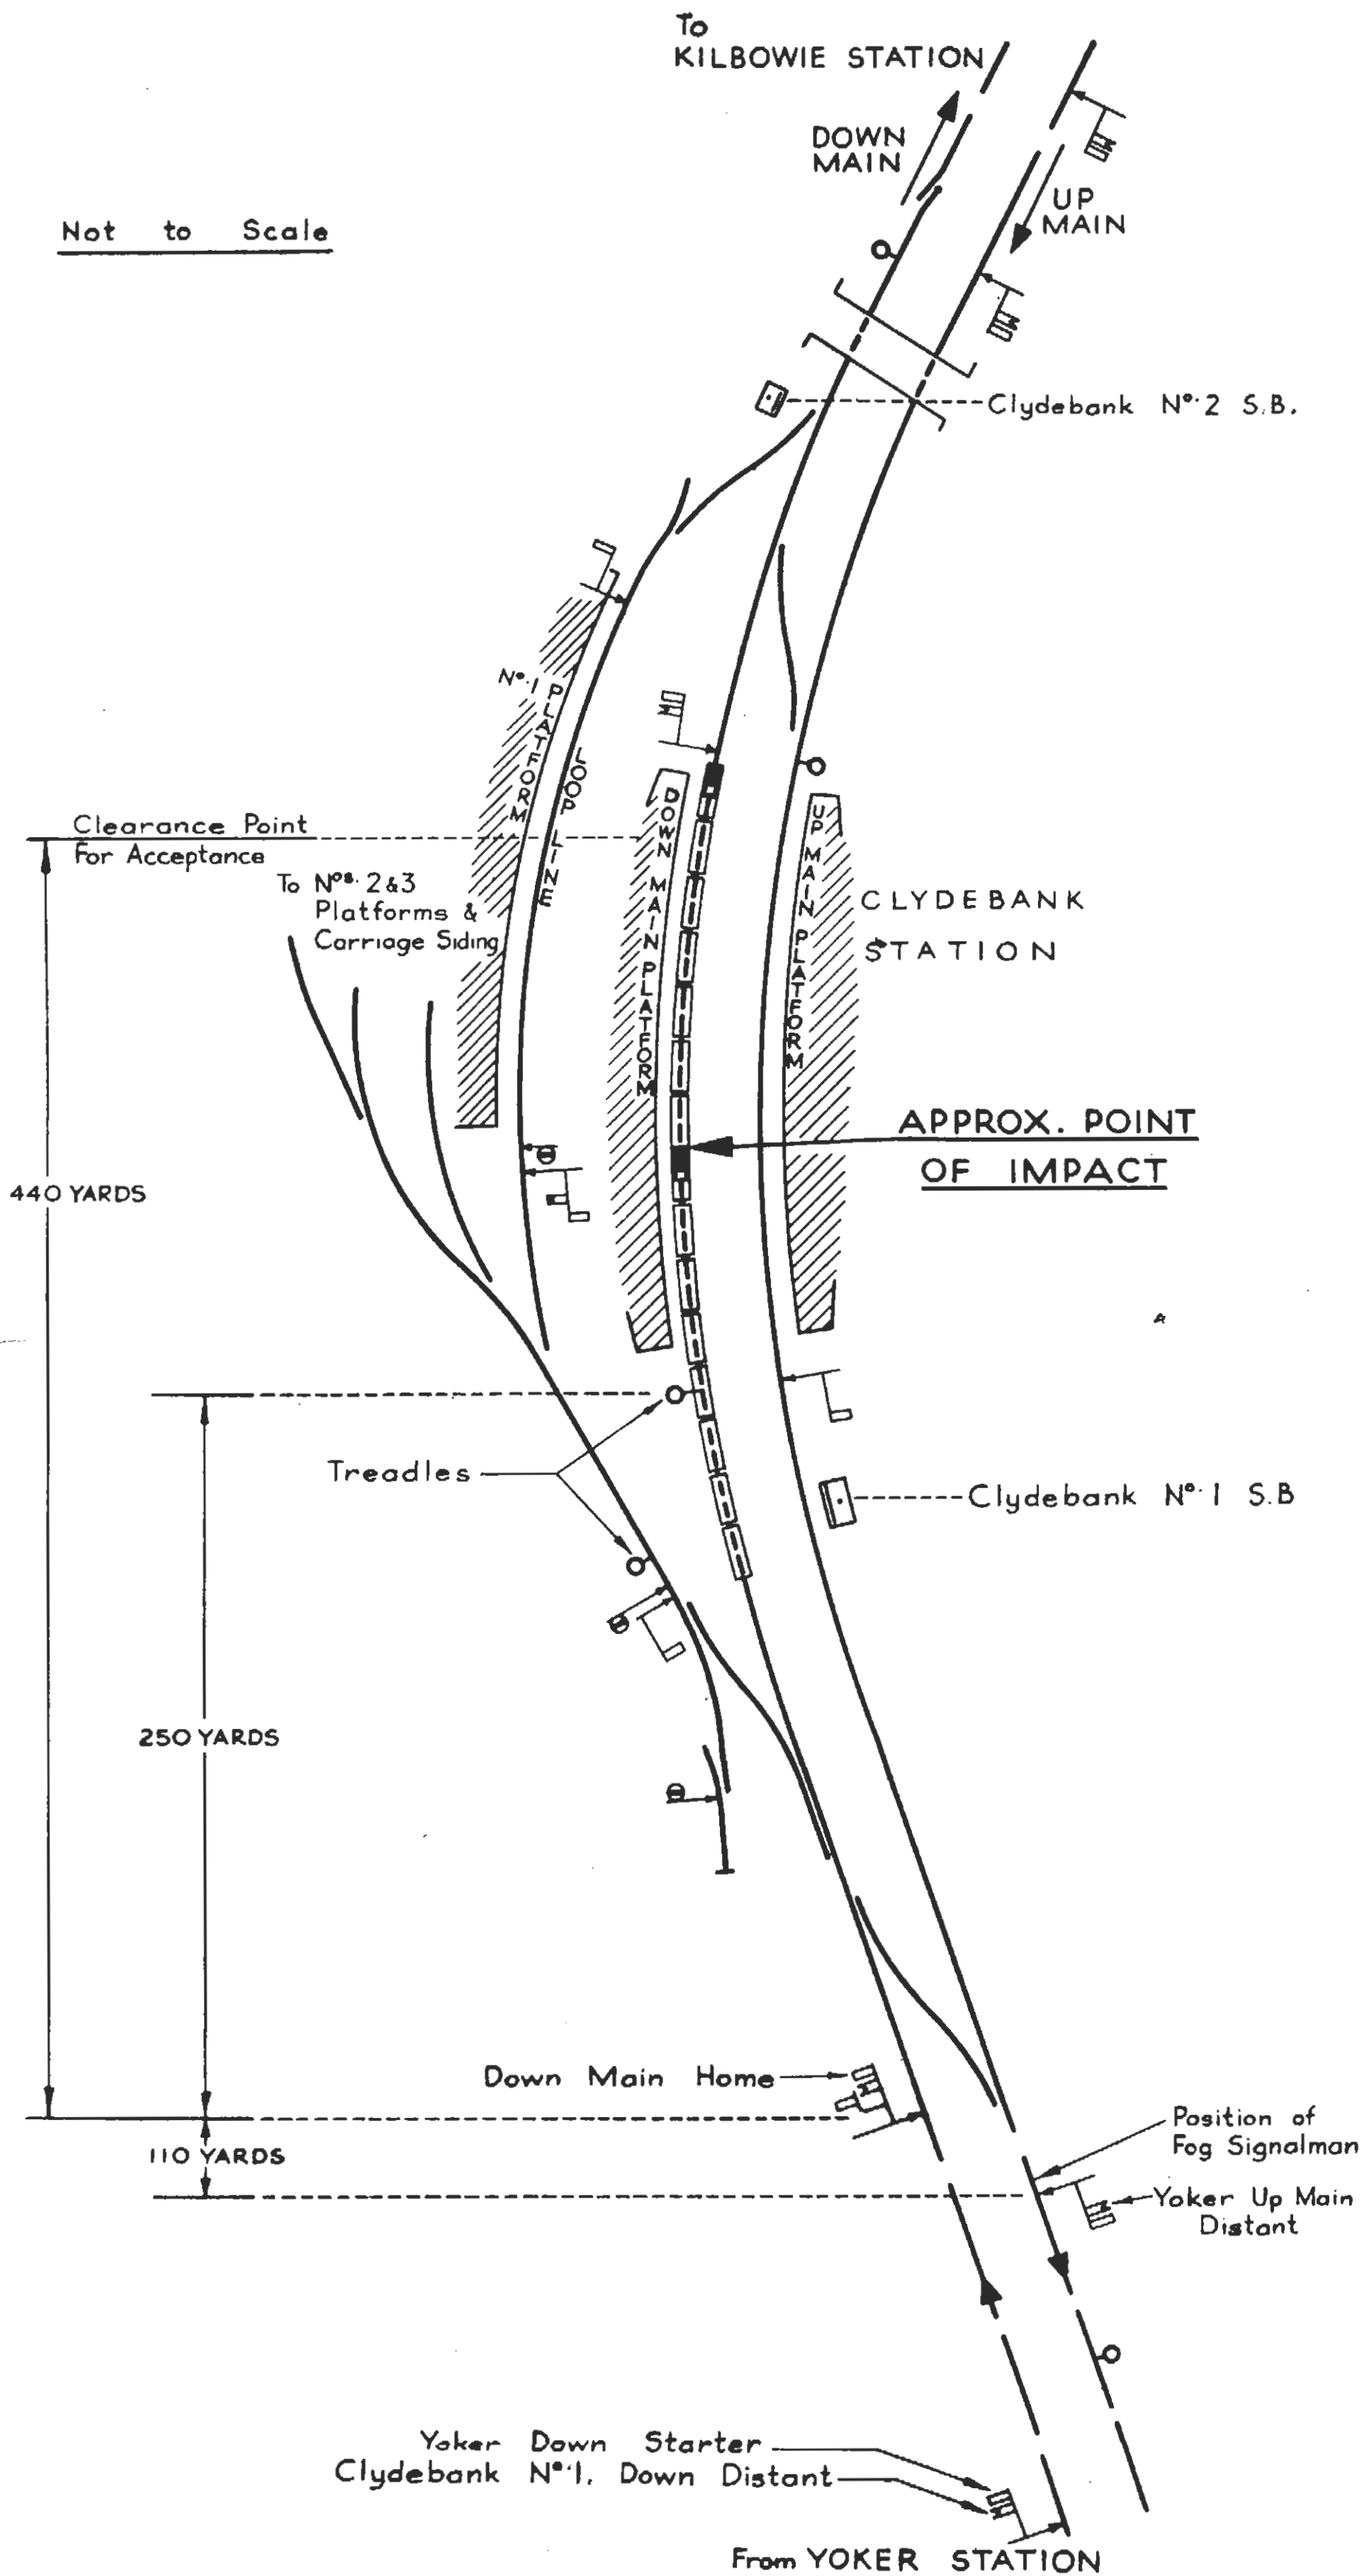
A diagram of the line and of the lay out at Clydebank Station is given opposite.

Approaching the station, the Down main line falls at 1 in 120, and is on a right hand curve of 18½ chains.

Between Yoker, Clydebank No. 1, and Clydebank No. 2 signalboxes, the line is worked in accordance with the former L.M.S. Absolute Block Regulations, as modified for the Tyer's two-position Lock and Block system. Contact treadles are placed 250 yards in advance of the Down Home signal on the main line, and 203 yards in advance of the same signal on the Down loop line. When operated by the leading wheels of a train, the treadle releases the Lock and Block instrument for the acceptance of a following train.

There was a fogsignalman on duty at the Yoker Up Distant signal which, as will be seen from the diagram, is 110 yards in rear of the Clydebank No. 1 Down Home signal. No other fogsignalmen were on duty in the vicinity. The 6.50 a.m. train approached Clydebank No. 1 Down Home signal slowly, and the driver was prepared to stop, when the fireman, from the right hand side of the engine told him that he had seen a green light. This was, in fact, the light from the fogsignalman's hand lamp at the Yoker Up Distant signal, and it was, properly, on the cess side of the Up line. Upon hearing this information the driver concluded, without any justification, that the green light referred to the Down Home signal, that this signal had failed, and that he was intended to pass it at Danger. He therefore continued past the signal into the station, and collided at a speed of about 15 m.p.h. with the rear of the 6.40 a.m. train which was still standing at the platform. The driver caught sight of the tail-lamp of this train through the fog when about 20 yards away, and he applied his brakes fully, but there was no time for them to take effect.
