MINISTRY OF TRANSPORT

REPORT ON THE COLLISION

26th December 1962

WINSFORD STATION and
COPPENHALL JUNCTION

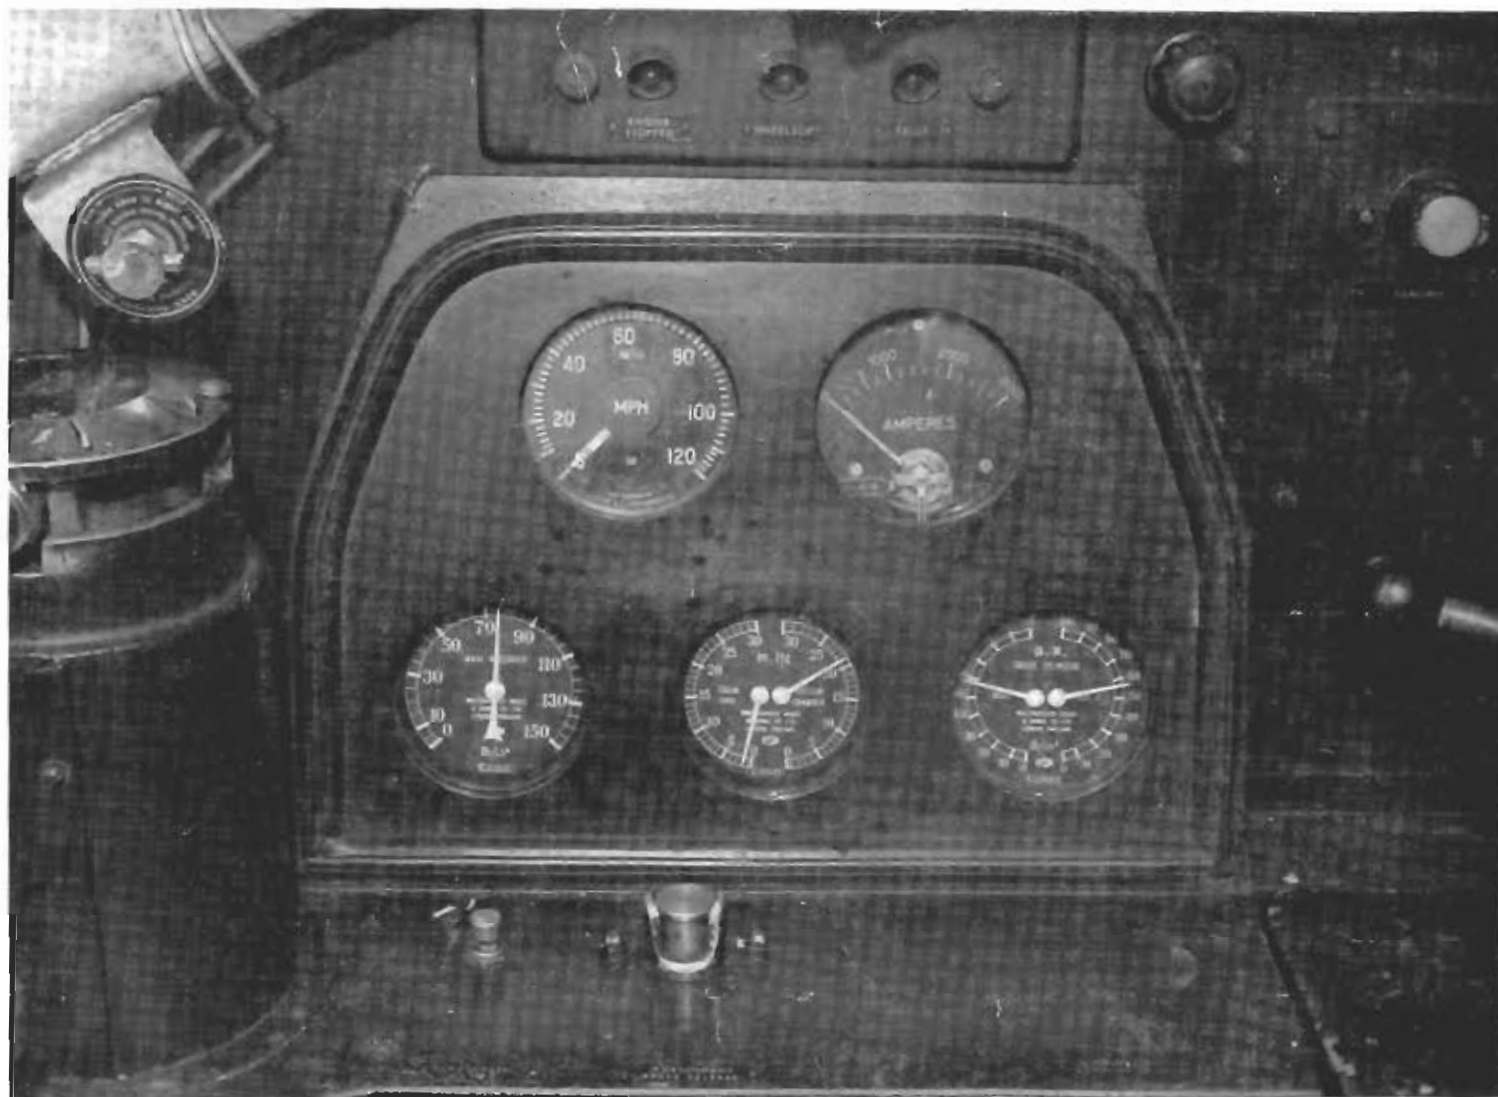
Instrument Panel of Diesel Locomotive.

11. The diesel locomotive had a driving compartment at each end and the driving position in each is on the left-hand side. Each compartment was equipped with a speedometer on an instrument panel situated in front of the driving seat. A photograph of the panel is reproduced opposite. It will be observed that there are no graduations between the 0 and 10 m.p.h. marks on the speedometer and that there is no figure against the latter mark.

50. The speedometers in the driving cabs at both ends of the diesel locomotive on the Mid-day Scot were thoroughly tested. It was found that they read between 1 m.p.h. and 2 m.p.h. high in the working range from 5 m.p.h. to 15 m.p.h. At 20 m.p.h. the error did not exceed 1 m.p.h. in any of the tests.

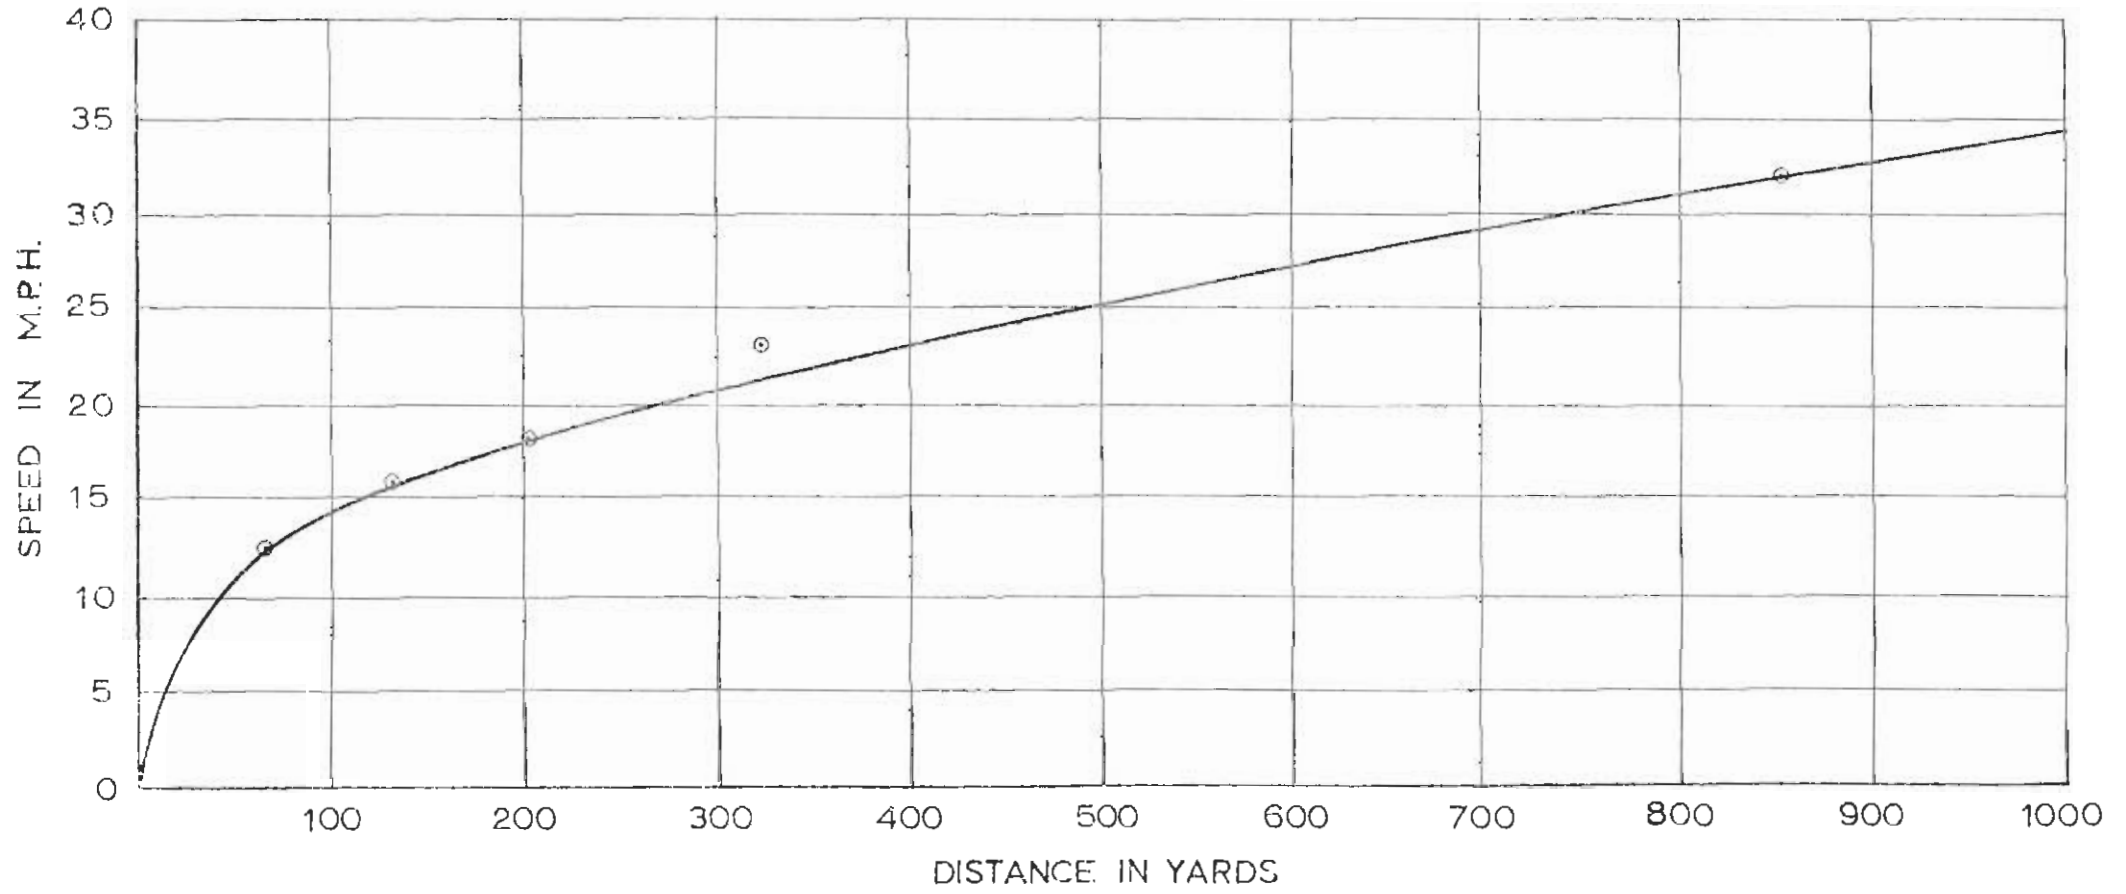
APPENDIX A

46. I carried out some acceleration and braking tests with a train similar in composition and weight to the Glasgow train, and hauled by a similar type of engine. The results are shown in the graphs in Appendices A and B.

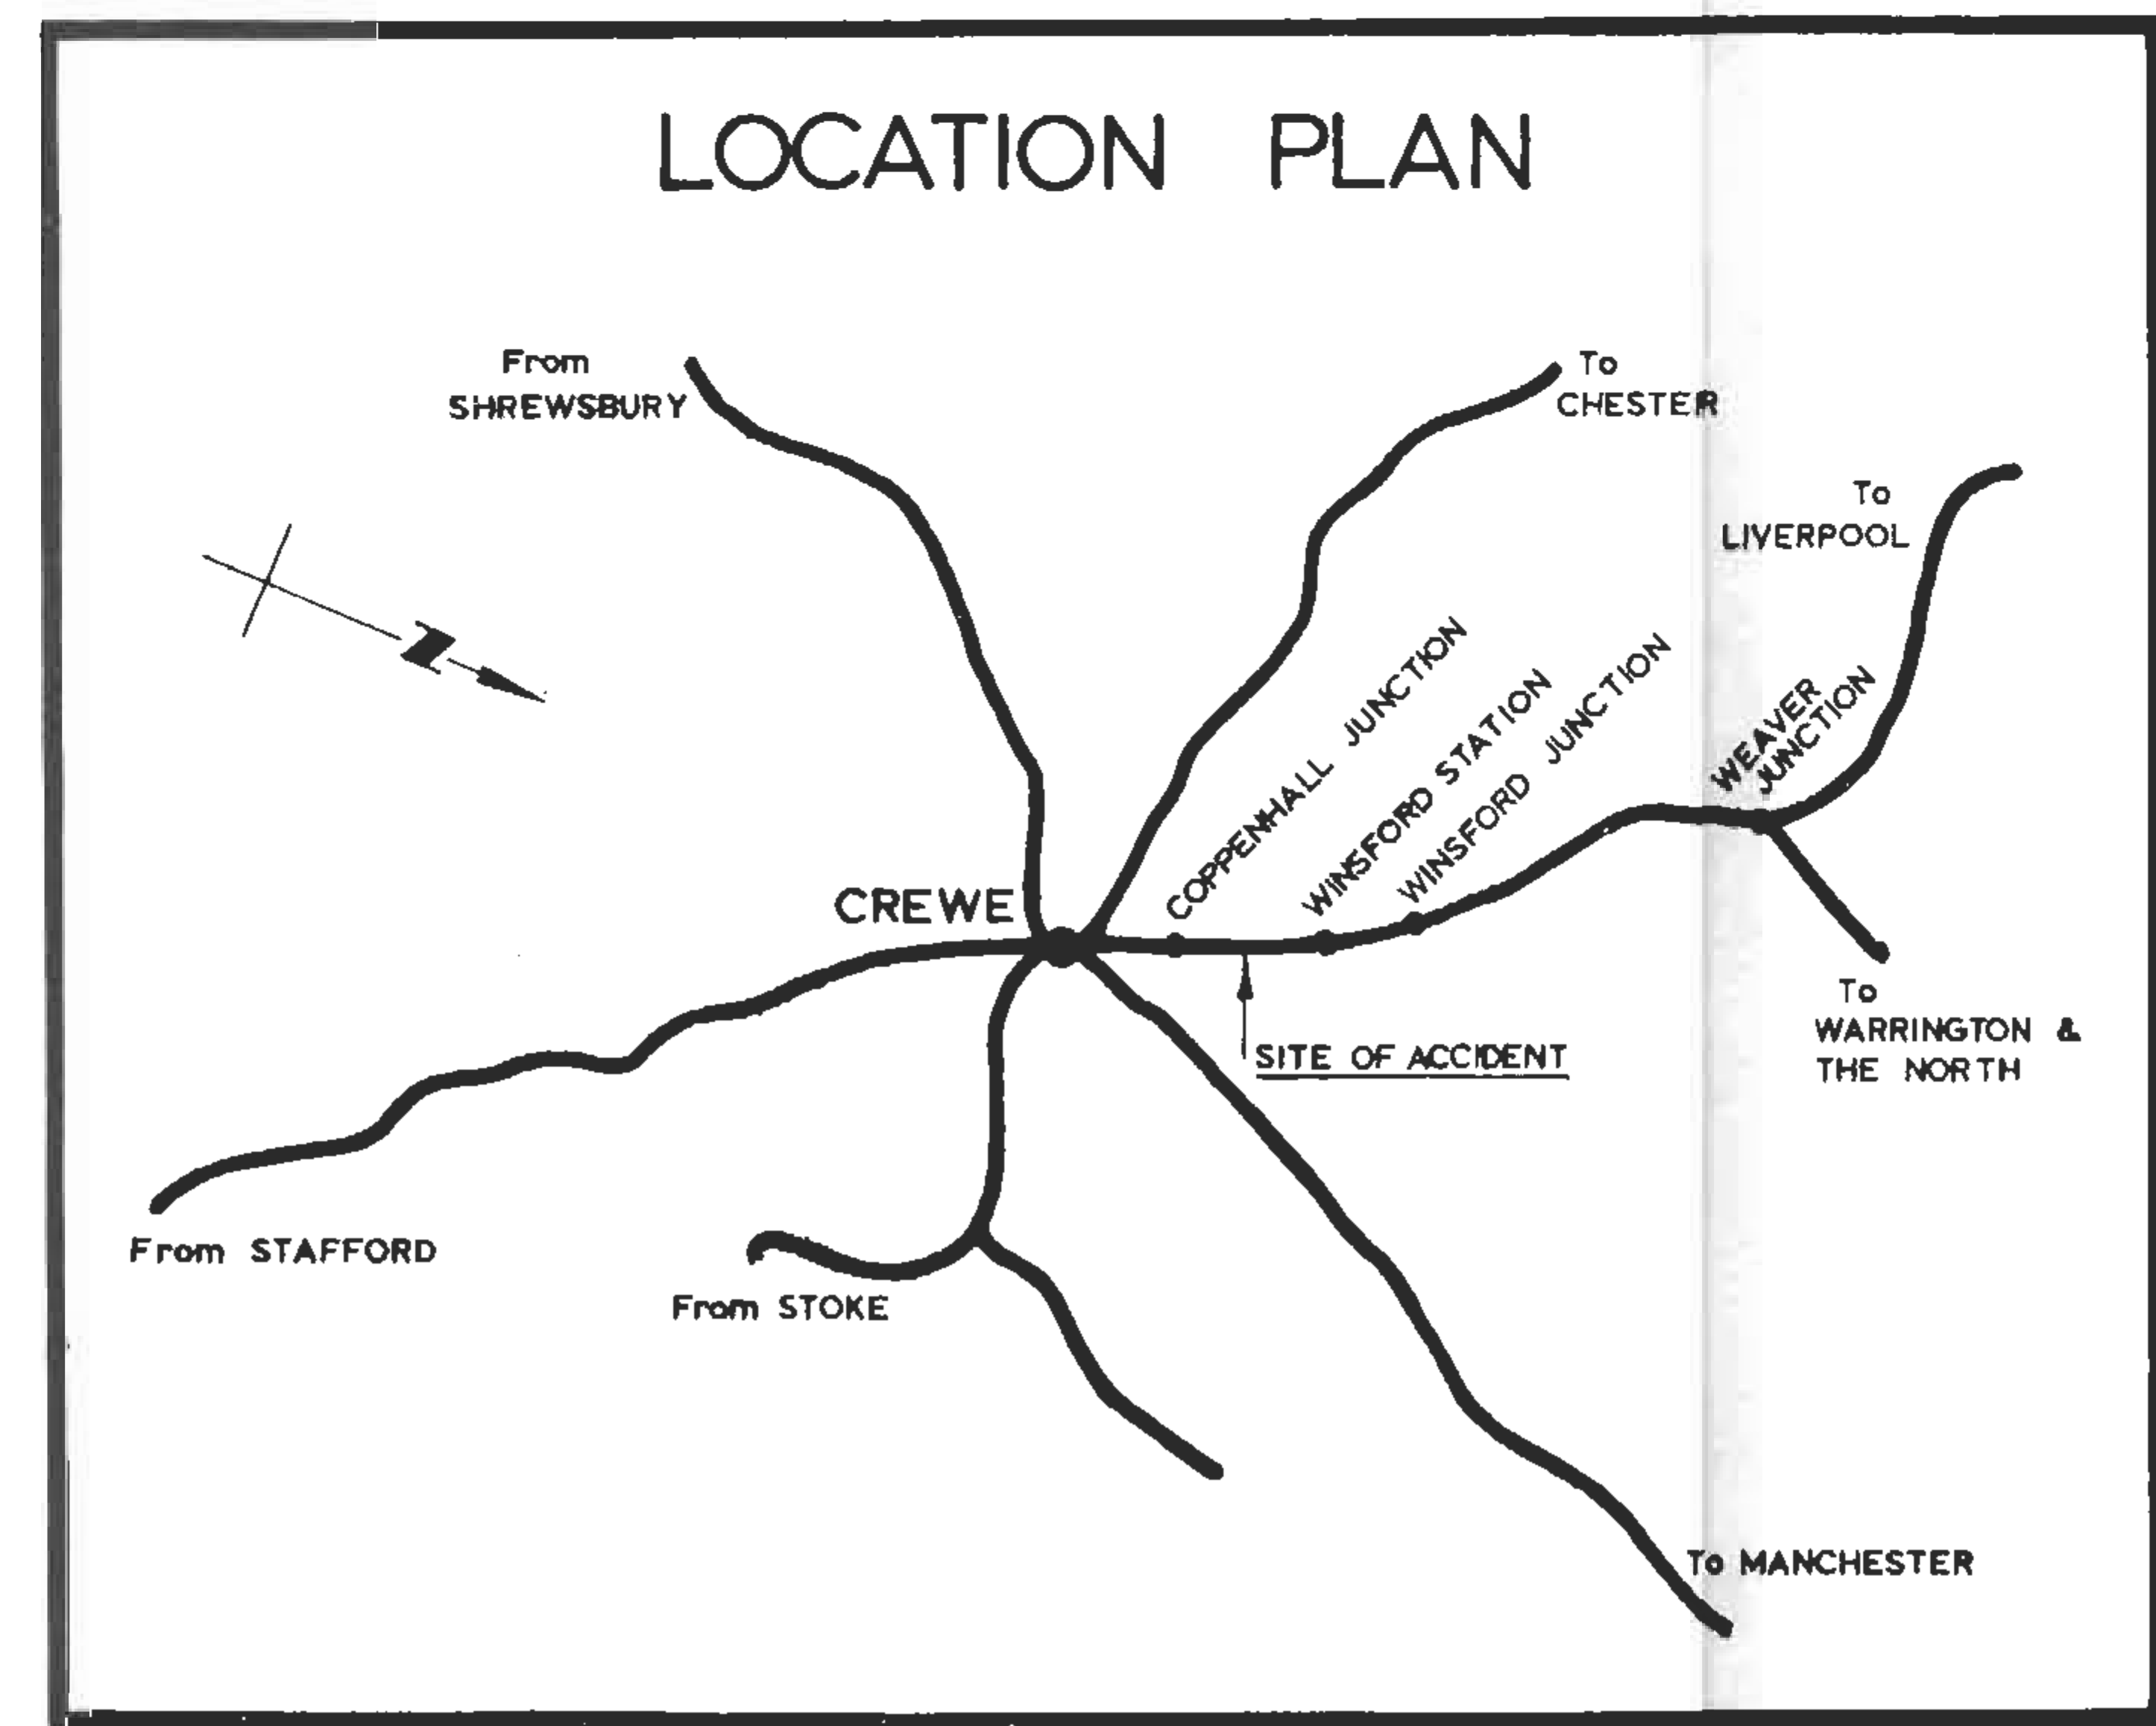
COLLISION NEAR WINSFORD 26th December 1962

2. The drawing shows the arrangements of the lines at Winsford Station box and from that box to Coppenhall Junction; it also shows the curvature of the lines, and the signalling. It will be noted that at signal no. 114 the Up lines lie on a slight right-handed curve of 265 chains radius; the curve continues for about 600 yards beyond the signal after which the lines run straight for some 700 yards to the point of collision, and on to signal no. 110. The distance between signals no. 110 and 114 is 1566 yards. The gradients are negligible.

4. It will be seen from the drawing that signal no. WS 28/29 is worked from Winsford Station box and that it controls the entry to the Up Fast and Up Slow lines ahead. The subsequent signals on these lines, up to Coppenhall Junction home signals, are automatic; they are nos. 114 and 116, 110 and 112, 106 and 108, and 102 and 104. Each pair of signals is supported on one cantilever structure; the lower numbered signal of each pair applies to the Fast line and the other to the Slow line. Each signal is situated just to the left of the line to which it applies. On the Down lines between Coppenhall Junction and Winsford Station the signals are also automatics and the accident occurred almost directly opposite signals no. 103 and 101 on the Down Slow and Down Fast lines respectively. Signals no. WS45 and WS46 are respectively the Winsford Station Down Slow and Down Fast line home signals, and they are situated about 500 yards on the Winsford Station side of signals no. 114 and 116 on the Up lines.
