# RAILWAY ACCIDENT

**Report on the Collision that  
occurred on 16th December 1972  
at Copyhold Junction  
near Haywards Heath**

IN THE  
SOUTHERN REGION  
BRITISH RAILWAYS

# COLLISION AT COPYHOLD JUNCTION (SOUTHERN REGION) ON 16th DECEMBER 1972.

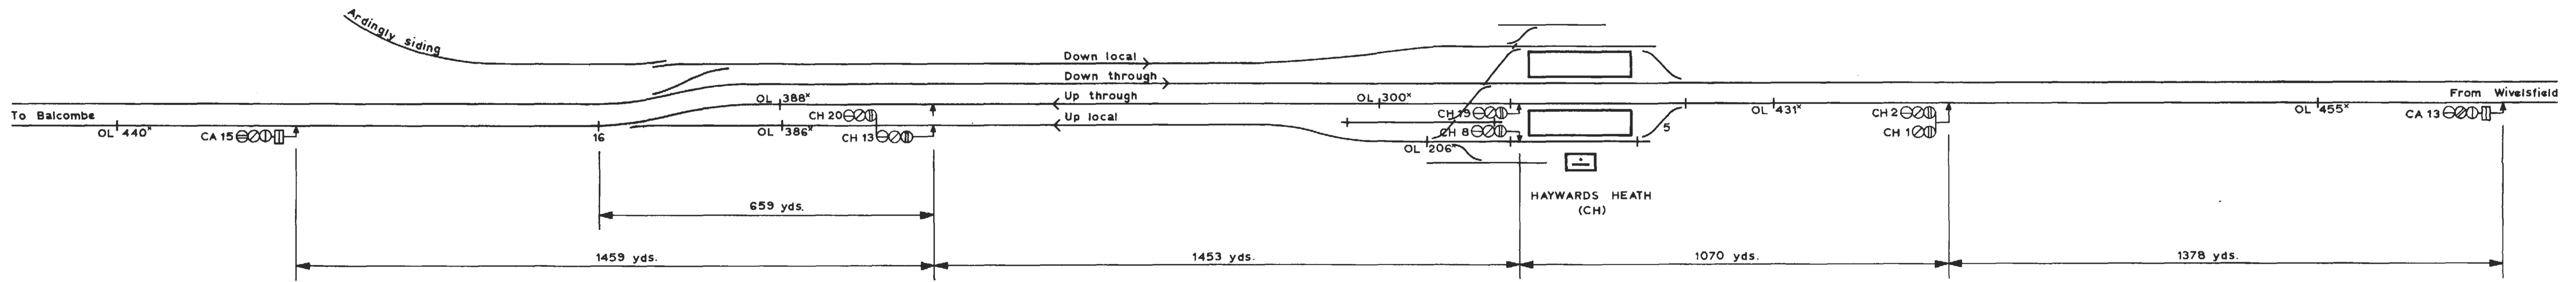
Signal diagram showing up line signals at Haywards Heath

4. Those points and signals relevant to the accident are shown on the drawing attached to this Report. On the approach to Haywards Heath from the South, the first controlled signal, CH 1/2, is a combined junction home signal with R/Y aspects, controlled by lever No. 1, reading to the Up Local line and R/Y/G aspects, controlled by lever No. 2, reading to the Up Through line. It is located on the approach to Haywards Heath tunnel, 648 yards in rear of No. 5 facing points where the Up Local line diverges from the Up Through

line and 1,070 yards in rear of Signals CH8 and CH19, the 3-aspect platform starting signals on the Up Local and Up Through lines respectively. The 3-aspect signals protecting No. 16 points, where the Up Local and Up Through lines merge at Copyhold Junction, are CH13 and CH20 respectively located 1,453 yards in advance of the platform Starting signals and 659 yards in rear of the points at Copyhold Junction. Both signals CH13 and CH20 are provided with a combined berth and overlap track circuit, the overlap lengths being 386 and 388 yards respectively. Beyond these overlaps, a common track circuit extends to beyond No. 16 points.

5. The gantry that supports Signals CH13 and CH20 stands on the left of the Up Local line with CH13 located on the supporting mast, 6 ft 4 ins from the running edge of the nearest rail, with the red aspect 11 ft 7½ ins above the rail level of the Up Local line. Signal CH20 is located on a cantilever arm 5 ft 4 ins to the left of the left hand running rail of the Up Through line and with the red aspect 16 ft 6 ins above rail level. From the Up Local line, on account of a gentle left hand curve, the Up Through line Signal CH20 comes into view first, at a distance of 572 yards, followed by CH13 at 528 yards. A continuous full view of both signals is obtained from the Up Local line over a distance of 506 yards.

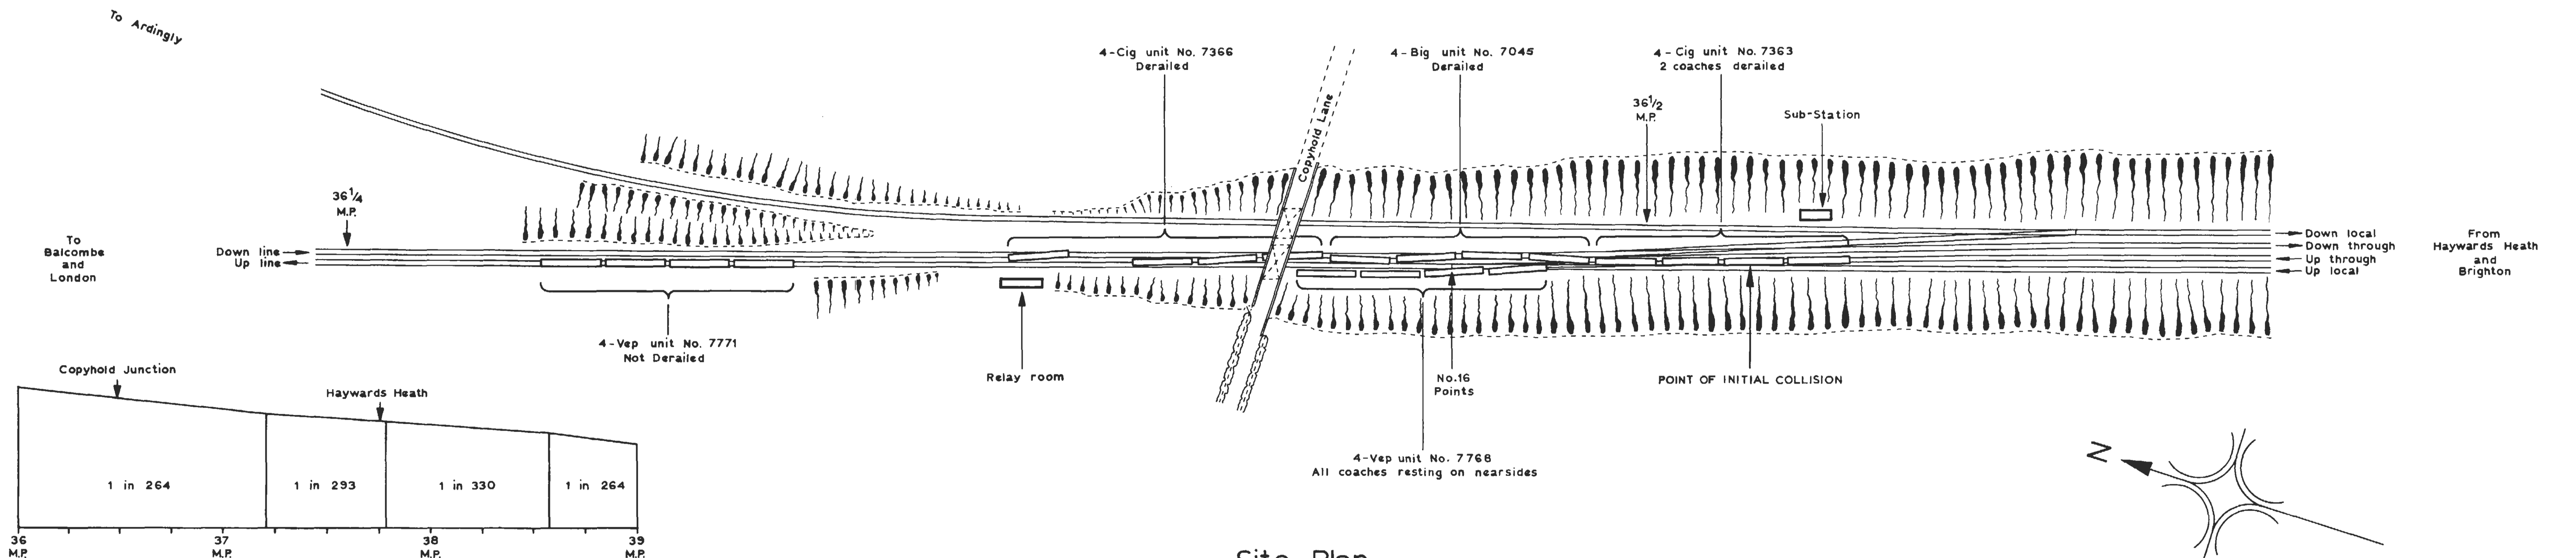
Site Plan

9. The actual point of collision, the fouling point where the Up Local line merged with the Up Through line at Copyhold Junction, lay 561 yards beyond Signals CH13 and CH20 and the initial contact was between the grab rail outside the driving cab of the Fast train and the side panelling in the area of the guard's compartment on the sixth coach of the Slow train. The marks of this contact indicated that the speed of the Fast train was only slightly higher than that of the Slow train at the moment of collision and the immediate result was that the leading driving trailer of the Fast train rolled over onto its right side, glanced off the centre pier of Copyhold Lane bridge and came to rest on the Down Main line about 80 yards beyond the bridge and separated by a coach length from the rest of the train, which was derailed all but the last 2 vehicles. The Slow train became divided between the 2 units, the leading 4 coaches being completely undamaged and coming to rest 250 yards beyond the bridge. The rear 4 coaches were all derailed towards the cutting side leaning over at an angle of about 45° with the fifth coach only a few feet from the brick abutment of the bridge.

11. The damage to the permanent way and signalling equipment was severe. Both the connections between the Through and Local lines were demolished together with over 300 yards of plain track. The point machines were destroyed and the main lineside signalling and telecommunications cables severed, thus cutting off power supplies to Haywards Heath signal box. The traction current was also discharged automatically as a result of the collision.
