MINISTRY OF TRANSPORT

RAILWAY ACCIDENT

REPORT ON THE COLLISION

# COLLISION between DESBOROUGH and GLENDON, 3rd July 1963

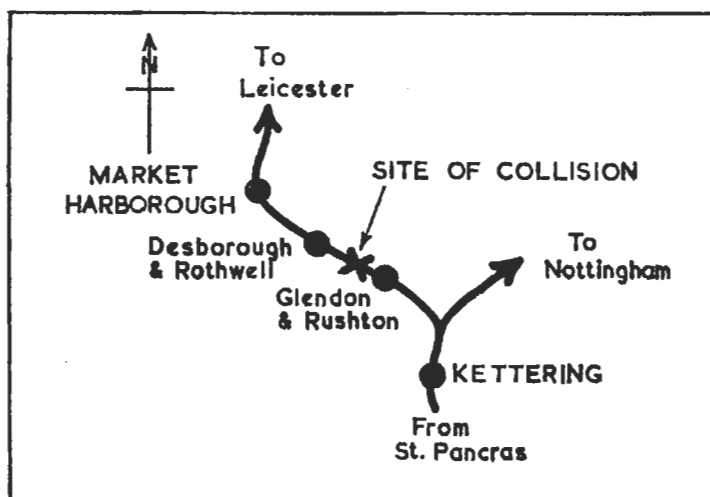
Site of collision

1. The diagram opposite shows the general arrangement of the route between Desborough signalbox at MP 78, and Glendon signalbox between MP 75½ and 75¾, and the position of the Up line signals and relevant track circuits. The signalboxes on either side are Desborough North and Glendon North Junction. In the Up direction, from Desborough towards Glendon, the double track route is on falling gradients for most of the way varying between 1 in 200 and 1 in 114, with short level lengths. Curves are easy, of about 1 mile radius or more, and there is a left-handed one of 1½ miles radius leading up to the point of collision at 76 m. 1176 yds. The formation in the area of collision is in cutting and the track is of 109 lbs. flat-bottom material on wood sleepers. There was a speed restriction of 15 m.p.h. in force on both lines near Glendon for a quarter of a mile on either side of MP 76, for formation and drainage work.
