SOUTHERN RAILWAY

I have the honour to report for the information of the Minister of War Transport, in accordance with the Order of 31st January, the result of my Inquiry into the accident which occurred at 8.23 p.m. on Sunday, 28th January, at Esher Station on the Western Section main line of the Southern Railway.

COLLISION AT ESHER 28TH JANUARY, 1945.

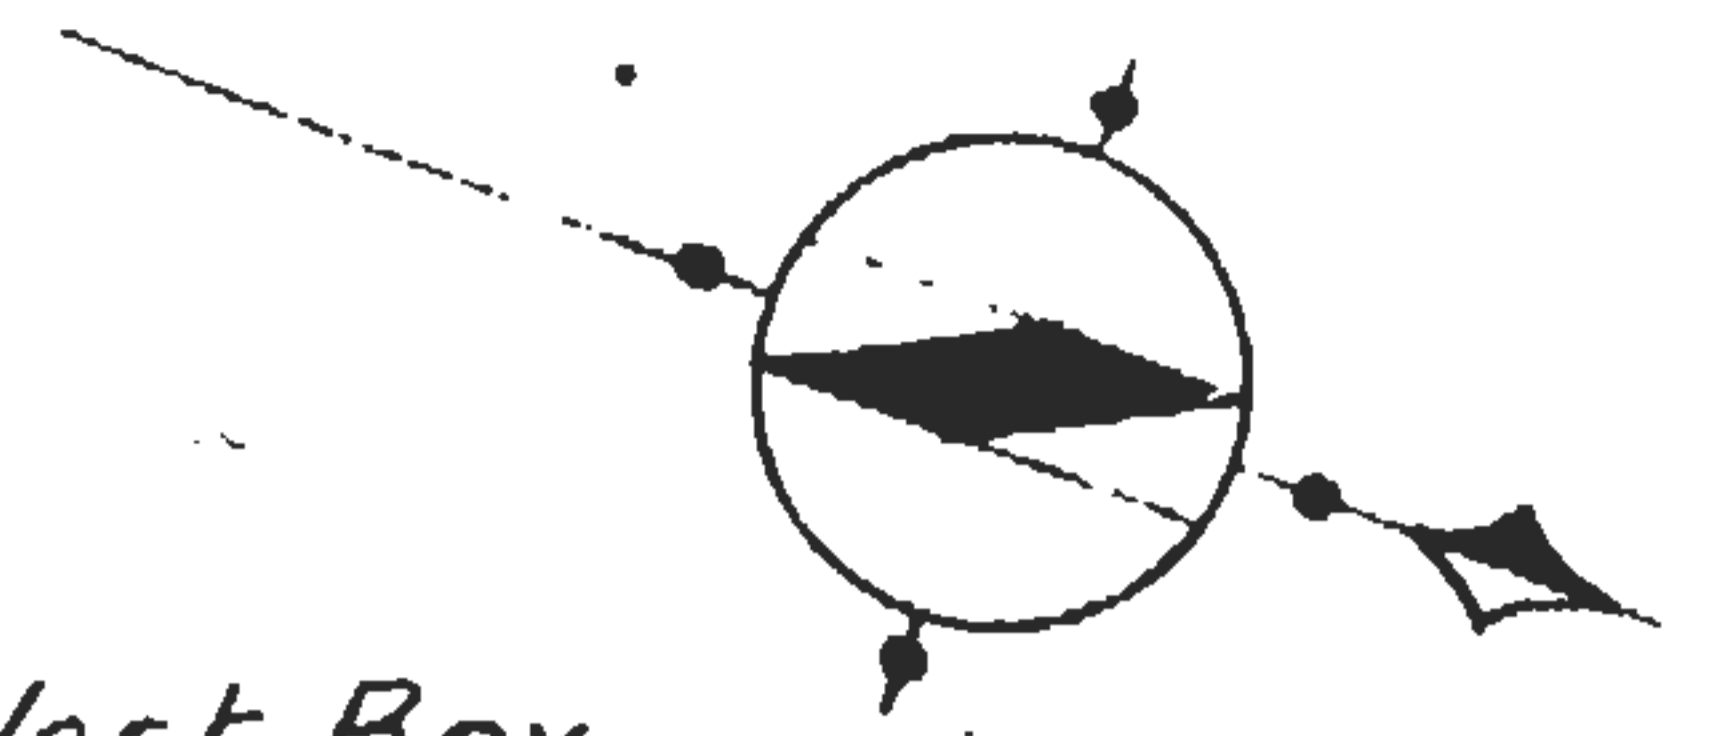
The 4 track main line between Surbiton and Esher runs in a direction roughly East (Waterloo) and West (Woking), the local tracks being on the outside and the through tracks in the centre. It is on bank and there is slight right hand curvature at intervals including the immediate approach to Esher Station. At Hampton Court Junction the Hampton Court branch down line crosses to the North by a flyover bridge, and a short distance further the Cobham branch up line crosses from the South by a flyunder. A diagram indicating relevant signals, crossovers etc., is attached. Gradients are negligible.
