MINISTRY OF TRANSPORT AND CIVIL AVIATION

RAILWAY ACCIDENTS

REPORT ON THE COLLISION
which occurred on
4th March 1958
at
GLOUCESTER ROAD JUNCTION
near NORWOOD JUNCTION
in the
SOUTHERN REGION
BRITISH RAILWAYS

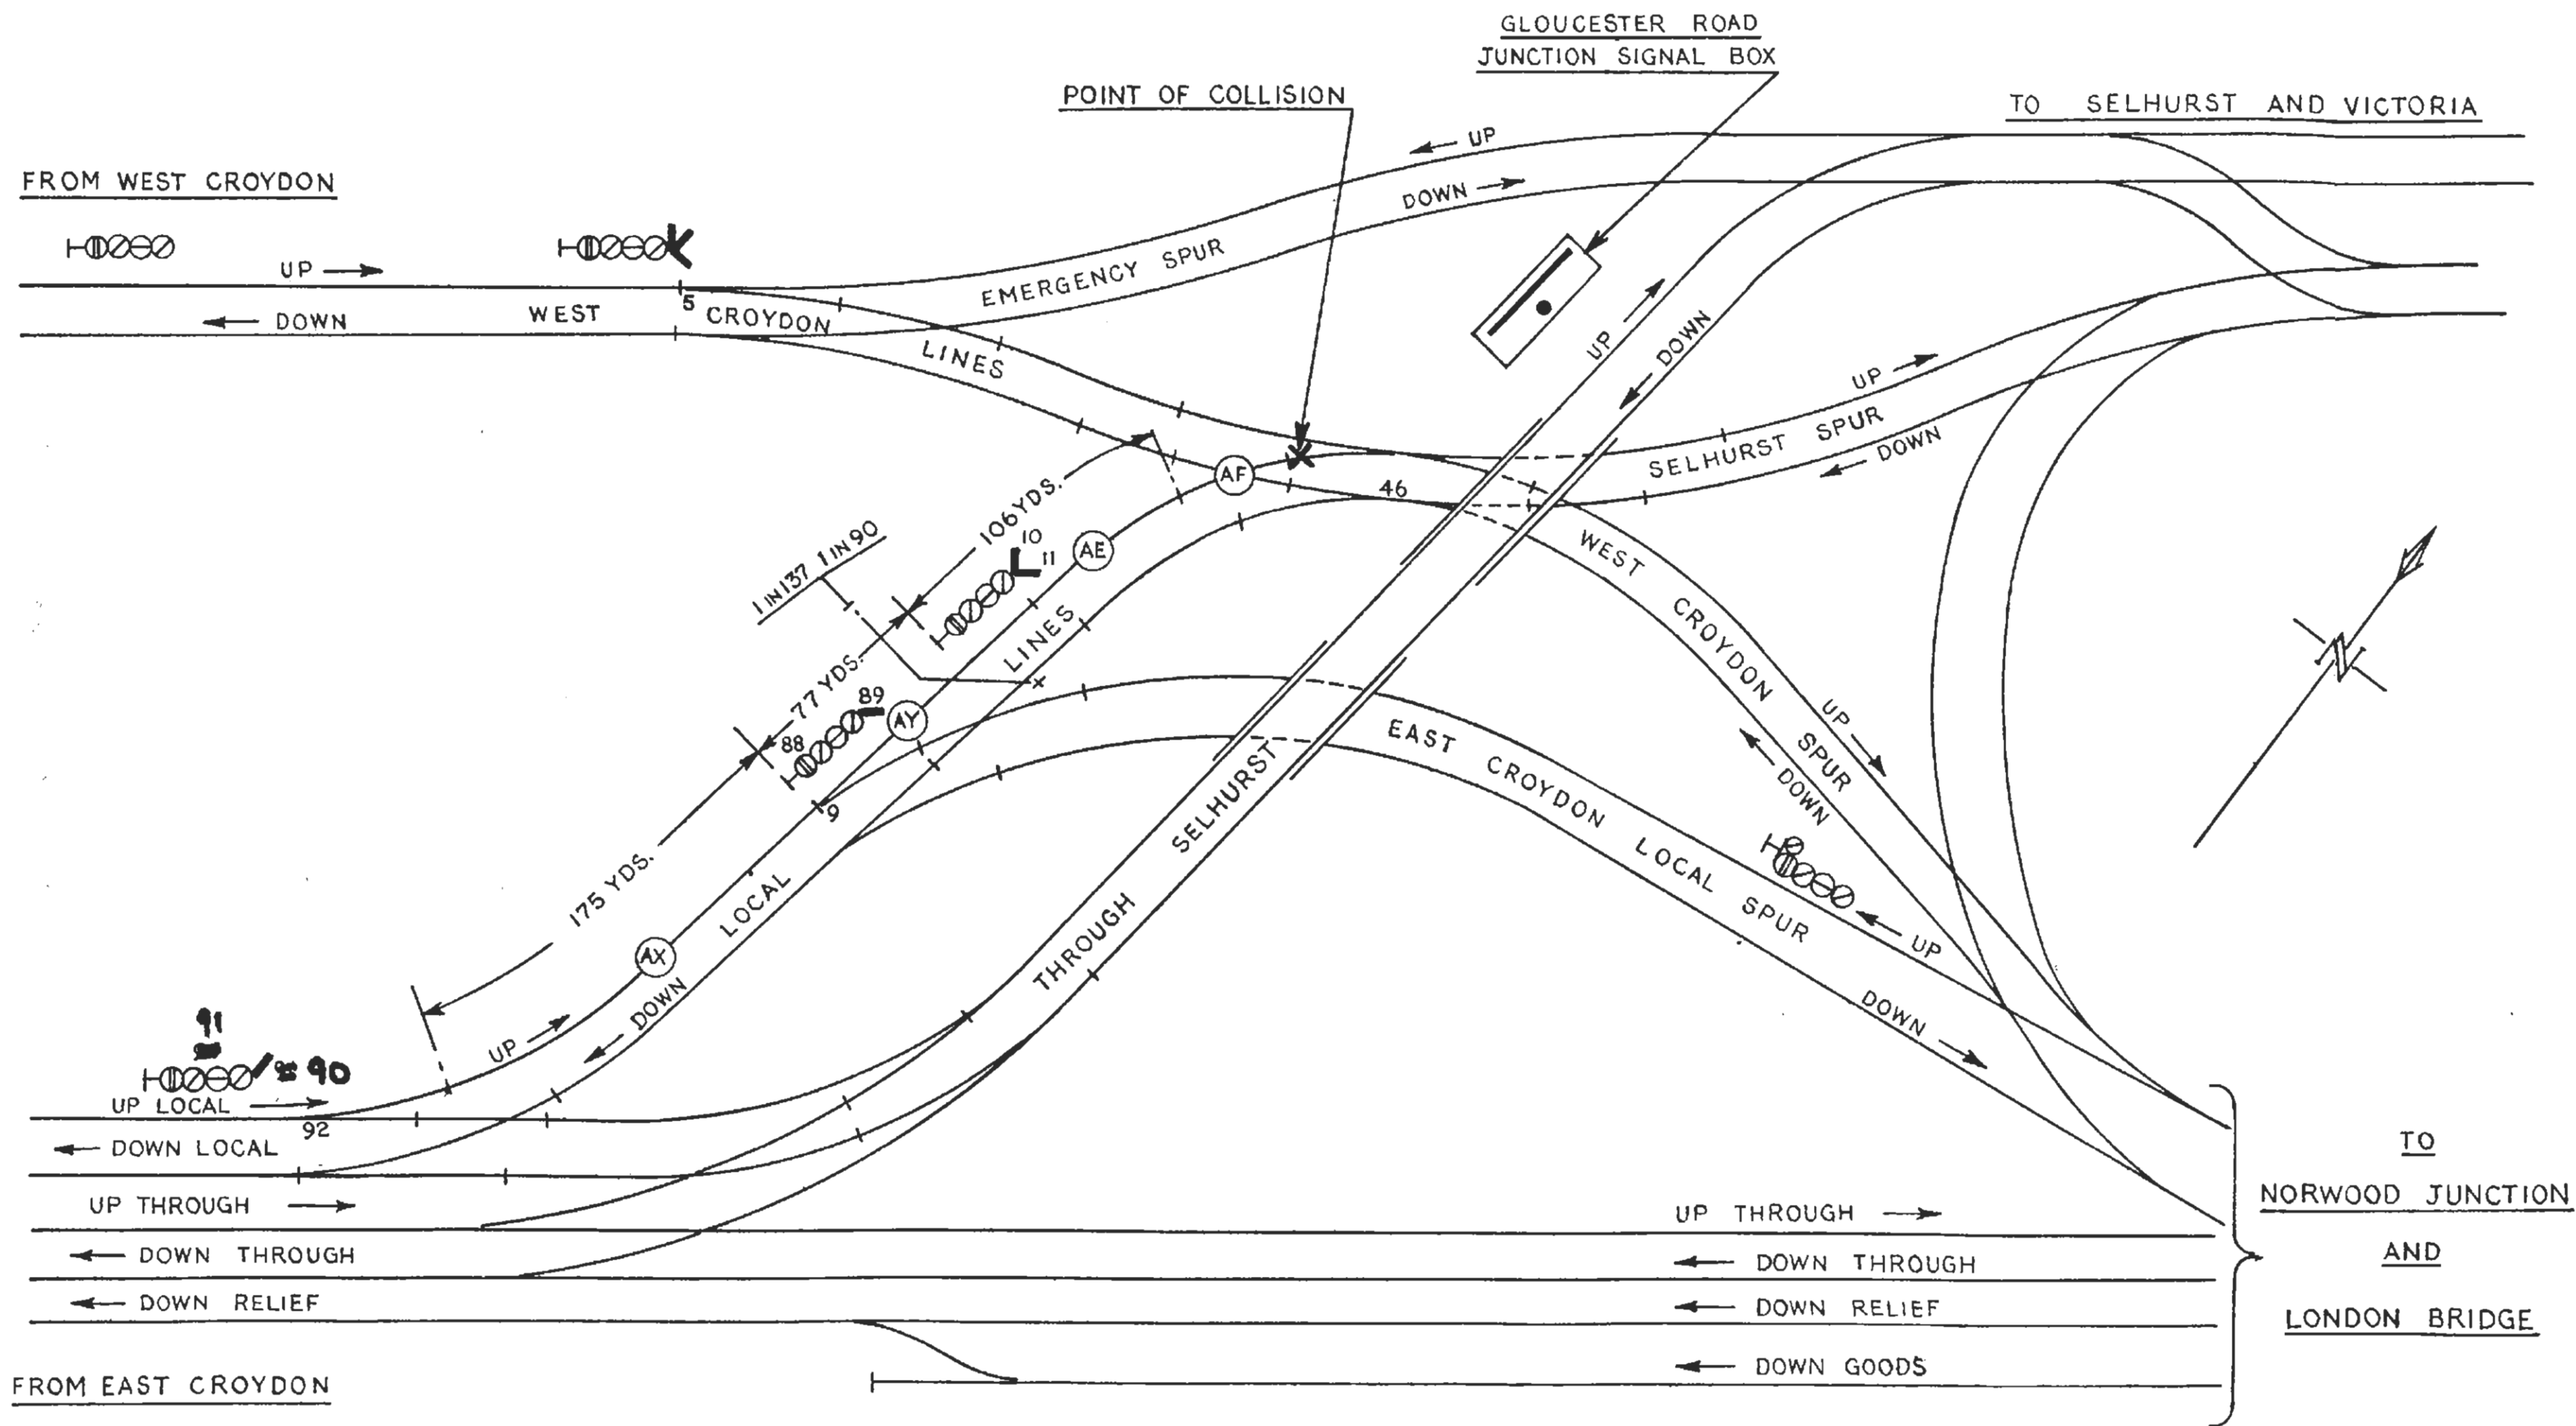
The sketch opposite illustrates the layout of the tracks and the position of some of the 4-aspect colour-light signals on them in the complicated area controlled by Gloucester Road Junction box. This box is provided with an electrically locked power frame from which all the points and signals in the area are operated.

The Up Local line from East Croydon, on which the steam train was travelling, falls at a gradient of 1 in 137 from points No. 92 to just beyond points No. 9, and from there to the converging junction ahead the gradient steepens to 1 in 90 and the line is partly in cutting. From points No. 92 onwards the line curves first to the left and then to the right, at radii of 19 and 32 chains respectively.

On the Up Local line signal No. 90 (with a left-handed direction indicator for the diverging route) is approach controlled from red to yellow, the latter being the most favourable aspect shown unless the signal ahead (No. 88/89) is green. If signal No. 10/11 is red, signal No. 88 also is approach controlled from red to yellow by track circuit AX. Signal No. 88/89 is 175 yards beyond the fouling point of points No. 92 and it has a right-handed direction indicator with three lunar white lights. The signal is operated by lever No. 88 when points No. 9 are set for the Up Local line to the converging junction and by lever No. 89 for a train to the East Croydon Local Spur line when the direction indicator becomes illuminated. Signal No. 10/11 is the protecting signal for the converging junction and it is situated 77 yards ahead of signal No. 88/89 and thus enables an 8-car electric train to stand at it and be clear of the fouling point in rear at points No. 92. Signal No. 10/11 is 106 yards and 125 yards respectively from the fouling points of the Down and Up West Croydon lines. The ordinary interlocking ensures that both the levers working it are locked normal when the junctions ahead are set for a train to or from West Croydon, but there is no such interlocking between lever No. 88 and the junction points.

It will be noted that from the right hand side of an engine signal No. 10/11 comes into view 22 yards before signal No. 88/89; also, that the latter signal does not come into view until after the engine has occupied track circuit AX, and consequently the delayed clearance of the signal is not observed.

- (a) The approach track circuit on signal No. 88/89 is to be split so that when the signal ahead (No. 10/11) is at danger signal No. 88 will not clear from red to yellow until the train is about 50 yards from it.
- (b) The interlocking is to be altered in such a way that the pulling of lever No. 88 will lock points No. 46 for the Down Local line and points No. 5 for the Up Emergency Spur. A time release will be provided to prevent lever No. 88 being replaced too soon after a train has passed the signal.

Item (a) will ensure that a driver will have a reasonably long view of signal No. 88/89 at red, even from the right hand side of a steam engine, and should invariably see the aspect change. He should therefore be in no doubt as to which route his train is to take and an overrun beyond signal No. 10/11 is
