REPORT ON THE COLLISION

9th June 1953 near

GOLLANFIELD JUNCTION

SCOTTISH REGION

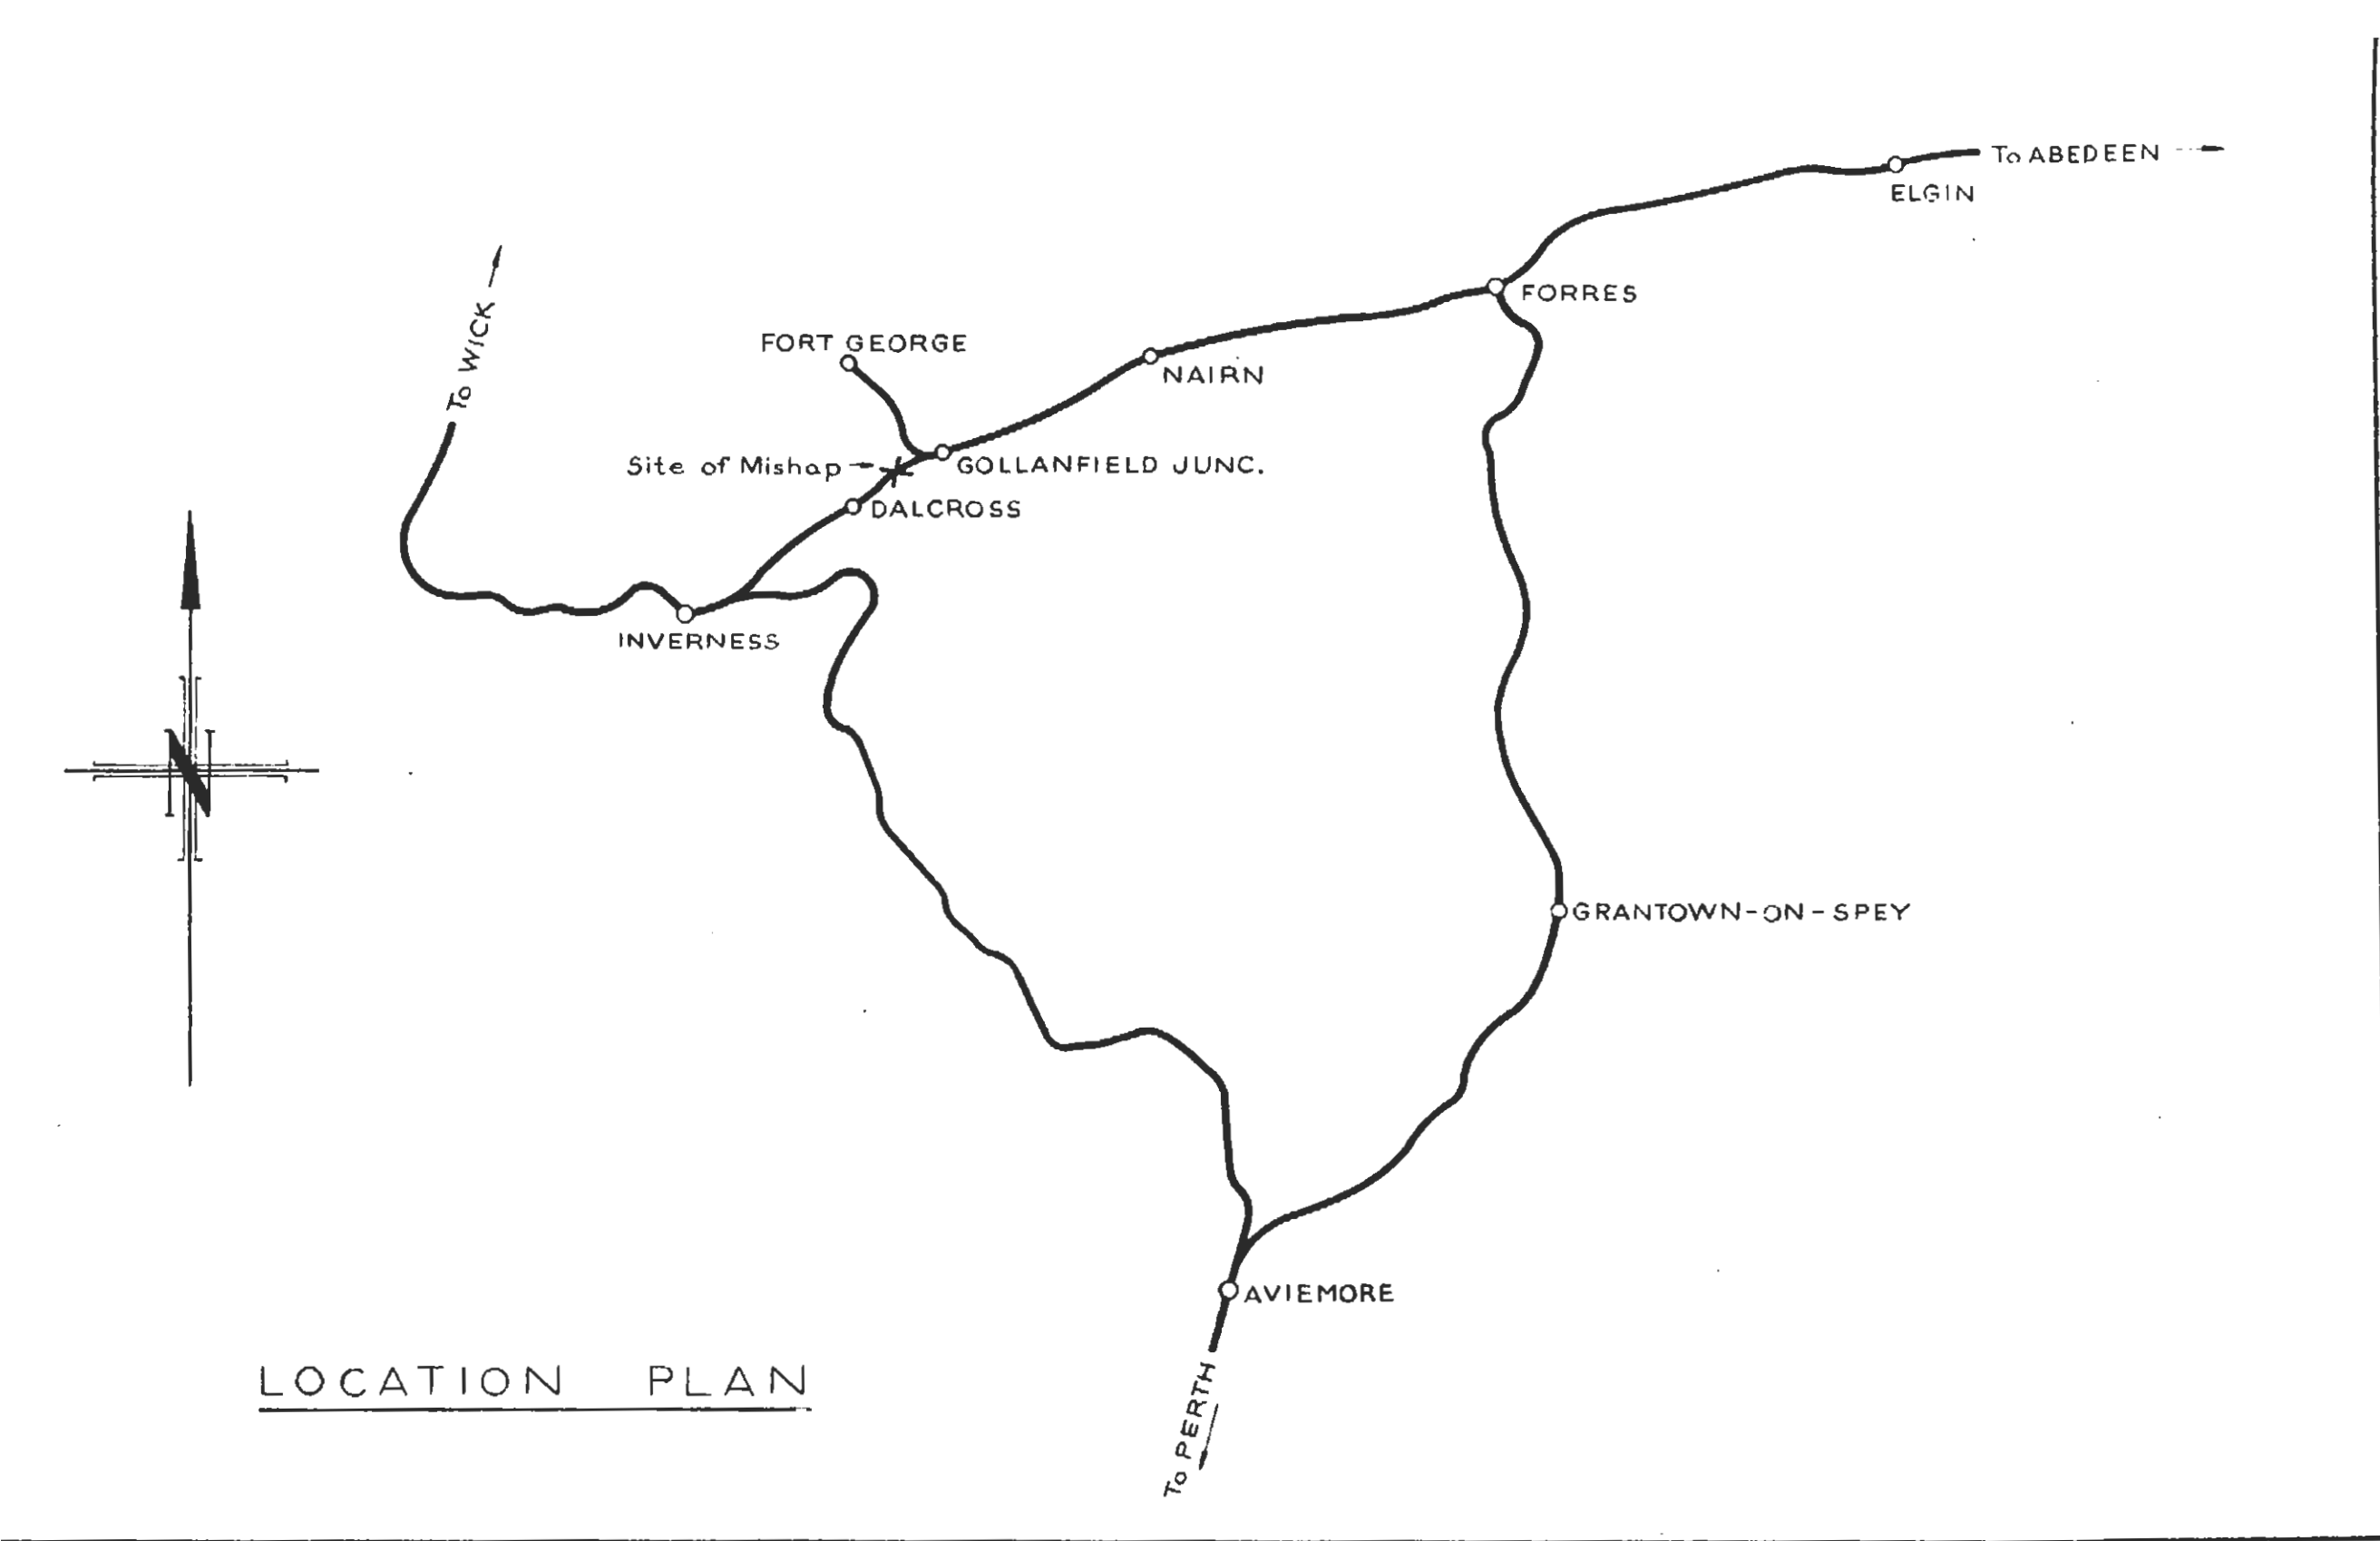
# COLLISION AT GOLLANFIELD JUNCTION

2. Gollanfield Junction is situated on the former London Midland & Scottish Railway between Nairn, which is  $5\frac{1}{2}$  miles to the East (Up direction), and Inverness and Dalcross which are 9 miles and  $2\frac{1}{2}$  miles respectively to the West. It is a simple crossing station on the single line with an Up and a Down loop, and is equipped with a distant, home and starting signal for each direction. A short branch line to Fort George connects with the Up loop, but this had no bearing on the accident.

From the signal box at Gollanfield, Down trains can first be seen when passing through bridge No. 83. Up trains can be seen only when they are very close to the Up home signal.

Train working to Dalcross is by key token and to Nairn by tablet; the instruments are in the booking office on the Down platform. Signals and points are worked from the signal box nearly opposite on the Up loop. The normal positions of the east and west facing points are for the Down and the Up loops respectively.
