RAILWAY ACCIDENT

**Report on the Collision that
occurred on 4th July 1977
near Hall Road Station**

**IN THE
LONDON MIDLAND REGION
BRITISH RAILWAYS**

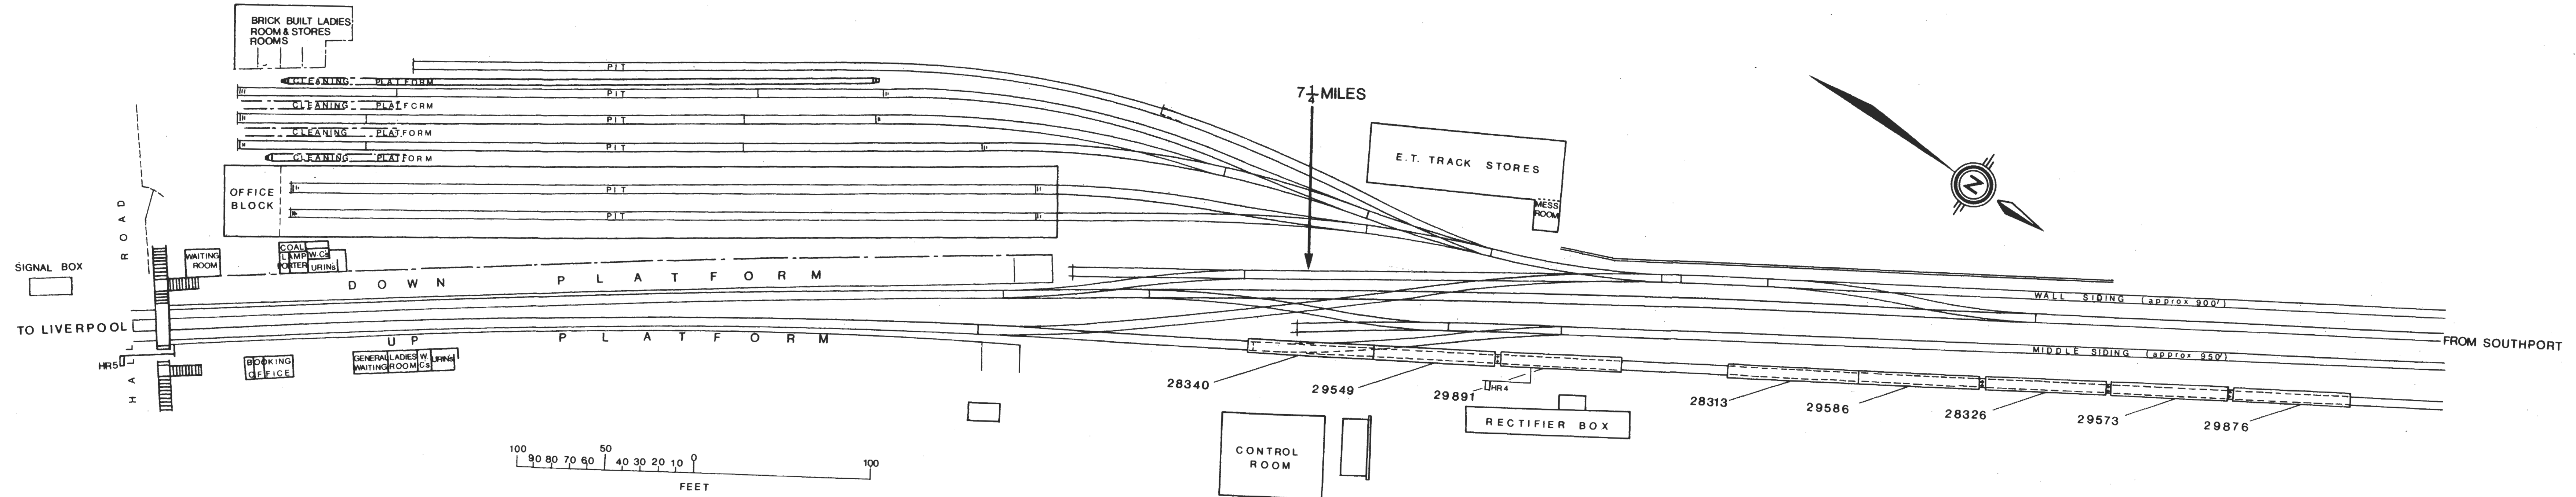
FIG. 1. GENERAL PLAN SHOWING SITE OF COLLISION
AND POSITIONS WHERE TRAINS CAME TO REST

1. Hall Road Station lies on the Liverpool-Southport line approximately $7\frac{1}{2}$ miles from Liverpool. Figure 1 at the back of this Report shows the track layout in the station area and the positions where the two trains came to rest, while Figure 3 shows the gradients between Formby and Hall Road Stations, and a location diagram is at Figure 4. The line from Liverpool to Southport is electrified on the conductor rail system at 650 volts DC, and the Working Instructions for DC Electrified Lines in the Liverpool area apply.

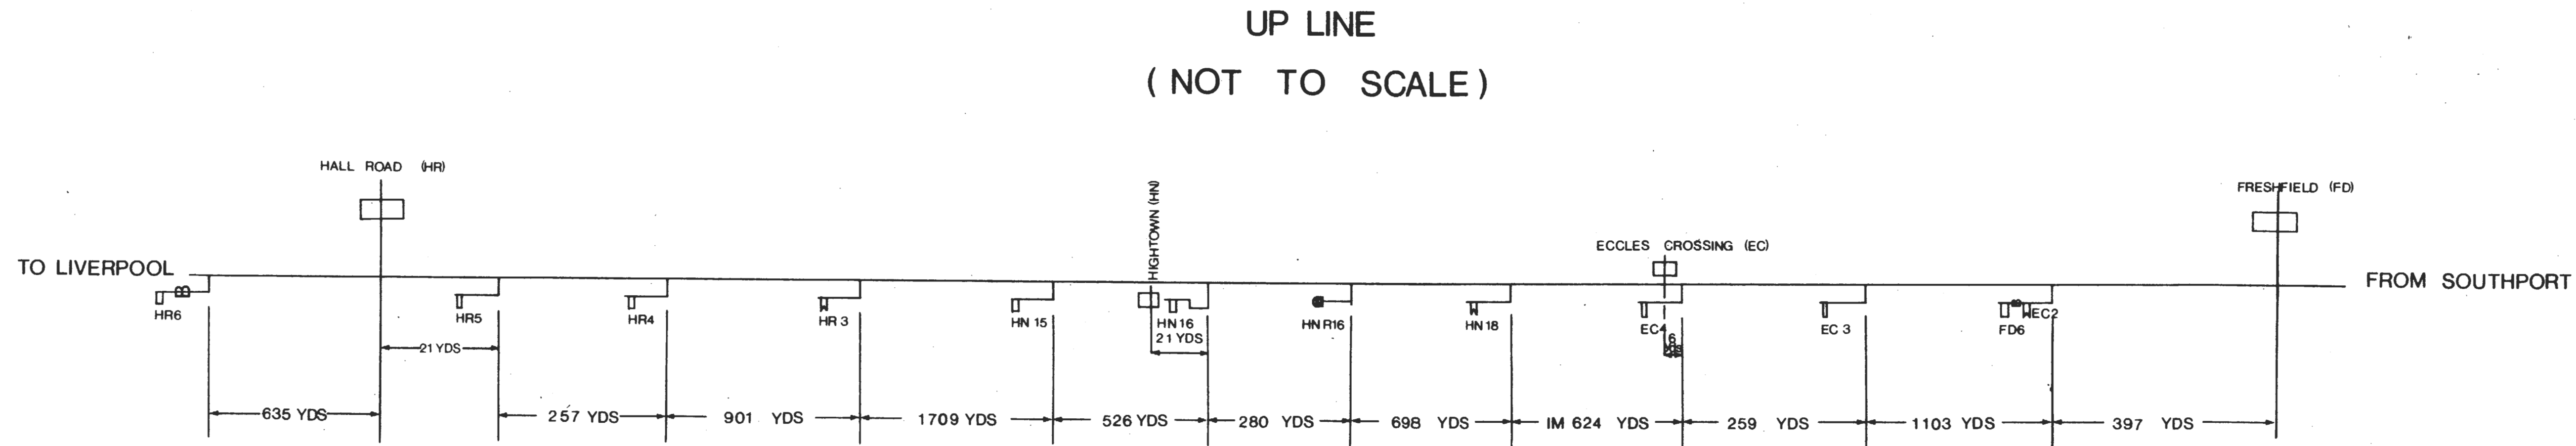
FIG. 2. SIGNALLING DIAGRAM, FRESHFIELD-HALL ROAD

7. A diagram giving details of the signalling between Eccles Crossing, Hightown, and Hall Road Signal Boxes is given at Figure 2 at the end of this Report. A table summarising the signalling controls provided at Eccles Crossing, Hightown, and Hall Road Signal Boxes at the time of the accident is given below:
