RAILWAY ACCIDENT

**Report on the Derailment that
occurred on 7th September 1981
at Harrow North Junction**

**ON THE
METROPOLITAN LINE
OF LONDON TRANSPORT RAILWAYS**

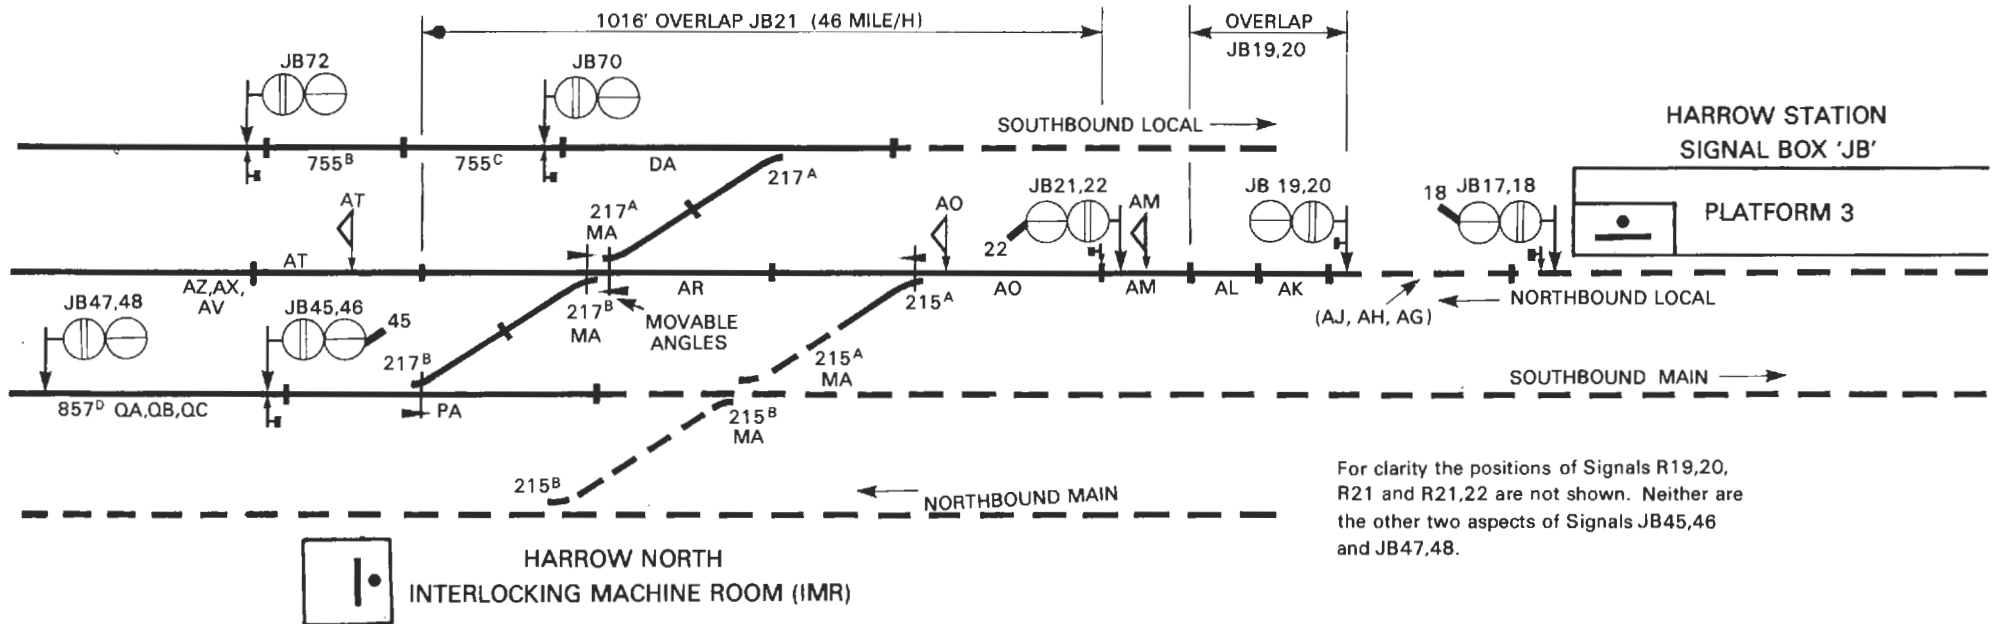
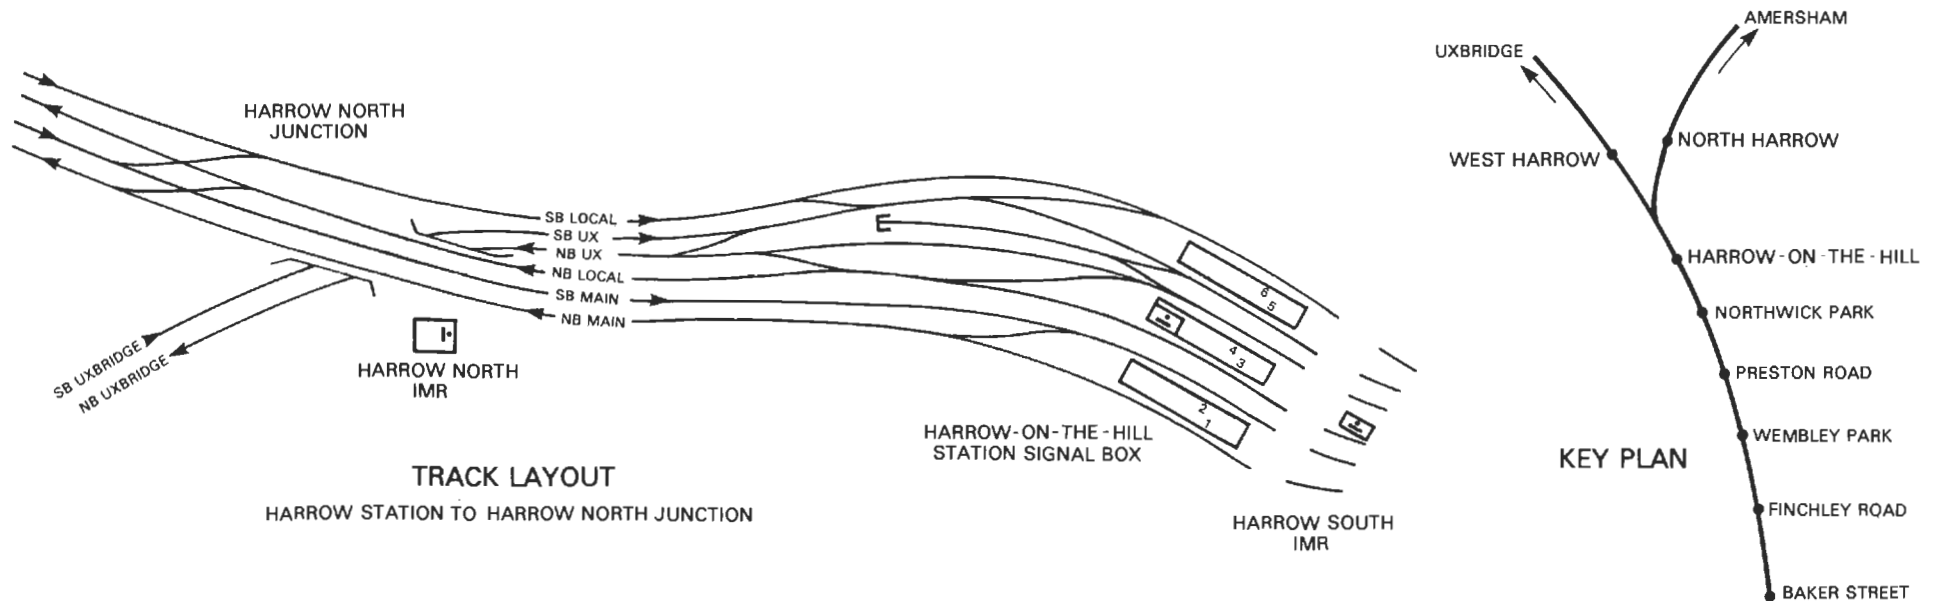
PART SIGNALLING PLAN

1. The Metropolitan line from Baker Street to Watford at Harrow-on-the-Hill Station runs approximately East to West and the six tracks through the station, reading from North to South, are called Southbound Local (SB Local), Southbound Uxbridge, Northbound Uxbridge, Northbound Local (NB Local), Southbound Main (SB Main) and Northbound Main (NB Main). All are electrified on the 650V DC 4th rail system. Some 750 m towards Watford from Harrow Station the Uxbridge lines diverge to the left and dive under the NB Local and SB and NB Main lines. The double crossover at Harrow North Junction lies 200 m past the bridge over the Uxbridge lines and has facing connections on the SB Main and NB Local lines; the crossovers over the intervening lines are formed by switched diamonds known as Movable Angles (MA). The Northbound crossover is numbered 215 and the Southbound 217. Harrow North Interlocking Machine Room (IMR) is located on the Harrow Station side of the bridge. The track layout is shown on the diagram on the facing page.

2. The Local and Uxbridge lines have standard LT 2-aspect colour-light signalling controlled by route-setting levers in the Harrow-on-the-Hill Station Signal Box (prefix JB) whereas the signals on the Main lines are a mixture of 3 and 4-aspect colour-lights. All lines are fully track-circuited. The signalling at the station is controlled directly from the signal box but there are remote IMRs at Harrow South and North Junctions. On the Northbound Local line the starting signal from platform No. 3 at Harrow-on-the-Hill Station is JB17/18 and the signal protecting Harrow North Junction is JB21/22. Both signals have junction indicators. Even numbered northbound signals refer to routes over diverging junctions in advance. The intervening signals are numbered R19/20, JB19/20 & R21 (a combined stop and repeater signal) and R21/22. On the SB Main the signal protecting the junction is JB45/46 and the signal in rear of it is JB47/48. Both are 4-aspect signals. Nos. 45 and 47 refer to the diverging route; the former has a junction indicator. All stop signals have train-stops associated with them and all facing connections and movable angles have ground track locks. An extract of the signalling diagram showing the signals, turnouts and track circuits is on the facing page.

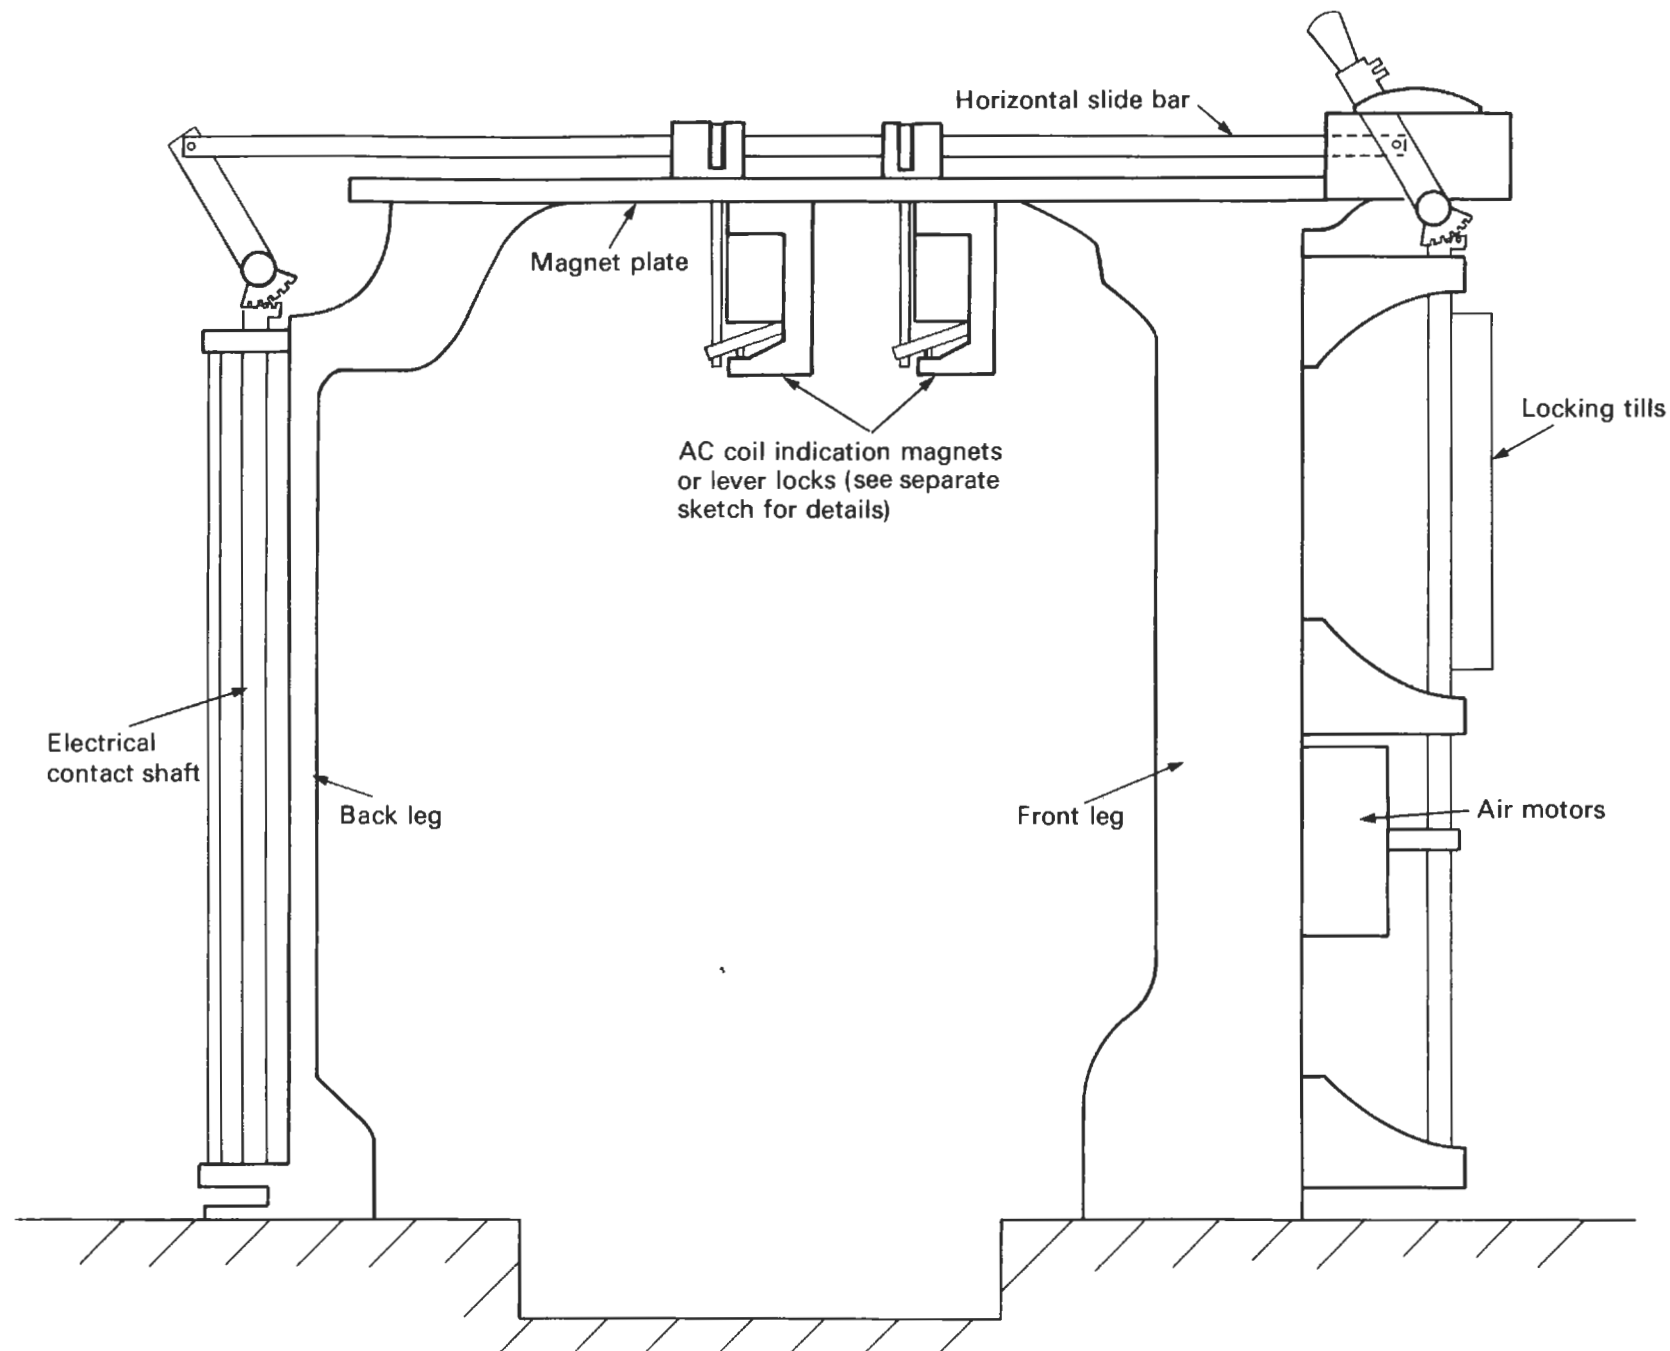
Simplified sketch of Westinghouse Type N2 remote control locking frame

3. Westinghouse electro-pneumatic miniature-lever locking frames are installed in the signal box and IMRs; the remote locking frame in the IMR being style 'N2'. Each miniature lever in the 'N2' frame works between notched quadrant plates and at its pivot carries a bevel pinion which drives the vertical locking shaft. The locking shafts are held on bearings attached to the front leg of the frame and carry locking tills on their upper parts. An air motor is fitted to the bottom part of each shaft. Each air motor has two independent

cylinders, one to provide the normal to reverse movement and the other the reverse to normal movement. Each cylinder is controlled by a separate electro-pneumatic valve. Also attached to each miniature lever is a horizontal locking slide bar which has at its other extremity a bevel-drive mechanism for driving a second vertical shaft which carries the electrical contacts and which is secured in bearings attached to the back leg of the frame. The front and back legs are connected by a horizontal $\frac{1}{2}$ in thick 'magnet' plate below which can be mounted two AC coil indication or lock magnets per lever. A cruciform turret which locates the lever locking slide and the locking catch is cast on the upper surface of the magnet plate above each magnet and the latch is connected to the magnet by a springloaded brass stem. This stem is located at its lower end by an adjusting diabolito nut which rests in a fork at the non-pivoted end of the armature and this nut is secured in position by a tabbed copper lock plate and a lock nut. An outline drawing of the frame and a drawing of the details of the electric lever lock are at the back of this report.

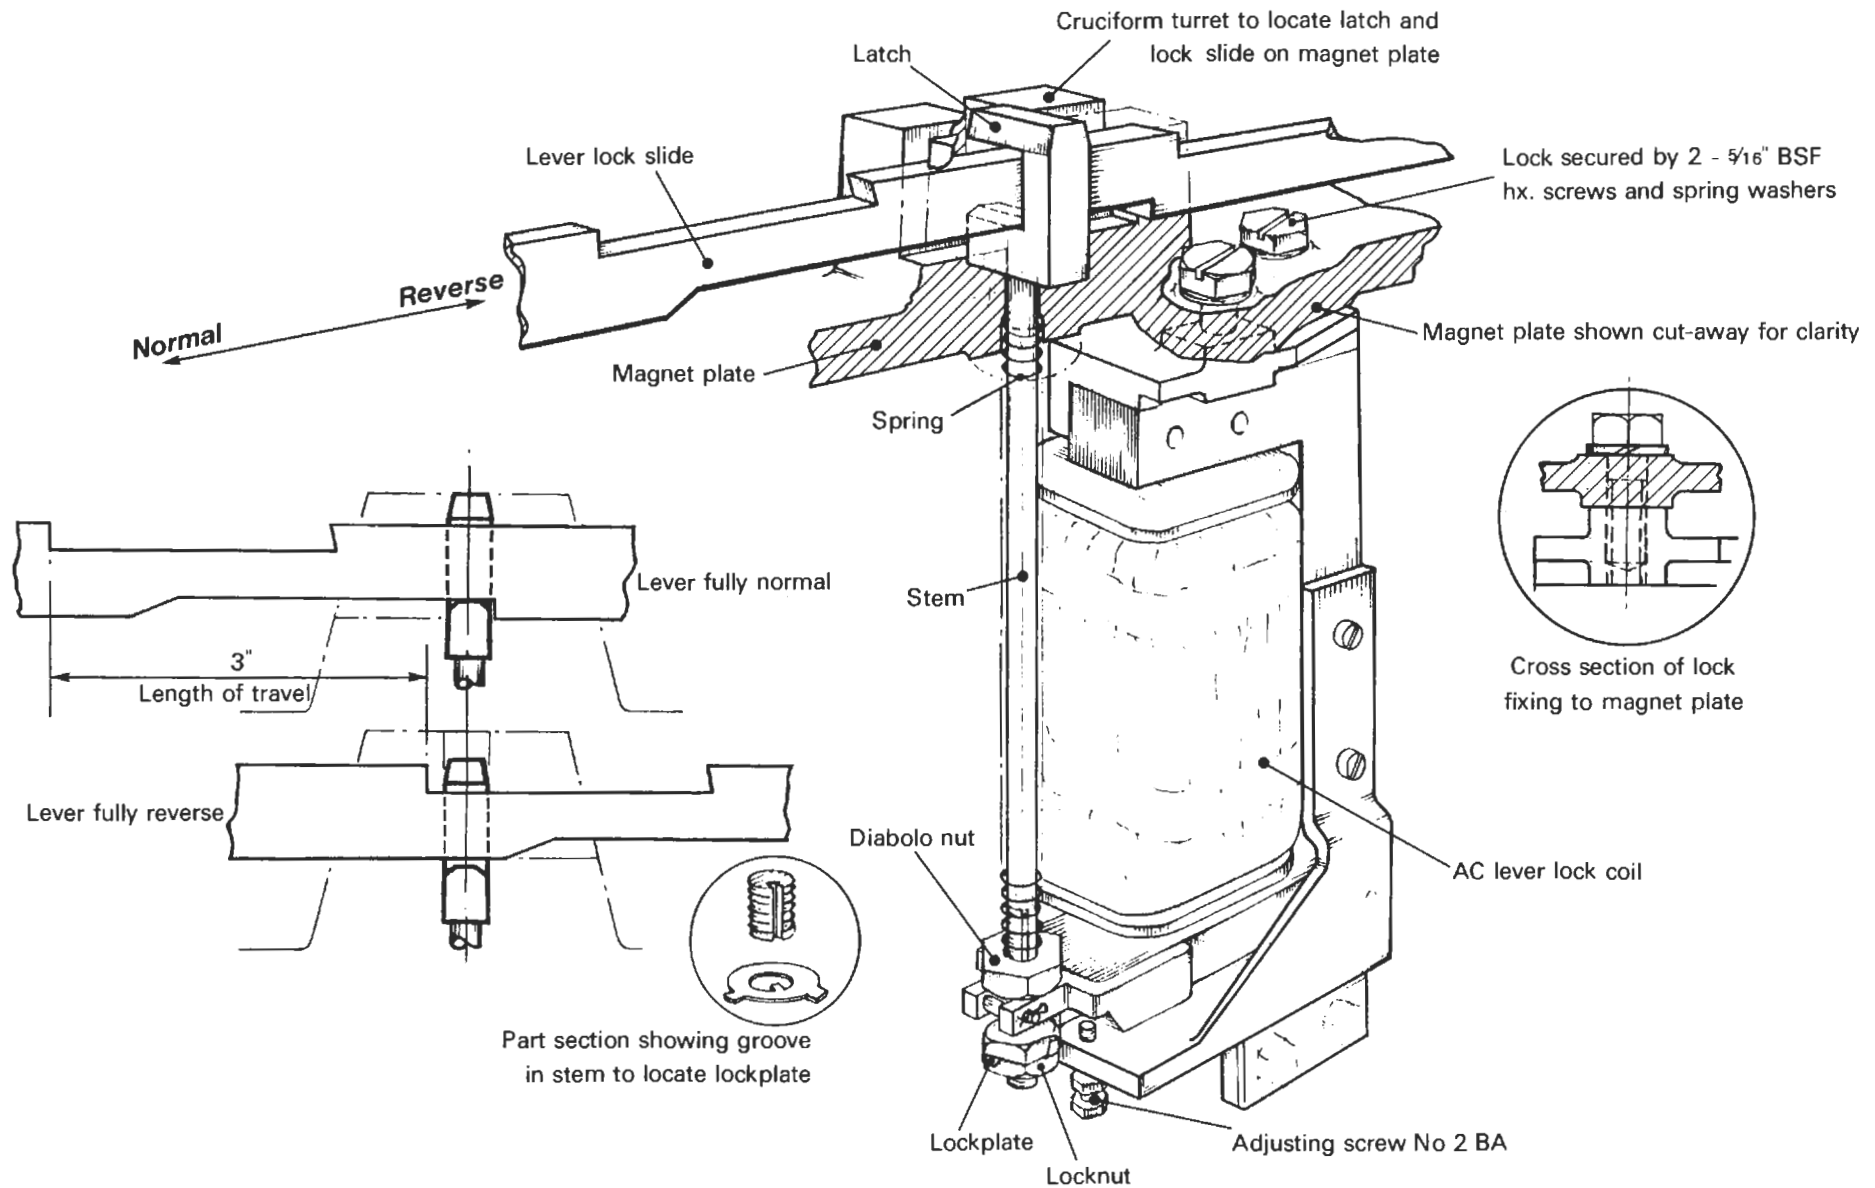
Mounting of lever lock on power frame magnet plate

reached. He said the reason for the latch not holding No. 21 lever slide was that the effective length of the stem had been increased, thus lifting the latch when the lock was de-energised, because the diabolo nut had worked its way down the threaded portion of the stem. The position of the diabolo nut was set to give the correct clearances to the latch and then secured in this position by a copper lock plate and lock nut. However, after the accident, the lock plate and lock nut were found complete in the pit below the frame. Their absence had allowed the diabolo nut to become unscrewed down the threaded portion of the stem because of the vibration on the frame during lever movements and because the concentric push-off spring exerts a continuous downward force on the nut. Both the tabs of the copper lock plate were complete, showed signs of having been correctly bent and should have prevented the lock nut from turning. No satisfactory explanation of the lock plate failure could be found. All the other similar locks on LT had been examined and no repetition of the fault discovered. He had advised the manufacturers of the incident and understood that British Railways had also checked their locks, again without finding a similar fault. He concluded that the failure was an entirely random one. He commented that Locking Fitter Dight had carried out quite correctly the normal fault finding and correction process and he could not blame him for failing to spot such an obscure failure, which probably would have defeated many more experienced signal engineers.

21. The direct cause of the mechanical failure of the electric lock was the loss of the lock nut which allowed the adjusting nut to alter the setting of the locking latch. Quite when this loss occurred was not established; it may or may not have happened before Locking Fitter Dight attended to the frame two days earlier. The lock nut had been correctly fitted with a copper locking plate (or tab washer) whose tabs showed that at some time after their initial installation they had been properly bent over to prevent the rotation of the lock nut. This is a well-proven method in general engineering use. Inspection of most if not all similar locks in use in this country has not revealed a similar failure. I therefore consider this to be an entirely isolated failure and accordingly have no recommendations to make. I also consider that Locking Fitter Dight cannot be blamed for his failure to notice this defect during his work on the frame. However London Transport decided that the means of preventing the lock nut from turning will be changed from a locking plate to a retaining clip and split pin because, in their view, this will give greater security and be more easily checked to see that it is still correctly fitted.
