REPORT ON THE COLLISION

22nd December 1955

HELLIFIELD STATION

BRITISH RAILWAYS

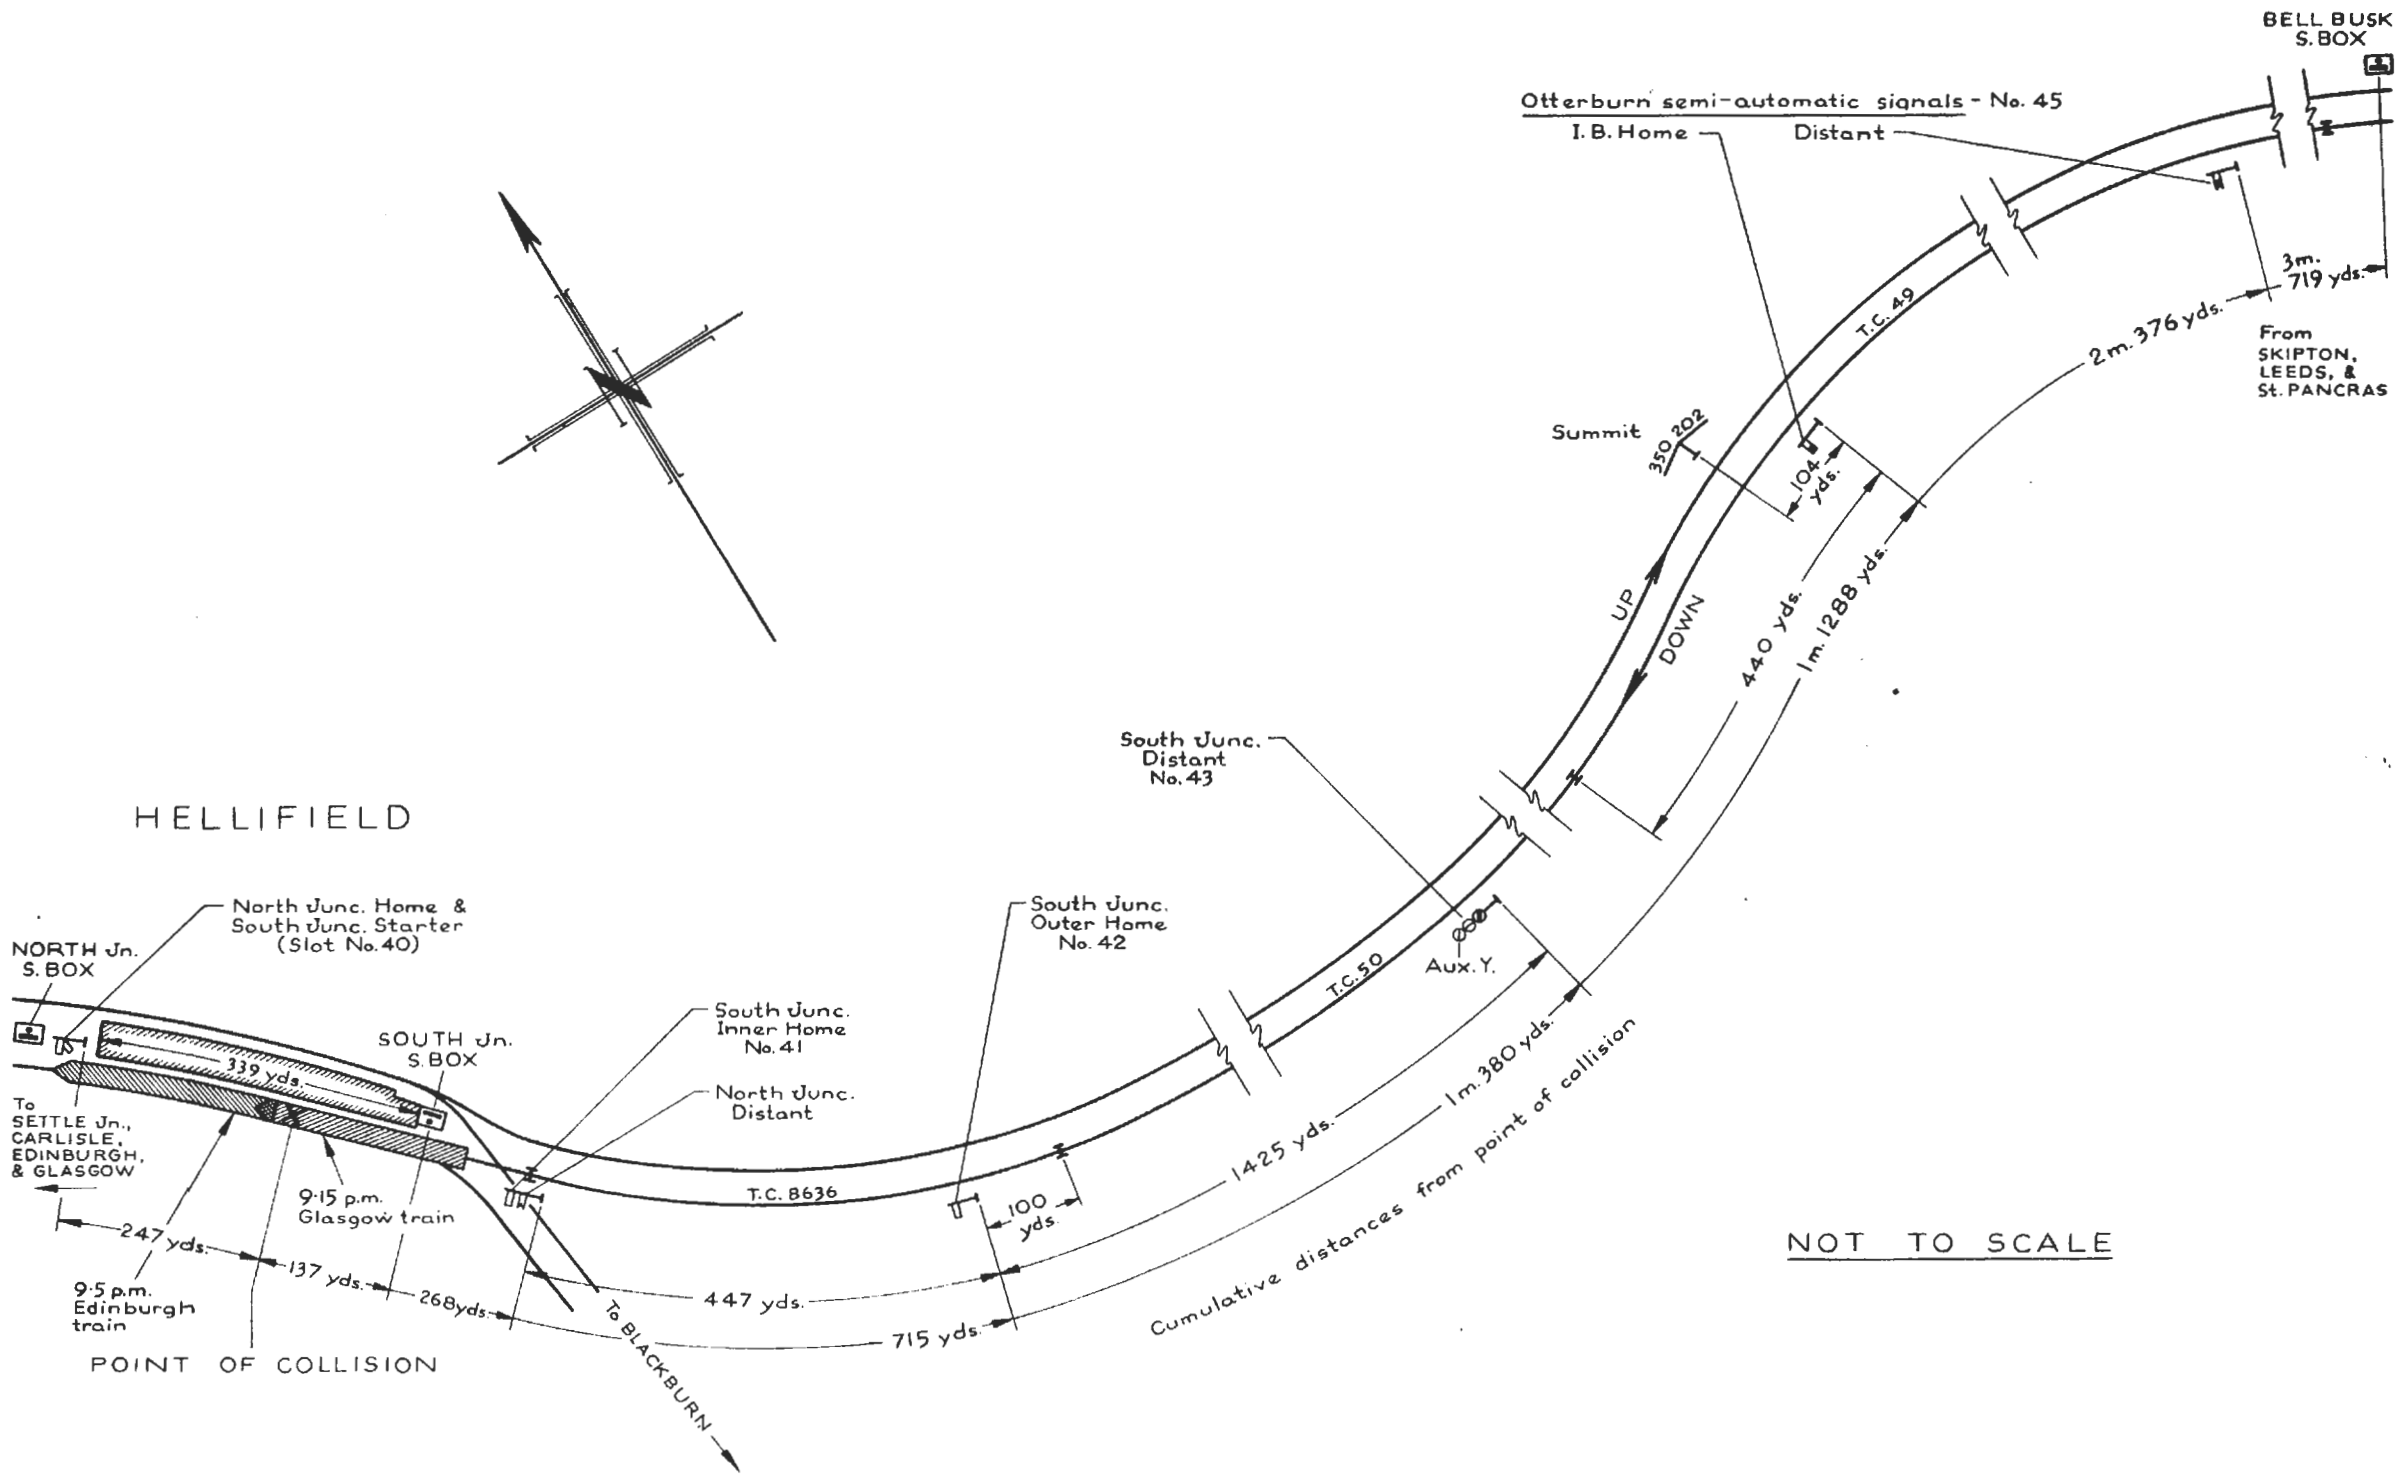
3. With reference to the sketch opposite, the former Midland Railway main line runs through Leicester, Leeds, Skipton, Hellifield and Settle to Carlisle and between Skipton and Hellifield it is double. In the Down direction from Skipton to Hellifield, a distance of 10 miles, the line runs roughly south-east to north-west. There are intermediate signal boxes at Delaney's Sidings, Gargrave and Bell Busk, which are respectively $7\frac{1}{2}$, $6\frac{1}{4}$ and $3\frac{1}{2}$ miles from Hellifield. The Down line rises 1 in 131 to 1 in 380 to a summit almost half-way between Bell Busk and Hellifield, and then falls at 1 in 121 to 1 in 350 through Hellifield to Settle Junction. Near the summit there is a curve to the left followed almost immediately by a long gentle curve to the right which extends almost continuously to the south end of Hellifield station. The station has an island platform with the Down main line on the west and the Up main line on the east side. There is a speed limit of 60 m.p.h. through the station.

4. There are two signal boxes at Hellifield called South Junction situated at the Skipton end of the platform, and North Junction which is some 65 yards beyond the Carlisle end. The signalling arrangements on the Down line from Bell Busk are shown in the sketch. The line is track circuited continuously from that box up to and through Hellifield Station, and the track circuits numbered in the sketch are indicated on the diagram in the South Junction box. Track circuit No. 49 is also indicated in Bell Busk

box. There are intermediate semaphore signals (an "intermediate block home" with a distant signal) about half way between Bell Busk and Hellfield and they are known as the Otterburn signals. They are semi-automatics and are controlled electrically by one lever (No. 45) in the South Junction box, and also by the track circuits; they are repeated in the box. The South Junction box also has a colour light distant signal (No. 43) and a semaphore outer home (No. 42), both of which are repeated, and an inner home (No. 41) all of which are situated on the left hand side of the track. The "sighting distances" of these signals from the footplate are as follows:—

<i>Right hand (Fireman's side)</i>	<i>Left hand (Driver's side)</i>
Distant signal—No. 43	372 yards	125 yards
Outer home signal—No. 42	430 yards	190 yards
Inner home signal—No. 41	502 yards	224 yards

5. The signal at the Carlisle end of the platform is the North Junction home signal which is also slotted as the South Junction starting signal by lever No. 40. The North Junction box has a semaphore distant situated under and slotted by the arm of the South Junction inner home. In view of the short distance between the North Junction box distant and home signals, there is a mechanical "underbolt" which prevents the clearing of the South Junction colour light distant (No. 43) before the North Junction distant, and there is an indicator in the South Junction box showing when the North Junction lever has been pulled. The replacing of the North Junction distant to Caution does not in itself change the aspect of distant signal No. 43 from Green to Yellow, nor is the latter controlled by track circuits. There is sequential locking between the South Junction levers Nos. 40 and 41 (electrical), and between Nos. 41 and 42, and Nos. 42 and 45 (mechanical).

10. The main signalling installation dates from 1910. The colour light distant signal was, however, installed in 1938, but at that time it was not the practice of the London Midland and Scottish Railway to control the aspects of such signals by track circuits. A scheme had, however, been prepared before this accident took place to control distant signal No. 43 by track circuit No. 8636 and also to provide a stick relay control on the Otterburn signals to prevent the arms clearing again until lever No. 45 is put to normal and re-pulled. These, and some other "proving" controls, were installed immediately after the accident.
