REPORT ON THE COLLISION

1st April 1960

HERNE HILL SORTING SIDINGS
SIGNAL BOX

SOUTHERN REGION
BRITISH RAILWAYS

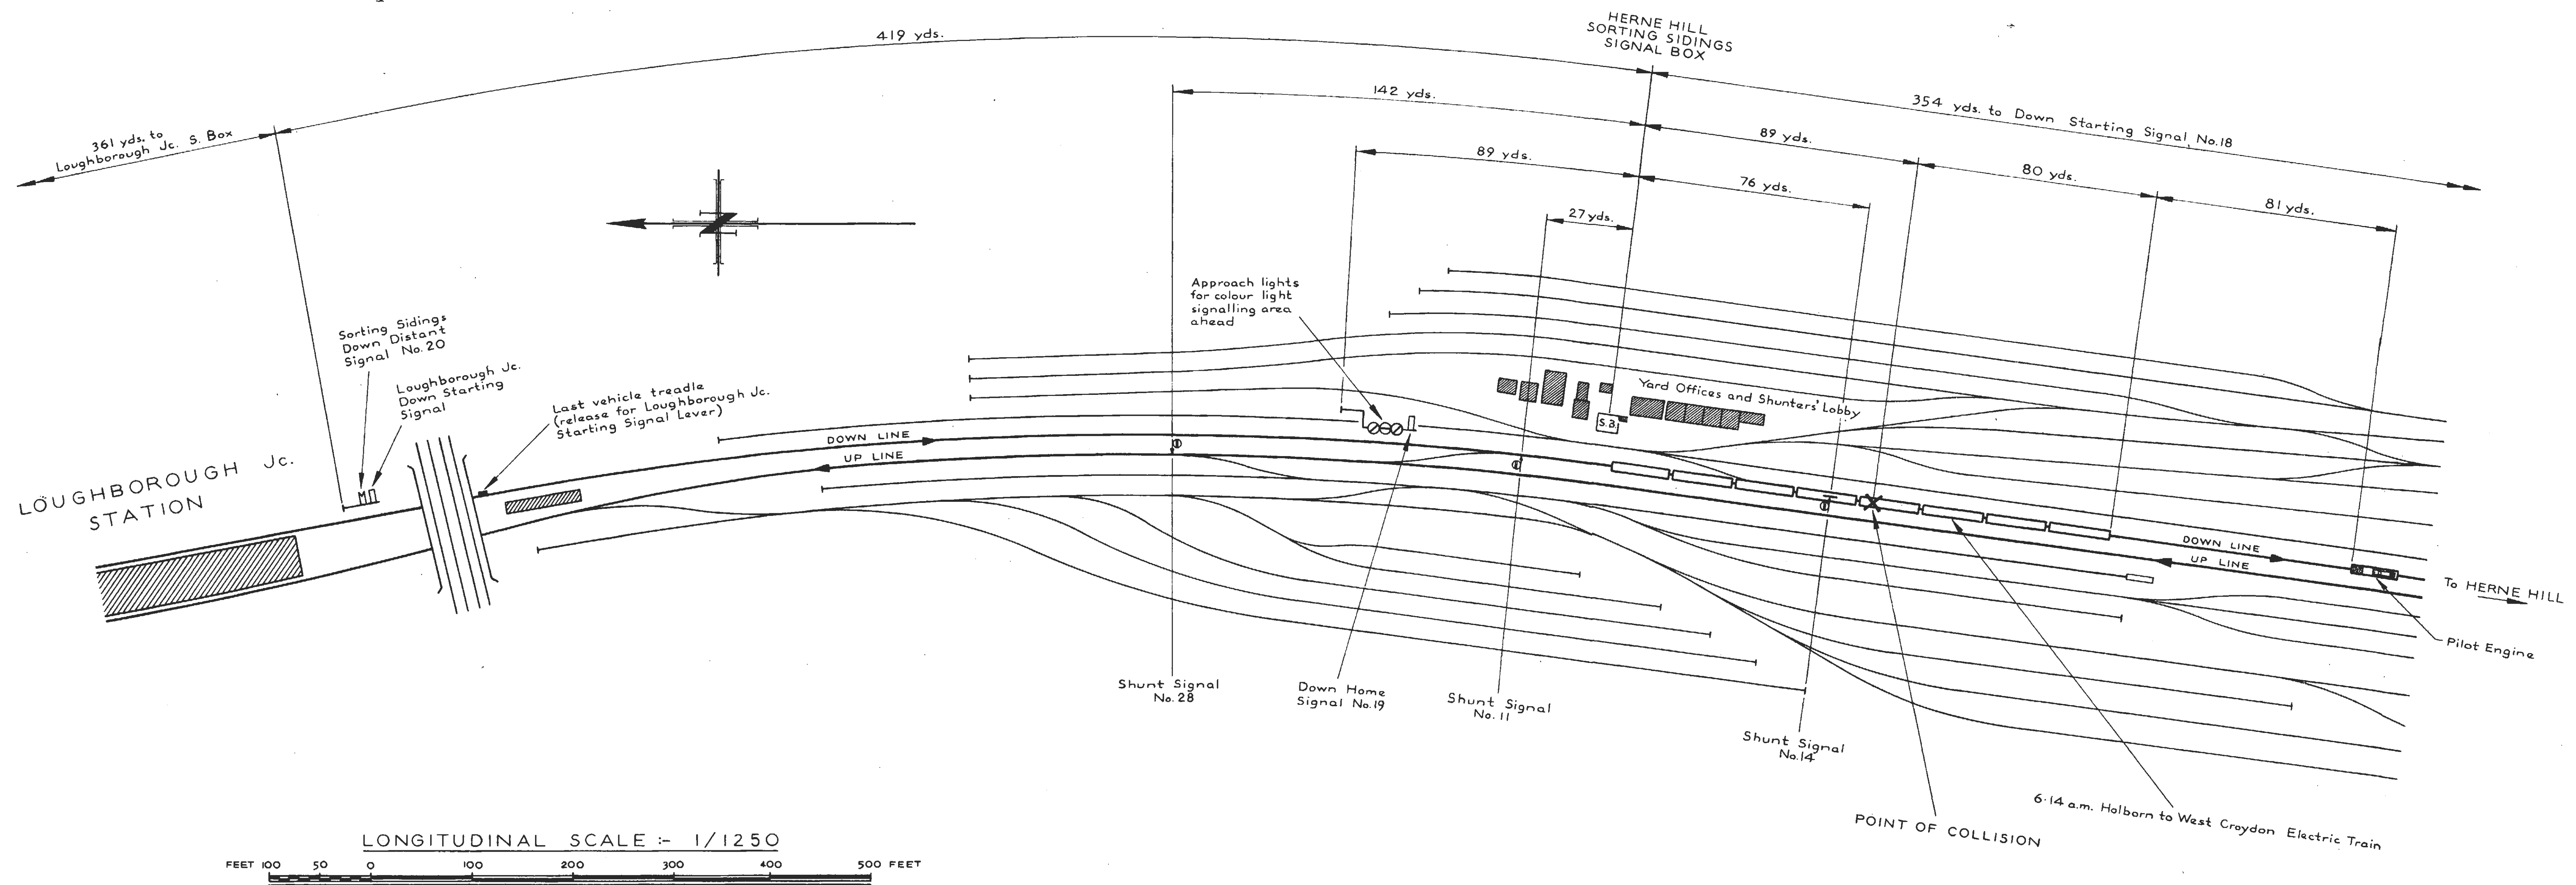
COLLISION AT HERNE HILL SORTING SIDINGS ON 1st. APRIL, 1960

The passenger train stopped 80 yards ahead of the point of collision, and the engine travelled a further 81 yards before it came to a stand.

The pilot engine had followed the departing train on the Down line for a distance of about 80 yards up to shunt signal No. 14 where it had been halted while the driver waited for the points to be set and for the signal to be given for the engine to run into the Down sidings: it was standing at this signal when it was hit by the electric train. It will be seen from the sketch that shunt signal No. 14 is 76 yards from the signal box; the engine was 13 yards beyond it, judging from the marks of the collision on the ground.
