# **RAILWAY ACCIDENT**

## **Report on the Collision that occurred on 9th July 1980 at Holborn Station**

ON THE  
CENTRAL LINE  
OF LONDON TRANSPORT RAILWAYS

COLLISION AT HOLBORN STATION (LT)  
9TH JULY 1980

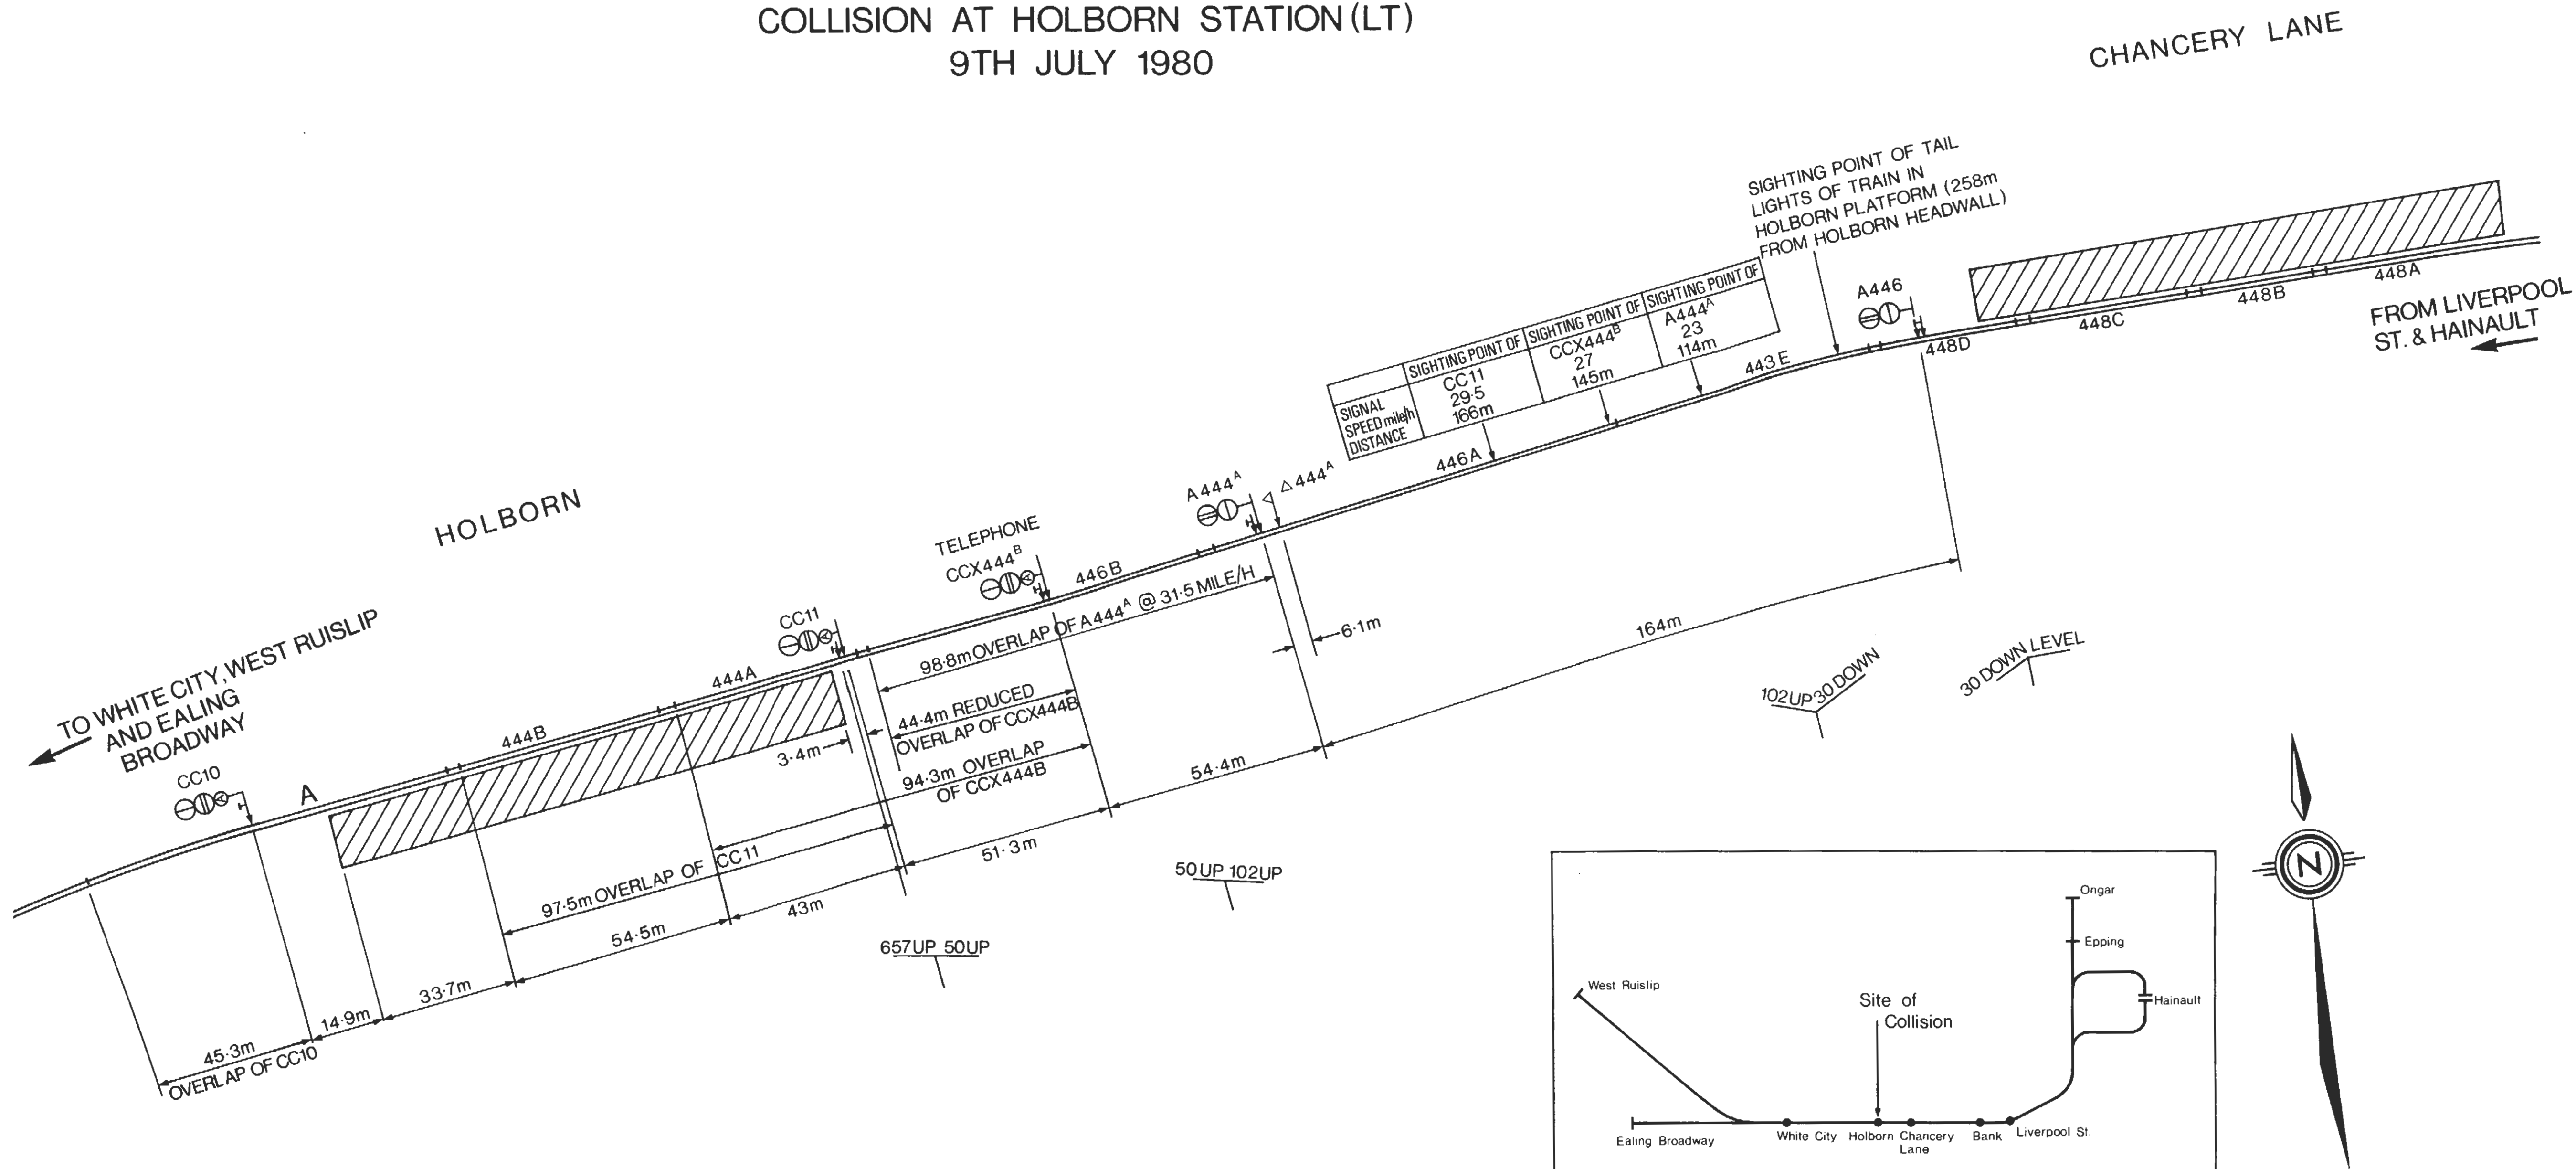
1. A diagram of the Central Line showing the track, gradients, sighting distances and signalling of the westbound line between Chancery Lane and Holborn is at the back of the report. At the time of the accident the signalling was operating automatically through the action of the continuous track circuiting although certain signals can be controlled when necessary from a signal cabin at Holborn. All signals are two aspect with two lamps per aspect and have an associated trainstop which is raised when the signal is at Danger and which will contact the tripcock of a passing train causing an emergency application of the brakes. The trainstop is lowered before the signal shows a proceed aspect.

A446	Chancery Lane Starting Signal	Signal remains at Danger until the speed of an approaching train is proved to have been reduced to 15 mile/h by the occupation of track circuits when it will clear if track circuits up to and including 446B are clear.
		169 Metres to:—
A444A	Holborn Outer Home Signal	With track circuit 444A occupied and track circuit 446B clear the signal remains at Danger until an approaching train is about 14 m from the signal and occupies rail circuit 444A which acts as an approach control and clears the signal.
		54 Metres to:—
CCX444B	Holborn Intermediate Home Signal	Remains at Danger until track circuits 444A and 444B are cleared by a departing train.
		51 Metres to:—
CC11	Holborn Inner Home Signal	At Danger until track circuit A is cleared by a departing train.
		3 Metres to:— Holborn Station headwall.

4. At Chancery Lane there is a headwall repeater for Signal A446. The total distance between the west headwall of Chancery Lane station and the east headwall at Holborn is about 292 m. The rear of T10 was probably about 1.5 m beyond the east headwall at Holborn before the accident. The signalling was designed in 1938/39 and commissioned in 1941. The new rolling stock introduced in 1962 has the same braking performance as the stock it replaced.

22. *Mr. Heaton* confirmed that after the accident the rail circuit on the approach to Signal A444A that permitted an approach to CCX444B with a reduced overlap had been taken out of use together with similar controls at four other locations. At another five locations a delay feature had been introduced so that the signal did not clear, and the train stop lower, until some seconds after the train had been detected approaching the signal. Thus, if a driver does not reduce the speed of his train approaching these signals, the train stop will not have lowered and the signal cleared by the time the train reaches it and the tripcock will be operated.
