RAILWAY ACCIDENT

Report on the Collision that occurred on 30th October 1968 at Selside near Horton-in-Ribblesdale

IN THE
LONDON MIDLAND REGION
BRITISH RAILWAYS

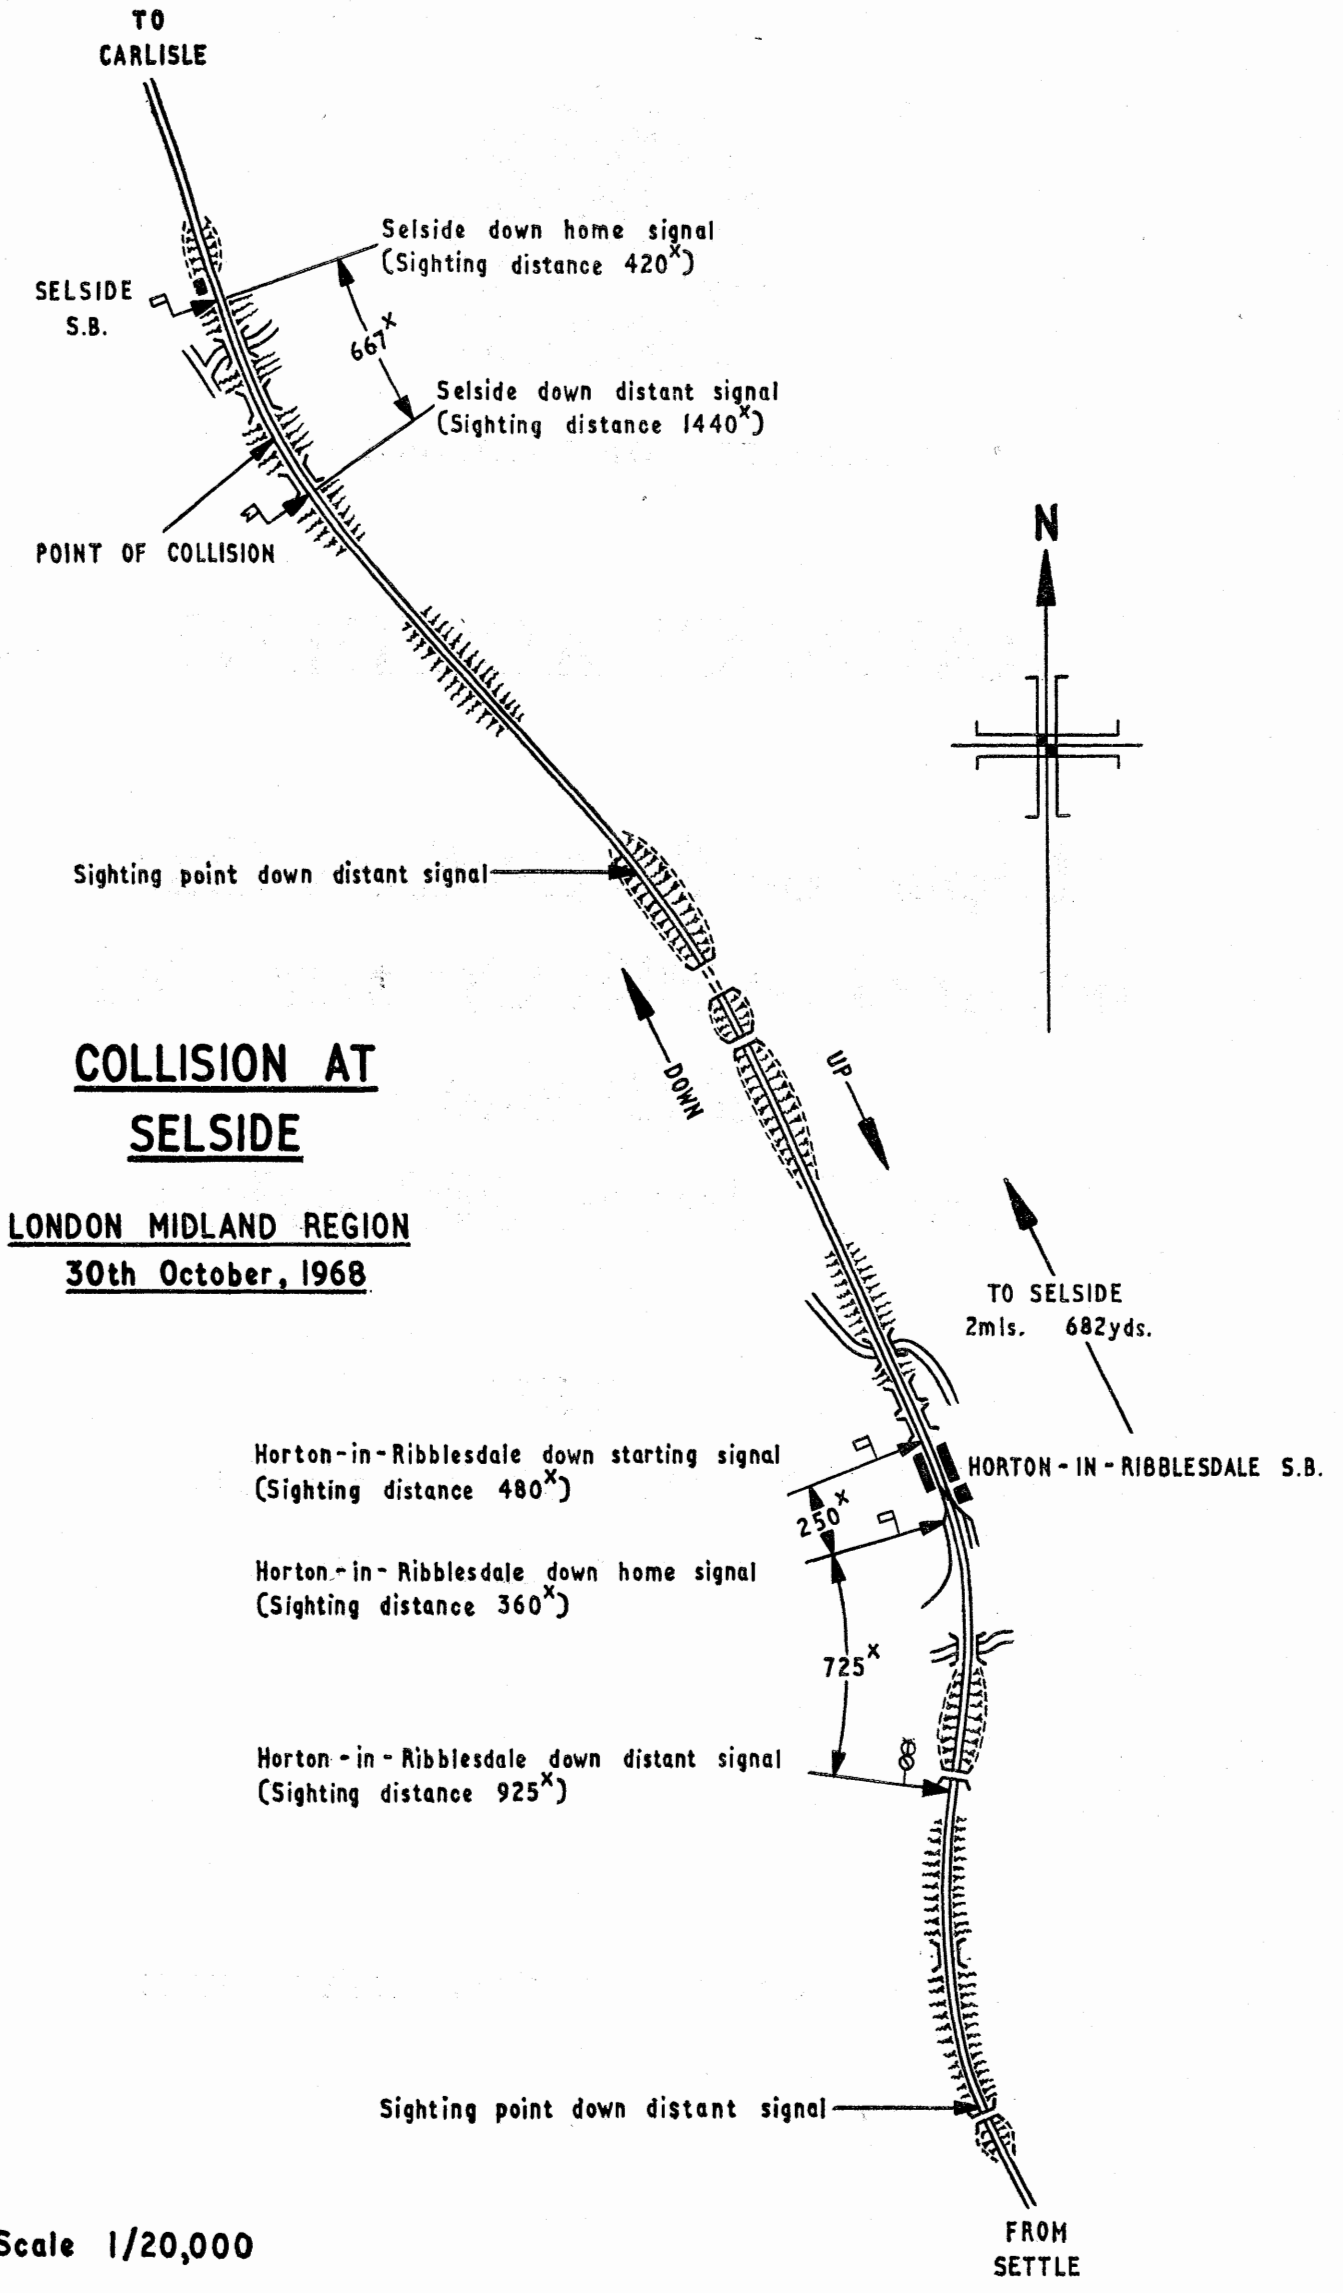
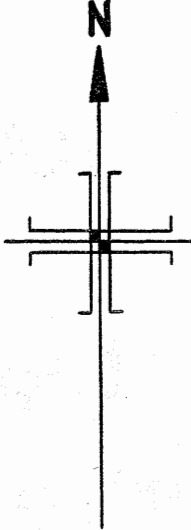
**COLLISION AT
SELSIDE**

Selside down home signal
(Sighting distance 420^x)

Selside down distant signal
(Sighting distance 1440^x)

POINT OF COLLISION

Horton-in-Ribblesdale down starting signal
(Sighting distance 480^x)

Horton-in-Ribblesdale down home signal
(Sighting distance 360^x)

Horton-in-Ribblesdale down distant signal
(Sighting distance 925^x)
