MINISTRY OF TRANSPORT & CIVIL AVIATION

RAILWAY ACCIDENTS

REPORT ON THE COLLISION
which occurred on
15th August 1953 at
IRK VALLEY JUNCTION,
near **MANCHESTER (VICTORIA),**
in the
LONDON MIDLAND REGION
BRITISH RAILWAYS

1953

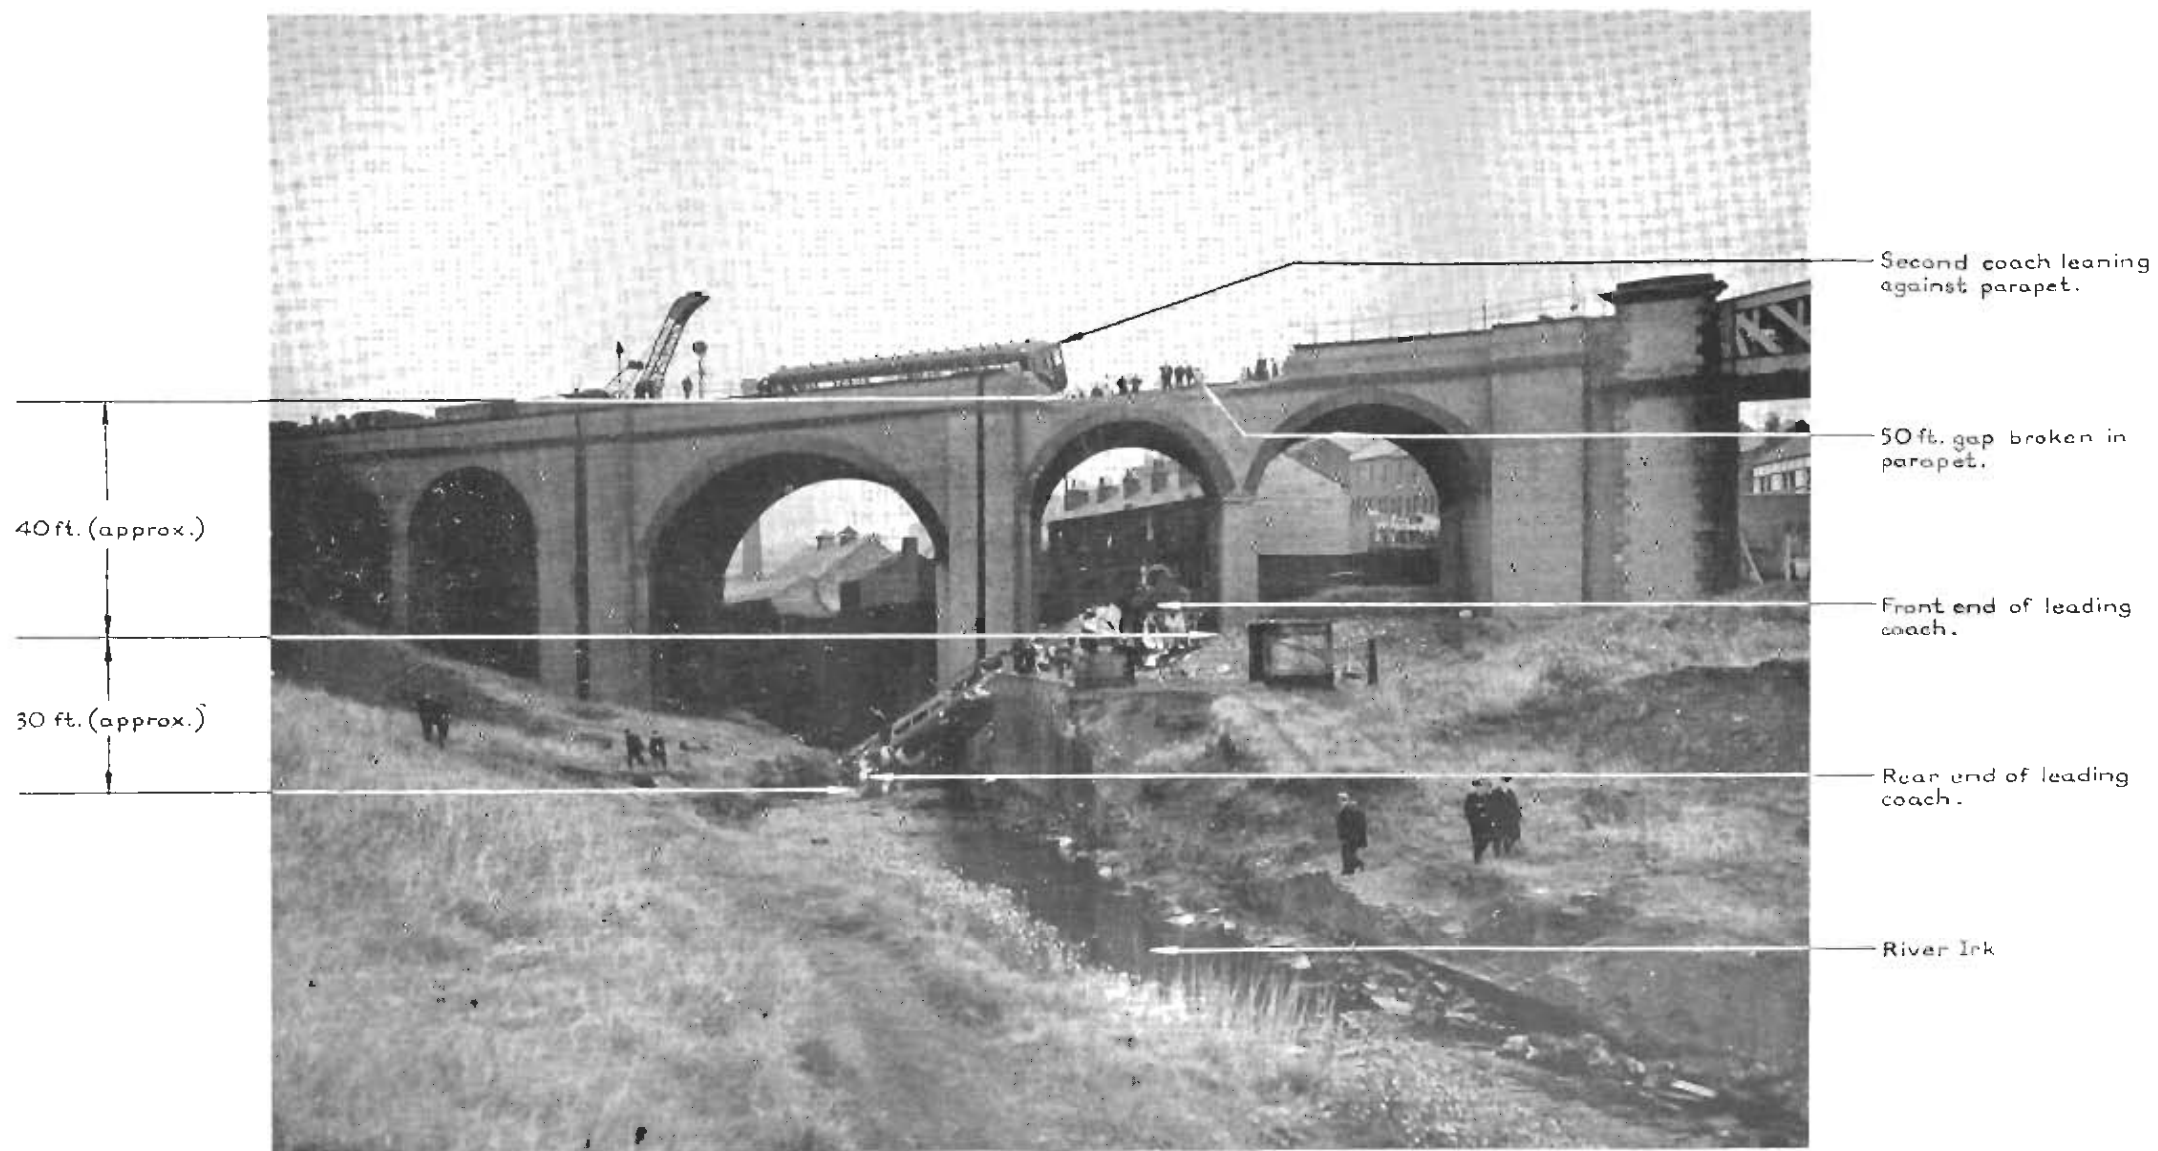
GENERAL VIEW FROM THE WEST OF THE WRECKAGE OF THE 7.20 a.m. ELECTRIC TRAIN

8. The majority of the casualties occurred in the leading electric coach which was wrecked beyond repair. The second coach was also heavily damaged with severe distortion of the whole underframe.

The photograph opposite shows the gap in the parapet of the viaduct and the leading coach of the electric train lying in the valley below.
