MINISTRY OF TRANSPORT

REPORT ON THE COLLISION

19th March 1962

KING EDWARD BRIDGE JUNCTION

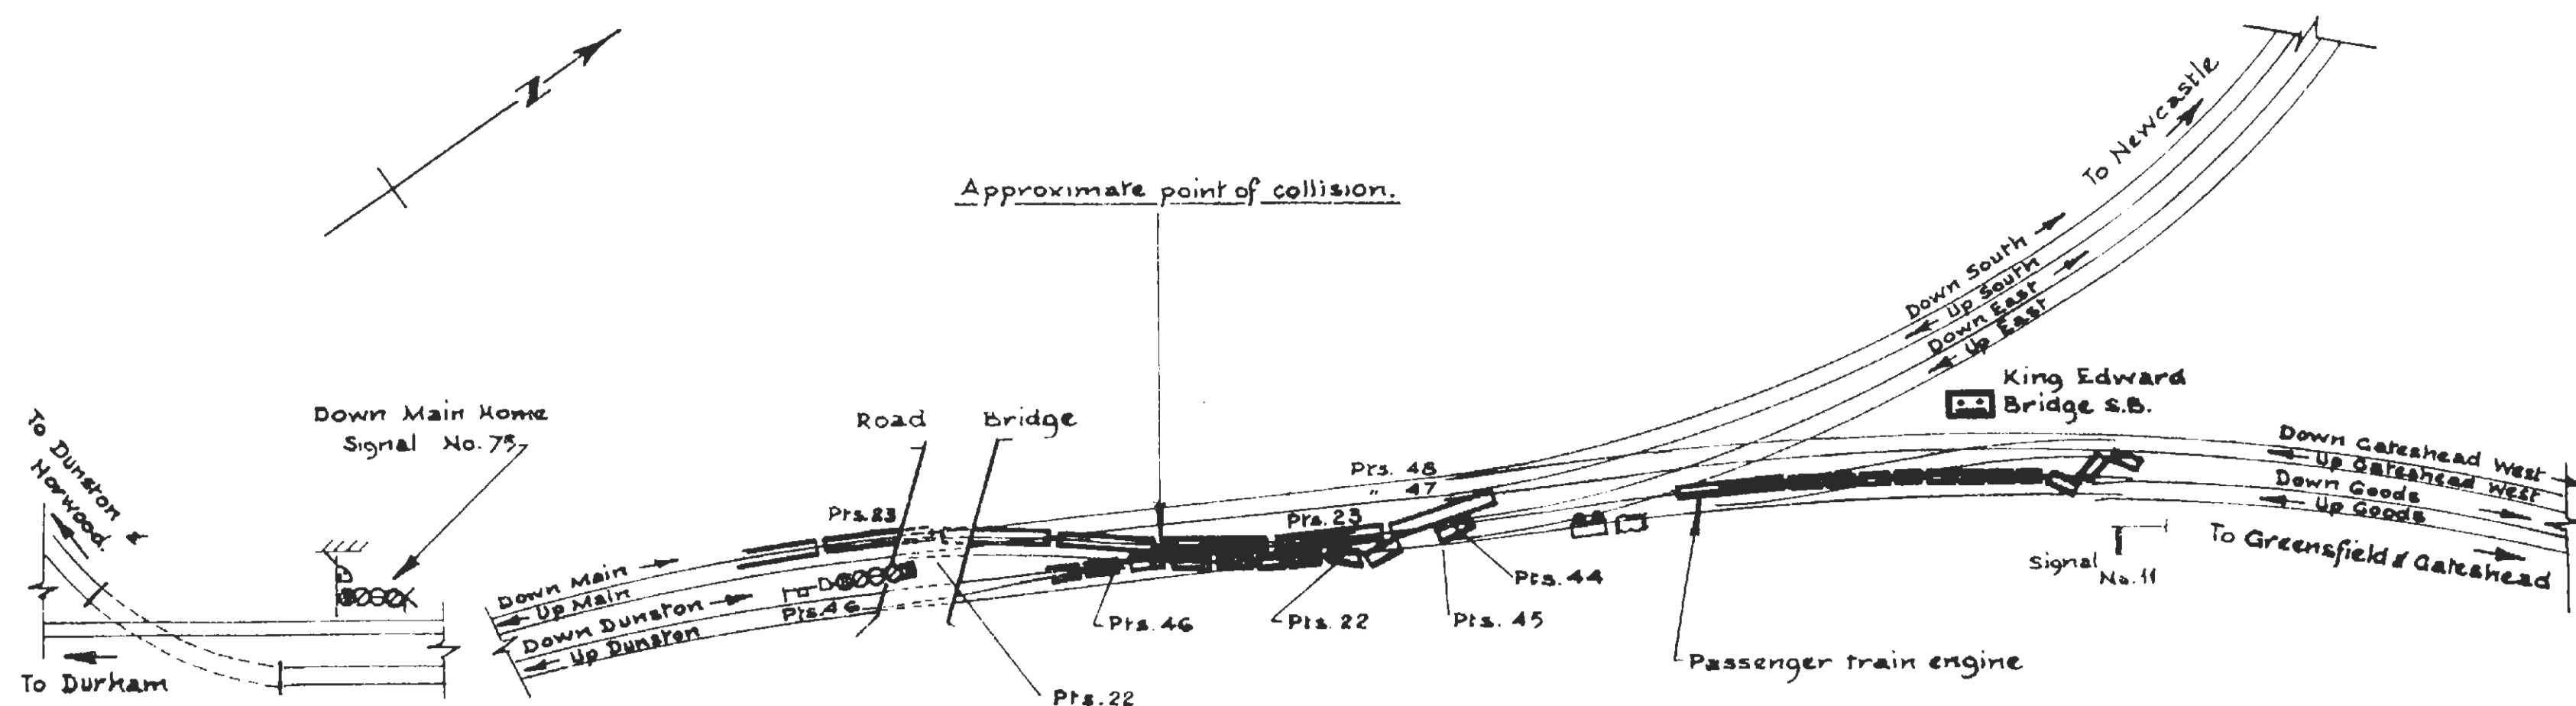
COLLISION AT KING EDWARD BRIDGE JUNCTION, 19th MARCH, 1962

The sketch map on the facing page illustrates the arrangement of lines in the vicinity of the accident and the position of the relevant signals.

The points on the Down Main line that were wrongly set for the passenger train were the facing ones of the pair in the crossover from the Down Main to the Down Dunston line, No. 23. There is a parallel crossover from the Up Dunston to the Up Main line, No. 22, and a trailing crossover between the goods lines, No. 46. The junction points, on the Newcastle side of these crossovers are Nos. 48 facing from the Down Main to the Down Gateshead West, 47 trailing between the Up Gateshead West and the Up Main, 44 facing from the Down Dunston line to the Down East line and 45 trailing between the Up East line and the Up Dunston line. The Dunston lines continue towards Gateshead as Goods lines.

In the area of the accident the line is in cutting between high retaining walls and there is a road bridge spanning the tracks at No. 23 facing points which are 223 yards from the signalbox. The junction points are about halfway between No. 23 facing points and the signalbox.

The Down Main signal on the approach to No. 23 facing points is 287 yards from them. It is a 4-aspect colour light, with a three way junction indicator for the main routes to Newcastle via the South and East lines respectively, and to the Down Goods line towards Gateshead. It also leads to the Down Gateshead West line for which there is no indicator. There is a subsidiary signal here. The Down Dunston line signal which protects the connections is also a 4-aspect colour light and is close to them.
