MINISTRY OF TRANSPORT

RAILWAY ACCIDENT

Report on the Derailment that occurred on 15th July 1966 at Kingham

IN THE
WESTERN REGION
BRITISH RAILWAYS

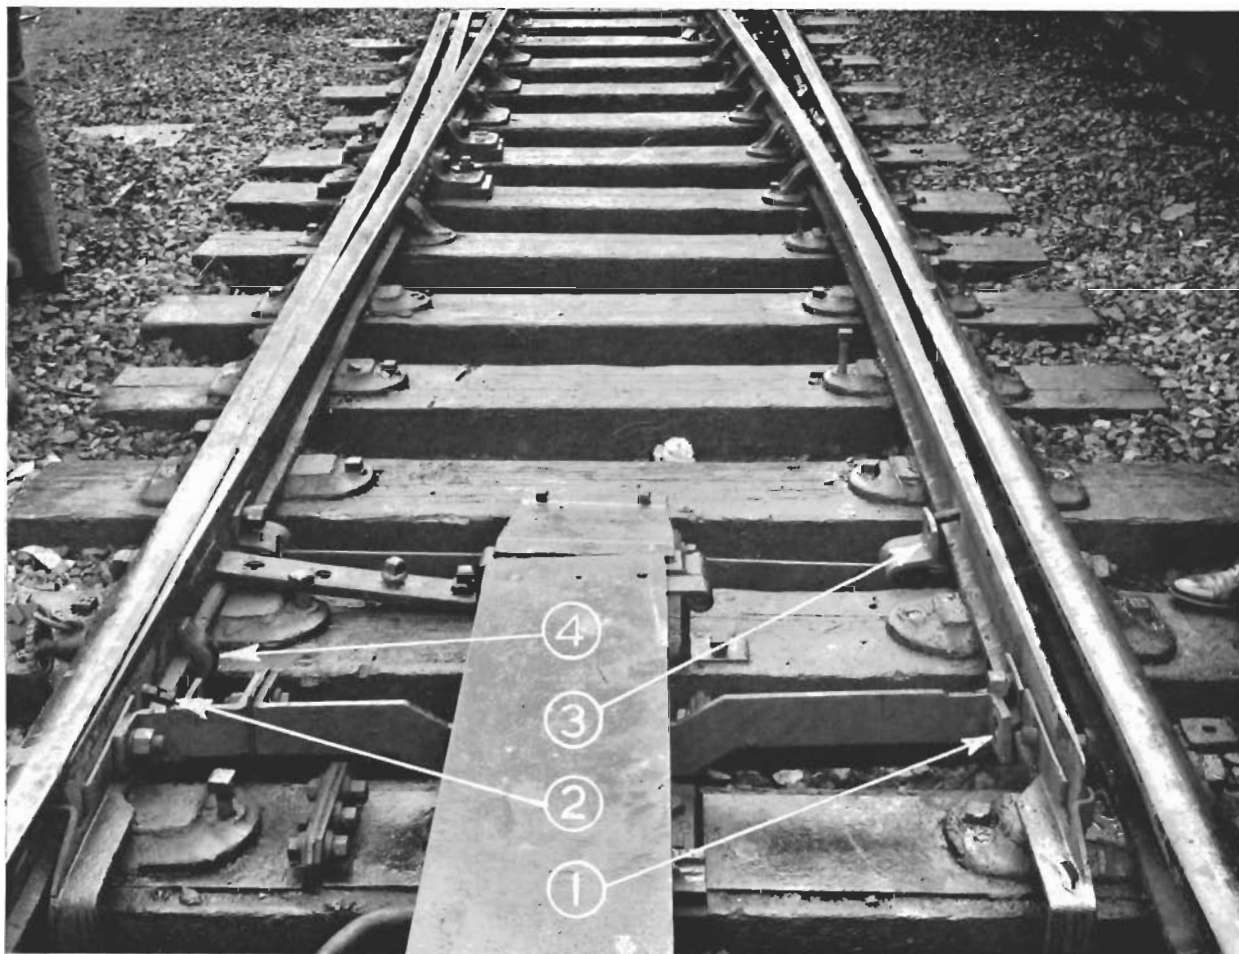
7. After the accident the right-hand switchblade stood about 1½ inches open from the stock rail, as shown in the accompanying photograph, but the trailing bogie of the last coach of the train must have forced it against the stock rail, since both switchblades were buckled indicating that the bogie had run between them and had become derailed as they converged. It then came into contact with a redundant diamond crossing about 25 yards further on and was thrown violently to the left, swinging round and mounting the ramp at the country end of the island platform, along which it rode for some 30 yards. The buckeye coupling at the leading end of the coach parted in the closed position from the remainder of the train on account of the relative movement of the two coach ends and the detached vehicle continued to run derailed until it came to rest at the London end of the station leaning against the Down platform. The remainder of the train came to a stand near the Up Main Advanced Starting signal as a result of the severance of the vacuum train pipe, having travelled a distance of approximately 620 yards from the point of initial derailment.

Photograph of the facing connection at which the derailment occurred with the open switch blade in the position in which it was found after the accident, showing:—

1. Nut missing at right-hand end of facing point lock stretcher
2. Nut missing from left-hand end of first point stretcher bar
3. Nut missing from right-hand end of second point stretcher bar
4. Closed switch blade secured by padlocked clip

29. I paid a visit to the scene of this derailment on the day it occurred, arriving at Kingham at about 17.30. The redundant facing connection, which was the point of initial derailment, had been left exactly as it was found by Sub-Inspector Cooper immediately after the accident, as shown in the photograph reproduced in this report, which was taken looking in the direction the train was travelling.

30. The heavy cranked steel bar in the foreground is the facing point lock stretcher. Beneath the hinged plate in the centre the locking plunger was fully home through the hole in the stretcher. The nut from the coarse-threaded bolt at the right-hand side was missing and nowhere to be found. This was the bolt upon which the Ganger and Sub-Ganger admitted to using a cold set and a mark can be discerned on the threaded portion of the bolt as if it has been damaged in the process.

31. Immediately behind the facing point lock stretcher and almost hidden by it lies the first point stretcher bar. On the left the nut was missing and the end of the bar had slipped off the fine-threaded bolt. It was from beneath this bolt, between the timbers, that the Permanent Way Inspector picked up a fine threaded nut which had been cut by a cold set.

32. Between the next pair of timbers can be seen the second point stretcher bar with the nut missing from the right-hand bolt. It was this nut that Acting Sub-Inspector Sollis averred he saw the ganger and sub-ganger split with a set and hammer. It was not found after the accident.

33. In the photograph, the locked clip securing the left-hand switch blade to the stock rail, and the additional precautionary measure consisting of a fishplate held down by two coach screws, can clearly be seen and it is at once apparent how the removal of the three stretcher bar nuts leaves the right-hand switch blade entirely free to move towards the stock rail.

34. The accident occurred because the unsecured open switch blade of a redundant facing connection moved under the vibration of a passing train, causing the trailing bogie of the last coach to become derailed. The switch blade was free to move because three nuts, one holding the switch blade to the facing point lock stretcher and one from each of the two point stretcher bars connecting the two switch blades, had been deliberately removed and no chock had been inserted between the open switch blade and the stock rail.

38. The Instructions reproduced in paragraph 10 of this Report would, if properly applied, have effectively prevented this accident. All the members of the Civil Engineer's staff concerned, however, including even the Assistant Divisional Engineer, were completely unaware of the existence of the amendment, issued 3 years previously, extending it to cover redundant switches. I have since been assured by the Chief Civil Engineer, Western Region that the importance of securing the open switch blades of redundant connections has been brought to the notice of all the staff concerned, and I am glad to report that a further amendment has now been issued to paragraph (iv) of the Instructions which deletes the words "... but a period of time is likely to elapse before the fittings are removed, ...". This has the effect of making it mandatory that switches in main passenger lines are to be secured immediately they are disconnected from the signalbox.
