MINISTRY OF TRANSPORT

REPORT ON THE COLLISION

which occurred on the
23rd January, 1948, at

LONDON BRIDGE
STATION

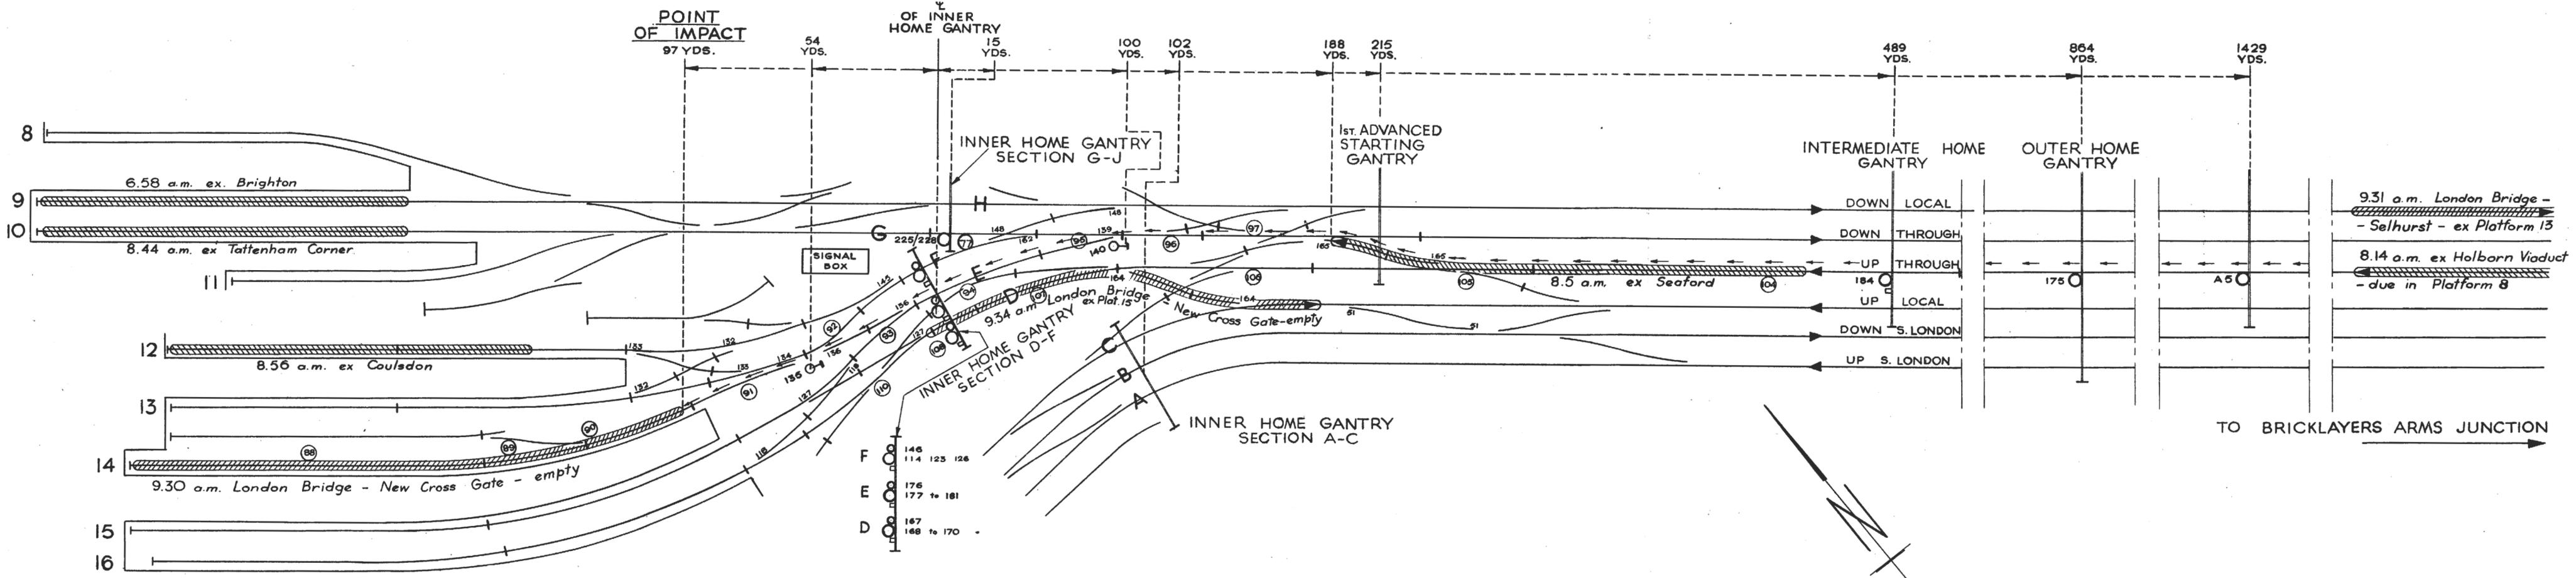
COLLISION AT LONDON BRIDGE

The relevant signals, track circuits, points, platforms, etc., are shown on the plan. The six Central Section lines are straight for just over a mile approaching the station, where they curve to the left at the facing junctions and then fan out through the controlling sections A, B, C, etc., to the Main Line and South London terminal platforms. The Main Line platforms vary in length and only Nos. 14, 15 and 16 are long enough to hold a 12-coach train. Ordinary type buffer stops are installed at the end of each platform line; consideration had been given to the provision of hydraulic buffers, but, owing to their length and the limited space available, they could not be fitted in without serious interference to traffic working. With the exception of No. 11 platform, all tracks are electrified on the third rail system.

7. The positions of trains, at the moment when the Seaford train was approaching the Inner Home Gantry, are shown on the plan and the movements in and out of the Main and Low Level stations immediately prior to the accident were as follows :—

18. This accident was caused by the 8.5 a.m. Seaford train overrunning Inner Home signal No. 177 at Danger, but, owing to the regrettable death of Motorman E. J. Watson and Passed Fireman B. H. Peddlesden, the circumstances in which this occurred must remain a matter for conjecture, especially as Guard Watmore, who might have thrown some light on it, did not see the Inner Home gantry before the leading coaches had passed it.

19. There is no doubt, however, regarding the indications displayed by the approach signals during the passage of the train. Outer Home No. 175 was held to yellow by the red aspect of Intermediate Home No. 184, which could not be changed until the 8.44 a.m. ex Tattenham Corner had cleared track circuit No. 77. Even after that, the Intermediate Home could only show a yellow aspect, with the route indicator displaying the letter E, as it was controlled by the Inner Homes, Nos. 177/181, at Danger, and no other route indication could be given with the road set through crossover No. 165 and points No. 139 reversed. Shunt signal No. 140 was correctly showing green, having been reversed in order to release No. 184, and shunt signal No. 176 was locked by No. 184; the levers of Inner Homes, Nos. 177/181, must all have been in the normal position; the route from E Section was set to No. 14 platform, due to Hulbert's inability to replace lever No. 136, hence the only signal of this group which was free of mechanical interlocking was No. 179, and it was held to Danger by the empty train in No. 14 platform occupying track circuits Nos. 88, 89 and 90.

20. It will be seen, therefore, that the Seaford train was correctly signalled and should have been brought to a stand at the Inner Home gantry, the signals on which were clearly visible for 200 yards, having come into full view after the train entered crossover No. 165. The route via E Section is constantly used by trains running into Nos. 14 to 16 platforms and the stop at the Inner Home is by no means unusual. Consequently, Motorman Watson, a man of 37 years' experience, should not have been taken by surprise at finding this signal at danger. There is no evidence, however, to suggest that he attempted to stop before he ran into No. 14 platform. On the other hand, Guard Watmore said he thought the train accelerated after passing the Intermediate Home, and hence, it is important to consider whether any adjacent signal might have been showing a green aspect, which Watson could have mistaken. I am satisfied, however, that all relevant signals were at danger for the reasons given in the next two paragraphs.
