RAILWAY ACCIDENTS

REPORT ON THE COLLISION

21st February 1955 at

LUDDENDENFOOT

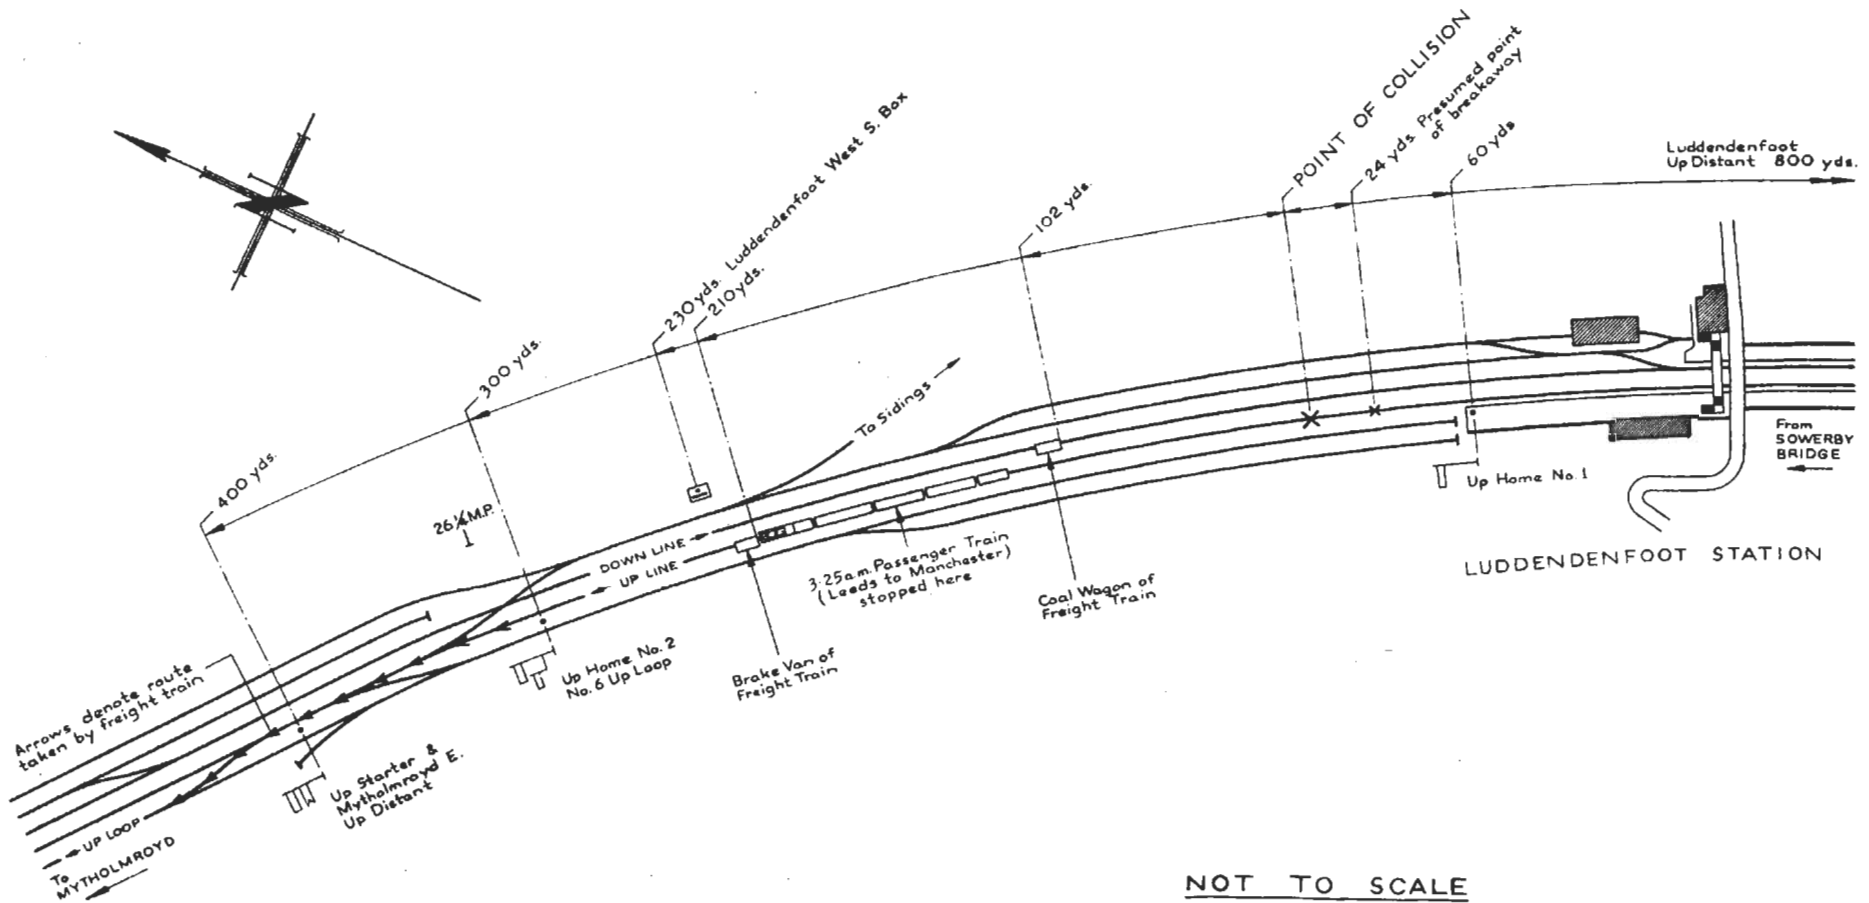
# COLLISION AT LUDDENDENFOOT ON 21<sup>ST</sup>. FEBRUARY, 1955

The gradient through Luddendenfoot is 1 in 400 and the Up line is on a left-handed curve of 75 chains radius. The layout of the tracks and the position of the relevant signals are shown on the accompanying sketch. The signal box is to the north of the line alongside a Down goods siding and the tracks at this place are, from North to South, Down goods siding, Down Main, Up Main, Up goods siding. There are four running lines about 170 yards further to the west where the Up Goods loop begins and the Down Slow joins the Down Main.

The Up Home No. 1 signal is at the west end of the station platform where there is a berth track circuit 230 yards in length. Up Home No. 2 and No. 6 Up Loop signals are 70 yards to the west of the box and the Up Starter is at the loop entrance 100 yards further on.

2. The fractured coupling link which caused the breakaway (see para. 11) was found 36 yards beyond the Up Home No. 1, and it is presumed that the division of the train occurred here. The approximate point of collision was located by pieces of the broken brakevan and quantities of spilt coal scattered over the tracks some 24 yards further on.
