RAILWAY ACCIDENT

Report on the Collision that occurred on 17th July 1967 at Maidstone East Station

IN THE
SOUTHERN REGION
BRITISH RAILWAYS

21st October, 1968.

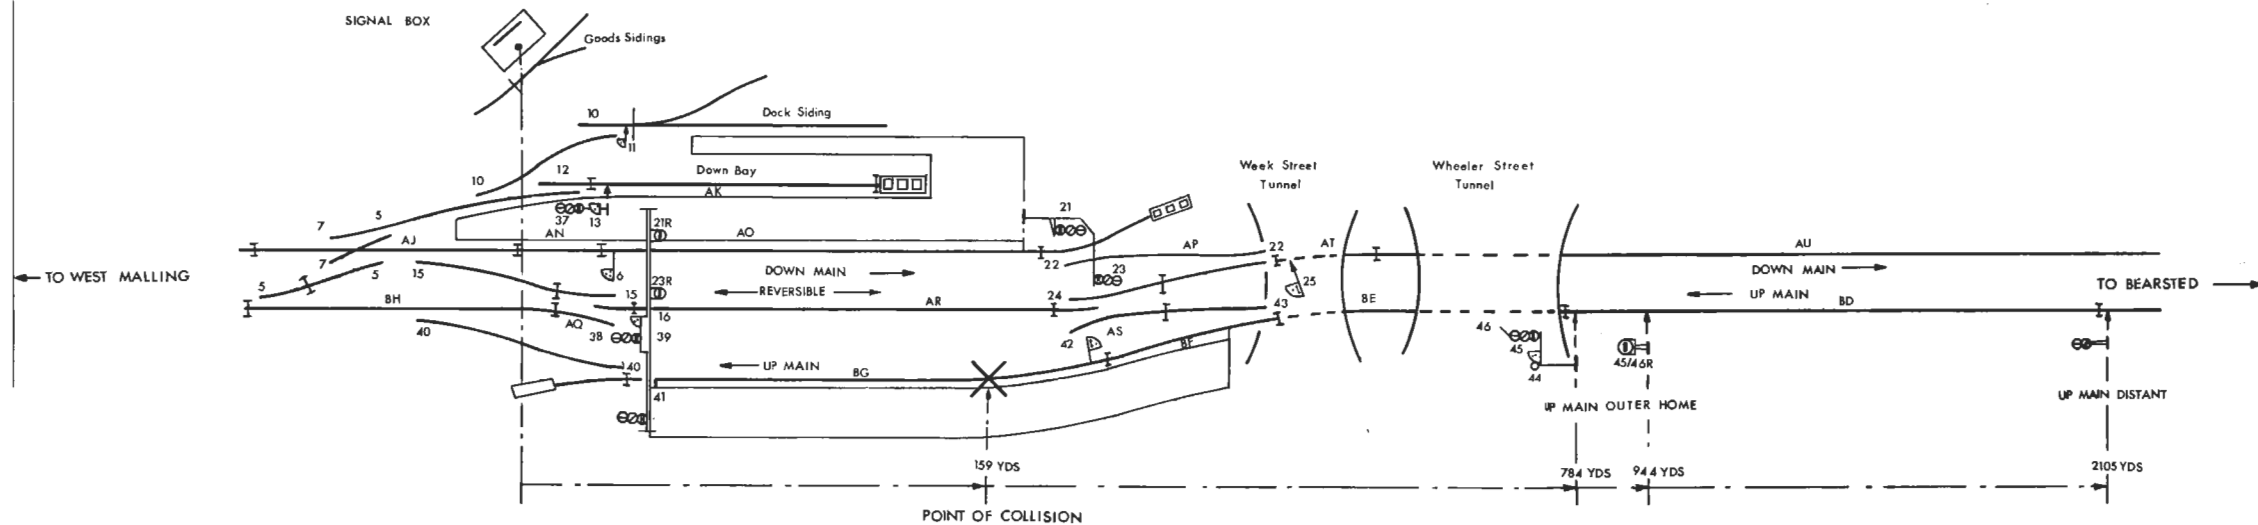
FIGURE I MAIDSTONE EAST SIGNALLING AND TRACK LAYOUT

1. Maidstone East Station lies on the London (Victoria)-Ashford line of the former London, Chatham and Dover Railway approximately 40 miles from London and 19 miles from Ashford. Figure 1 at the back of this Report shows the track and signal layout in the Maidstone East Station area, while a gradient diagram will be found at Figure II and a location diagram at Figure III. The line between Ashford, Maidstone East and Swanley Junction is double track, but at Maidstone East there is a central Reversible line between the Up and Down Main platform lines, with connections to the Up and Down Main lines at both ends of the station.
