MINISTRY OF TRANSPORT

REPORT ON THE COLLISION

6th November, 1947, at

MOTSPUR PARK JUNCTION

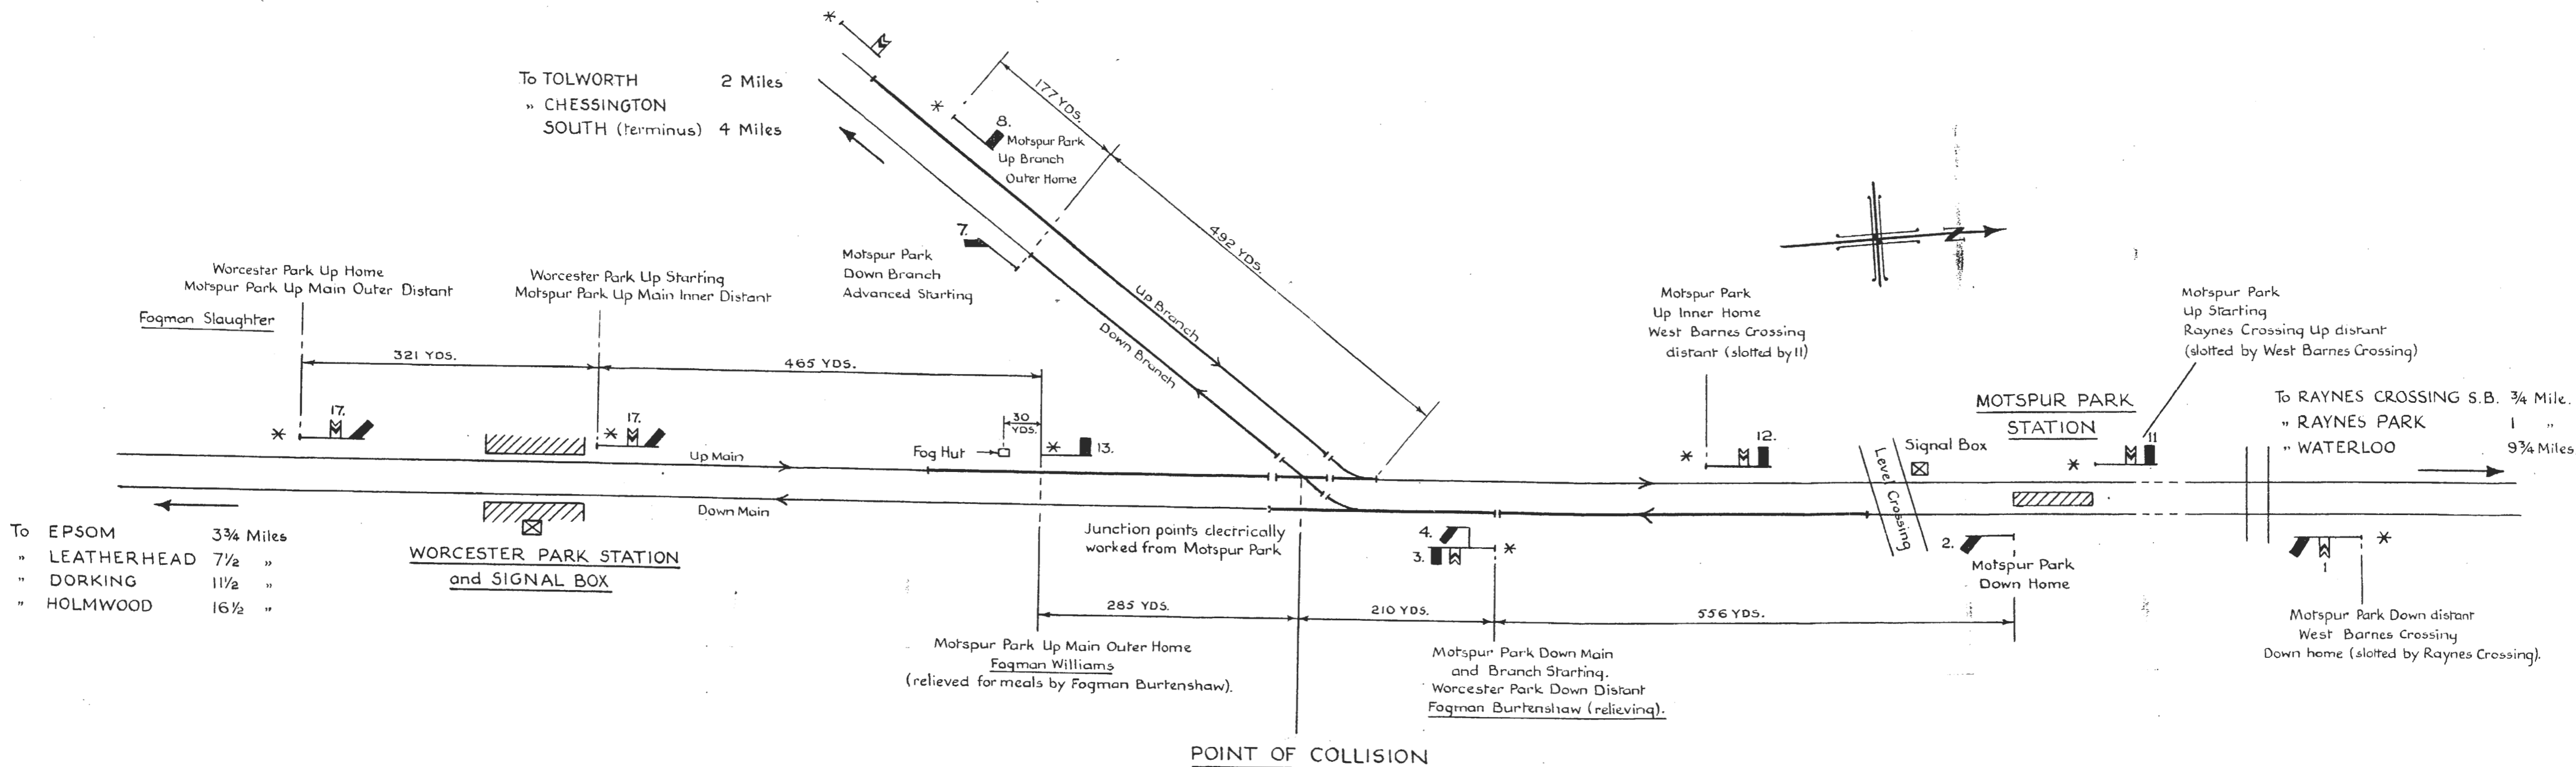
GENERAL DIAGRAM

4. The diagram shows the layout in the neighbourhood of Motspur Park Junction, also the signal aspects which were displayed to the two trains concerned. There are outer homes, Nos. 13 and 8 respectively, for the converging Up Main and Branch lines, but there are no inner homes in rear of the junction. By the special instructions at Motspur Park box, the signalman there is authorised to accept Up trains *which are booked to stop at Worcester Park* at full Line Clear when the junction is occupied, notwithstanding the modified clearance of 285 yards from No. 13 outer home signal to the fouling point. Such acceptance is permitted in fog when there are fogsignalmen at No. 13 and at the Up Main distant No. 17. As noted on the diagram this was the case at the time of the accident; the fog posts at the Up Branch distant and outer home signals were also manned, as well as those at the Up inner home and the Worcester Park Down distant. There are electrical repeaters on the ground at Signal No. 12, whose arms at one time were carried high on the post though they have since been lowered. None of the other signals concerned are so repeated.

5. Signal No. 13, which was passed at Danger by the Waterloo train, has an upper quadrant arm of standard design, 25 ft. above rail level on a lattice post, and is repeated in the box. In accordance with the Company's practice, the balance weight bar is on the upper half of the post, and an iron ladder of the usual type leads to the top of the post on its north side. The fogman's hut is 30 yards in rear of the signal, and there is a gap in the cess side conductor rail opposite to the hut to enable detonators to be placed.
