DEPARTMENT OF TRANSPORT

RAILWAY ACCIDENT

Report on the Collision
that occurred on 3rd August 1977
near New Cross

IN THE
SOUTHERN REGION
BRITISH RAILWAYS

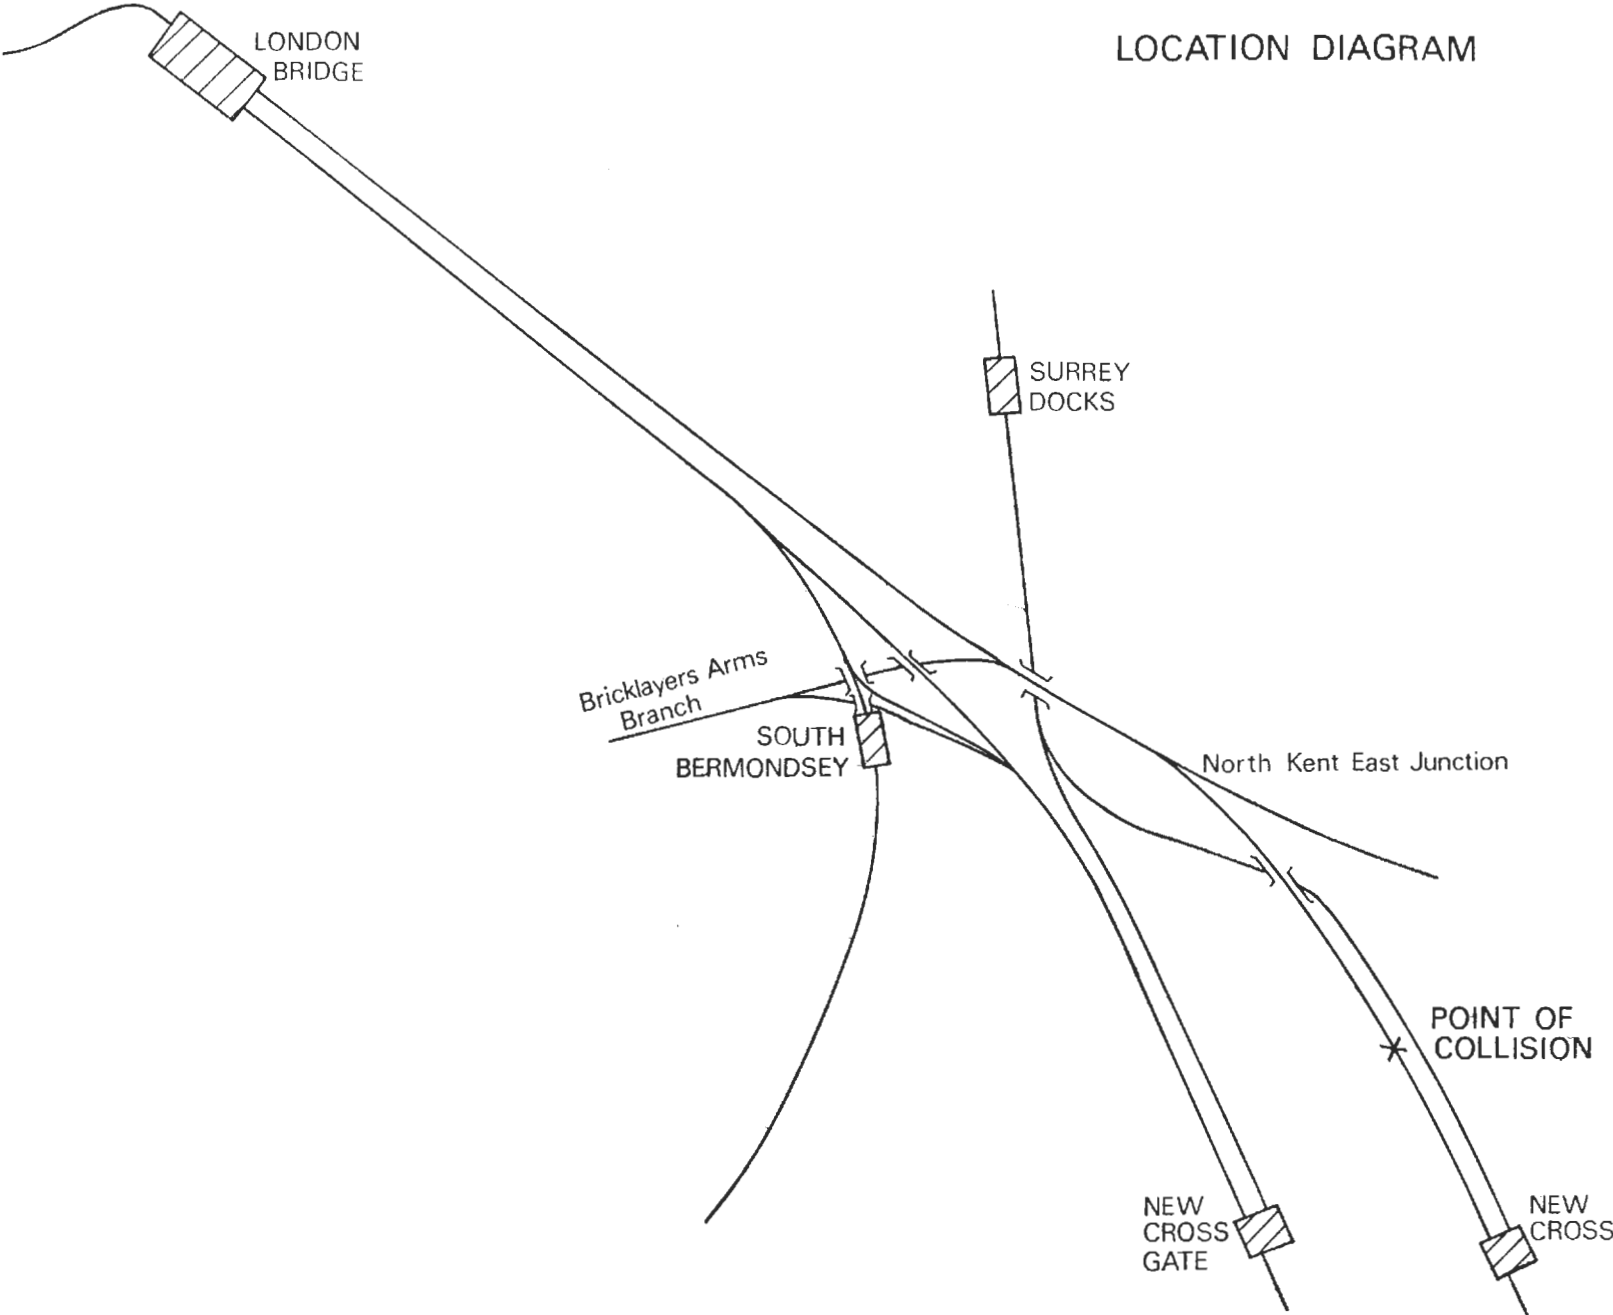
LOCATION DIAGRAM

As illustrated in the diagrams at the front and back of the report, the Bricklayers Arms goods branch connects with the No. 4 Down line at North Kent East Junction, and some half a mile to the east Nos. 4 and 5 lines converge at No. 819 points which is where the collision occurred. It will be noted that New Cross Station now only serves Nos. 1, 2 and 3 lines. Line speeds are 60 mile/h.

3. The signal on the No. 5 Down line parallel to signal L207 was L209; the fouling point between these two lines where they converge at points No. 819 is only 50 yards beyond these signals. The previous signal L189 was therefore approach controlled when L207 was at Danger so that L189 displayed a red aspect until a train had occupied its berth track circuit NT for 16 seconds, when it displayed a yellow aspect permitting the driver to draw up to L207. A similar arrangement existed on the No. 5 Down line. On 25th May 1977, following the two incidents in September 1976, Signal L207 was raised on a bracket some 18 inches in an attempt to make it more easily recognisable. Its viewing distance was then some 180 yards.
