RAILWAY ACCIDENTS

REPORT ON THE COLLISION
which occurred on
17th August 1951 at
NEWCASTLE CENTRAL STATION
in the
NORTH EASTERN REGION
BRITISH RAILWAYS

MINISTRY OF TRANSPORT,
Berkeley Square House,
Berkeley Square,
London, W.1.
10th November, 1951.

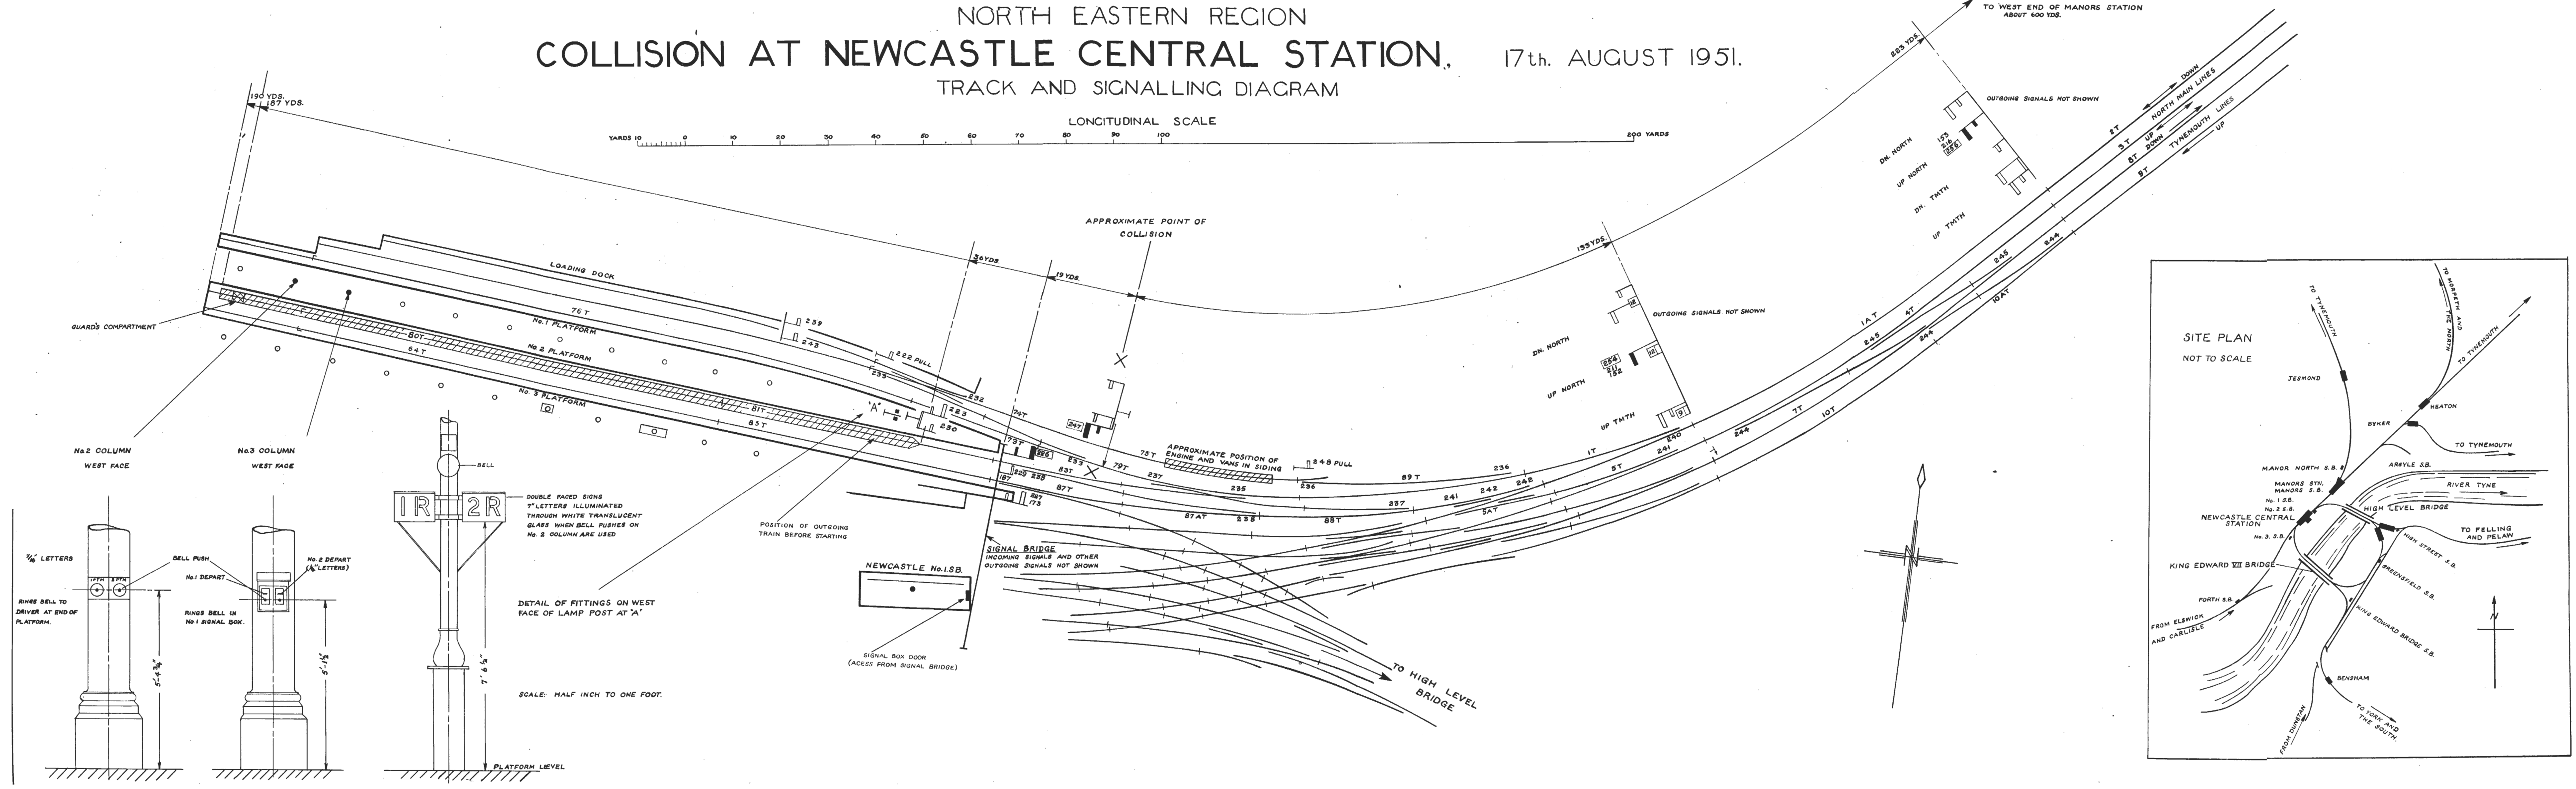
NORTH EASTERN REGION
COLLISION AT NEWCASTLE CENTRAL STATION, 17th. AUGUST 1951.
TRACK AND SIGNALLING DIAGRAM

4. The platforms concerned were Nos. 1, 2 and 3, all of which are straight. The outgoing train had been standing in No. 2 platform in the approximate position shown by the diagram, and Nos. 1 and 3 were unoccupied. The outgoing signal from No. 2 platform, No. 226, is an upper quadrant semaphore carried on a short post which is the furthest to the left of several on a long signal bridge; it leads only one way, to the Down North Main line with points 238 and 236 normal and points 235 and 240 reversed. There is a good view of No. 226 signal from the driving compartment of an eight-coach train standing in No. 2 platform in the position shown; owing, however, to the metal blackout screens which have been retained on the front driving windows of these trains at the request of the men to shield their eyes from glare and the danger of stone throwing, it is necessary for a motorman to lean forward a little in his seat to see the signal. It can also be seen easily by looking out from the left of the guard's compartment at the back of the train.

5. The incoming train had travelled from Manors, where it had made a booked stop, via the Up North Main Line, which is signalled for working in both directions. It was routed to No. 1 platform with Nos. 241, 242 and 237 points reversed and No. 233 points normal, and the relevant signals were Nos. 256, 254 and 247; No. 256 is a lower quadrant and Nos. 254 and 247 are upper quadrant semaphores, and No. 254 has a platform route indicator alongside it to the left. There is an excellent view of all three signals from the driving compartment of an incoming electric train. The back of No. 247 signal can also be seen clearly from the driving compartment of an outgoing train standing in No. 2 platform, but the view of one train from the other was partly obstructed by an engine and two vans which were standing in the siding in the approximate position shown by the diagram.

6. It will be seen from the diagram that there are subsidiary ("calling on") arms below the main arms of signals 226 and 247. In accordance with the practice of the former North Eastern Railway, the subsidiary as well as the main arm is cleared for an unrestricted movement. The subsidiary arms, however, were not concerned in this accident, nor their method of operation from the box.

7. The No. 1 signal box is situated in the position shown and is carried above the lines on a portal structure. It was installed in 1909 and contains a frame of 198 working and 62 spare miniature levers which operate the points and semaphore signals electro-pneumatically; there are also some colour light signals. During the two day shifts the box is normally worked by four signalmen at the frame, and one signalsman at the block instruments and bells; there is also an inspector to regulate the traffic, and the booking is done by two lads. The points and signals concerned in this case are worked from the eastern end of the frame, from which there is a good view of the ends of Nos. 1, 2 and 3 platforms and of the four tracks towards Manors. Although all four lines to Manors are continuously track circuited, incoming trains are signalled on the block in the ordinary way; outgoing trains are signalled by bell description only.
