RAILWAY ACCIDENTS

REPORT ON THE COLLISION

24th March 1956 at

OLD TRAFFORD JUNCTION

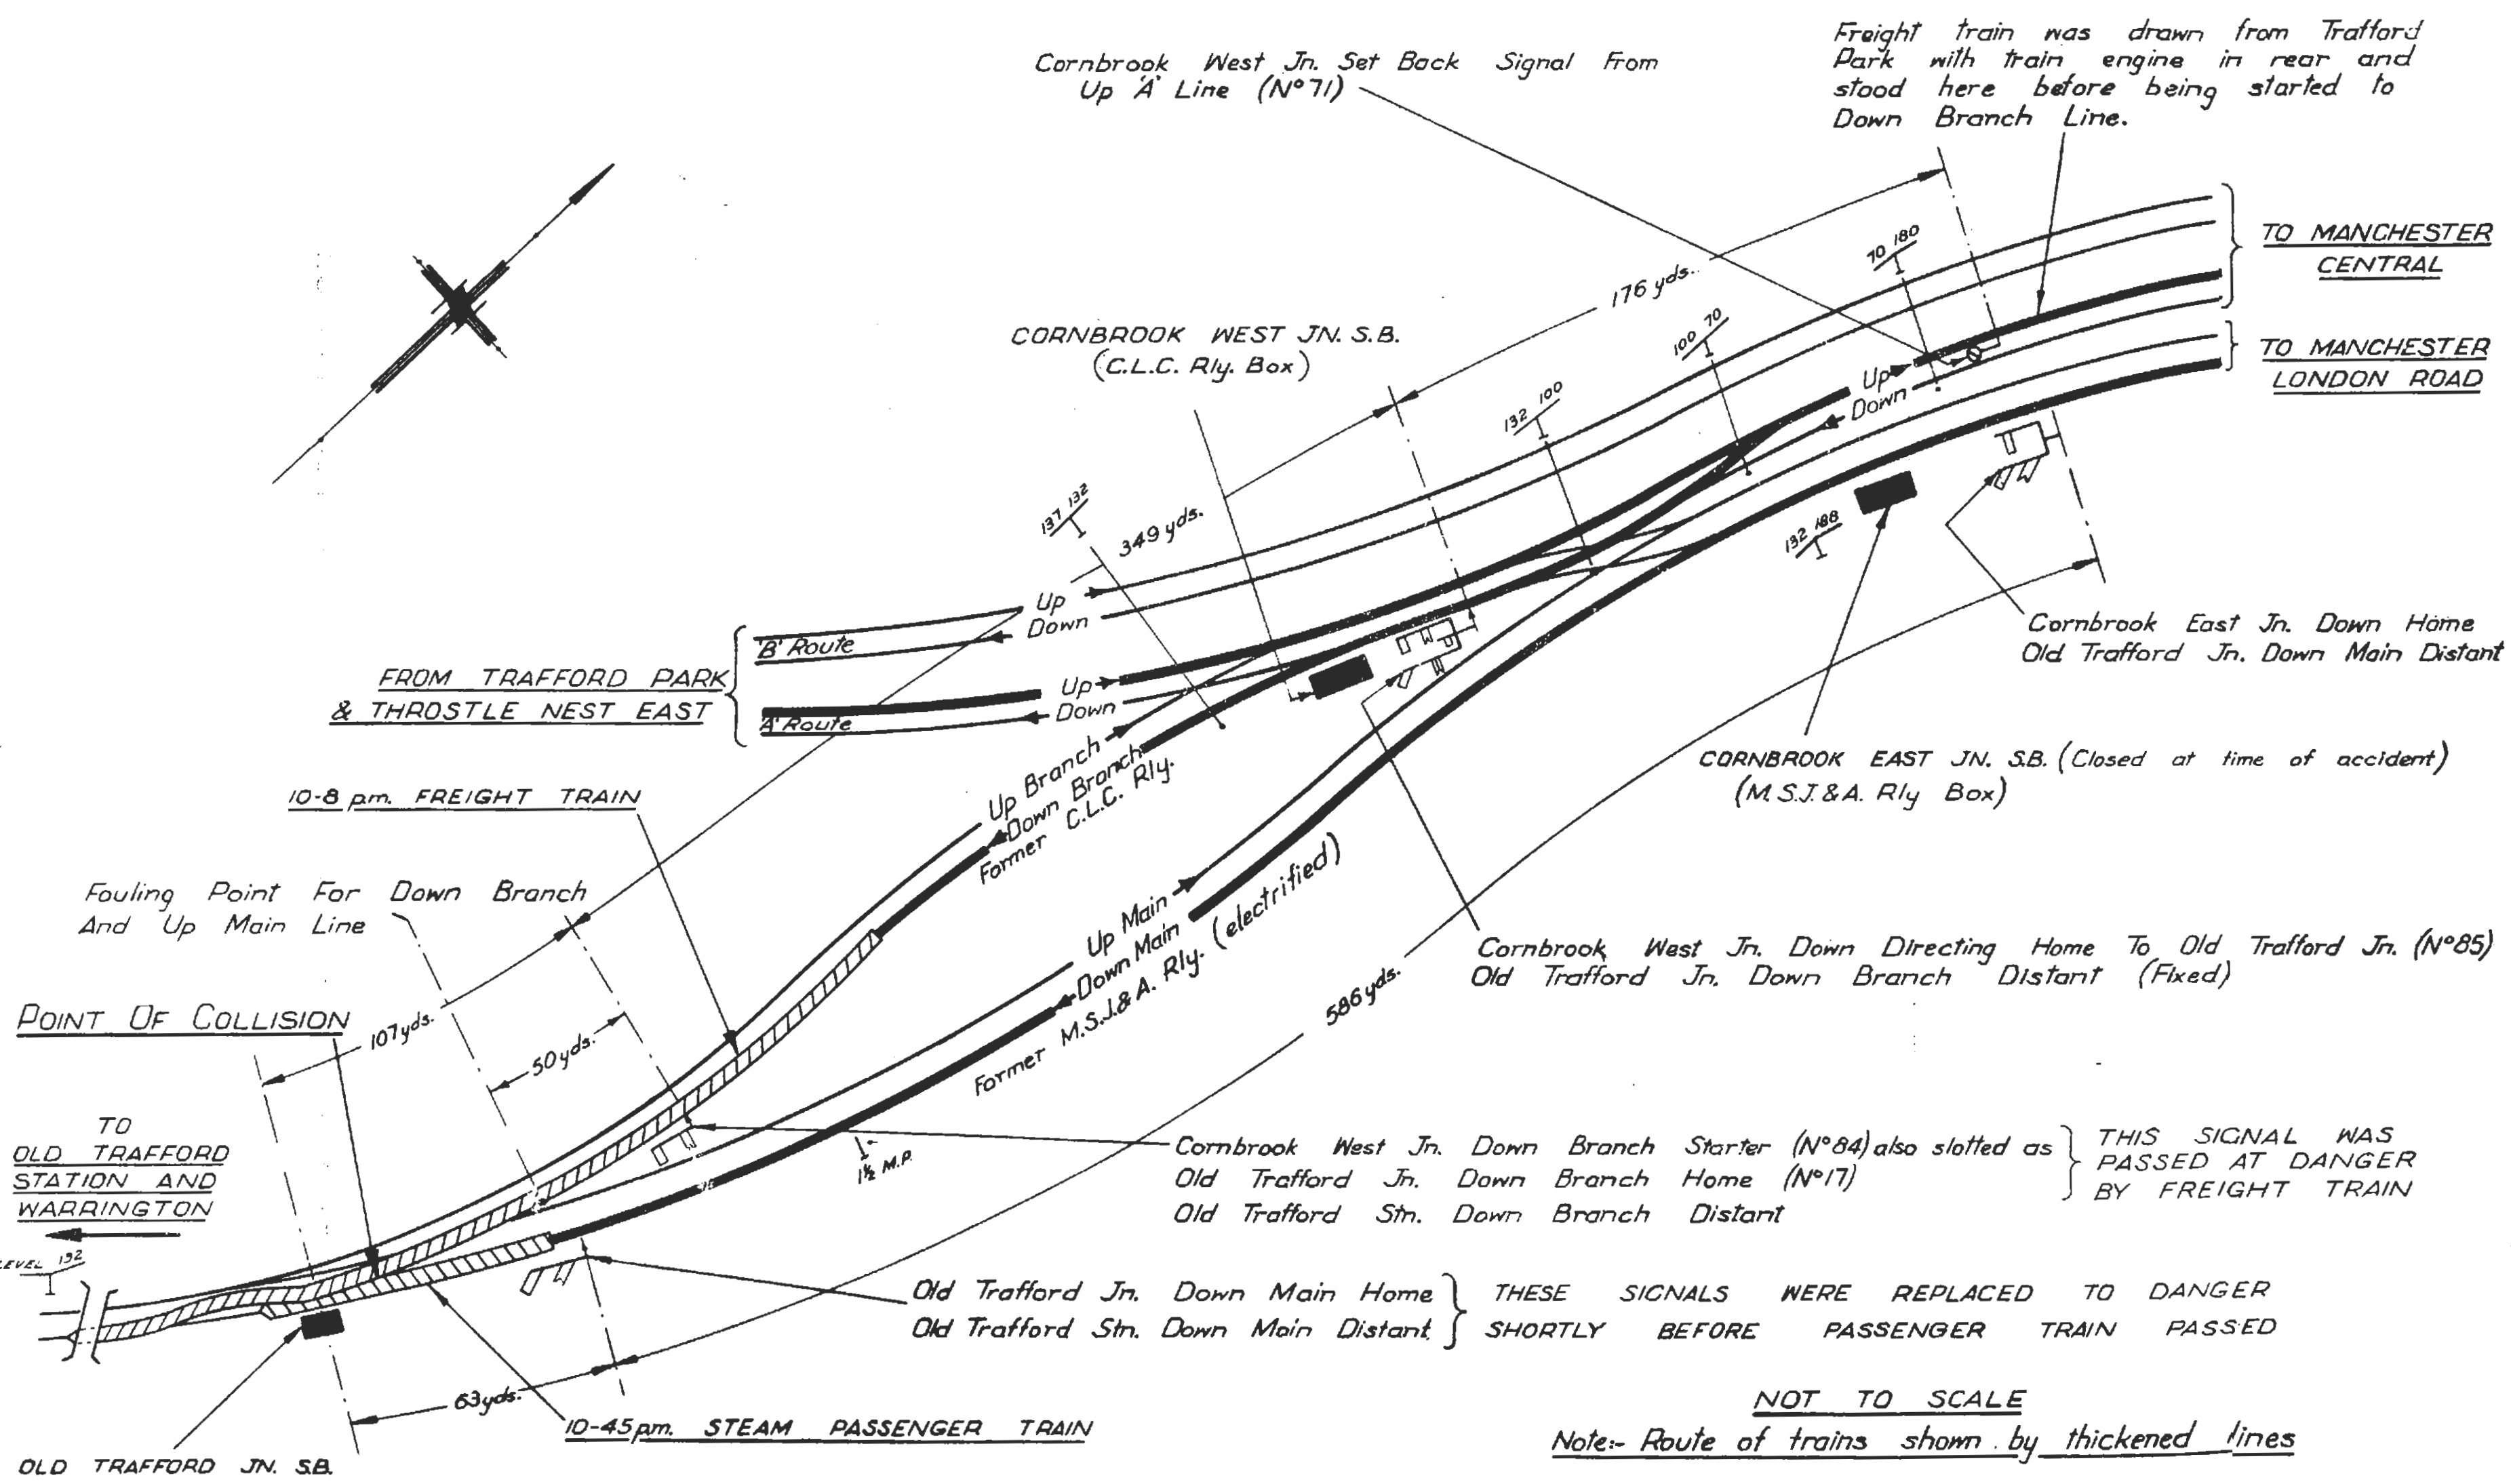
Cornbrook West Jn. Set Back Signal From Up 'A' Line (N°71)

Freight train was drawn from Trafford Park with train engine in rear and stood here before being started to Down Branch Line.

The layout of the lines and the positions of the relevant signals in the vicinity of Old Trafford Junction and Cornbrook West boxes are shown in the sketch opposite. In the Down direction the former Manchester, South Junction and Altrincham (M.S.J. and A.) Railway Main line falls at 1 in 132, and the Branch line, which is a part of the former Cheshire Lines Committee (C.L.C.) Railway, falls at 1 in 137 to Old Trafford Junction. Just beyond the junction the lines pass under a bridge; they continue to fall at 1 in 132 for about 100 yards and then become level. On the Branch line the junction is protected by a signal situated 107 yards from the box and 50 yards from the fouling point between the Up Main and Down Branch lines which is dually controlled as the Old Trafford Junction Down Branch home signal No. 17, and the Cornbrook West Down Branch starting signal, No. 84. Both that signal and the junction Down Main line home signal have distant signal arms for Old Trafford Station underneath them and all their lights are electric, and the distants show no lights when the stop arms above them are at danger. Both the signal posts are on the left-hand side of the line to which they apply, the stop arm of the Branch line signal being 22 ft. 6 ins. and that of the Main line signal 16 ft. above rail level, and the lights can be seen from the footplate of an engine approaching Old Trafford Junction on the Branch line before it passes Cornbrook West box. They again come into view almost simultaneously as the engine passes the box and, except when first one and then the other is obscured momentarily by a telegraph pole, they remain in view continuously showing the same clear "pattern" to the driver as the engine descends the gradient.
