MINISTRY OF TRANSPORT

REPORT ON THE COLLISION

PIERSHILL JUNCTION

EDINBURGH

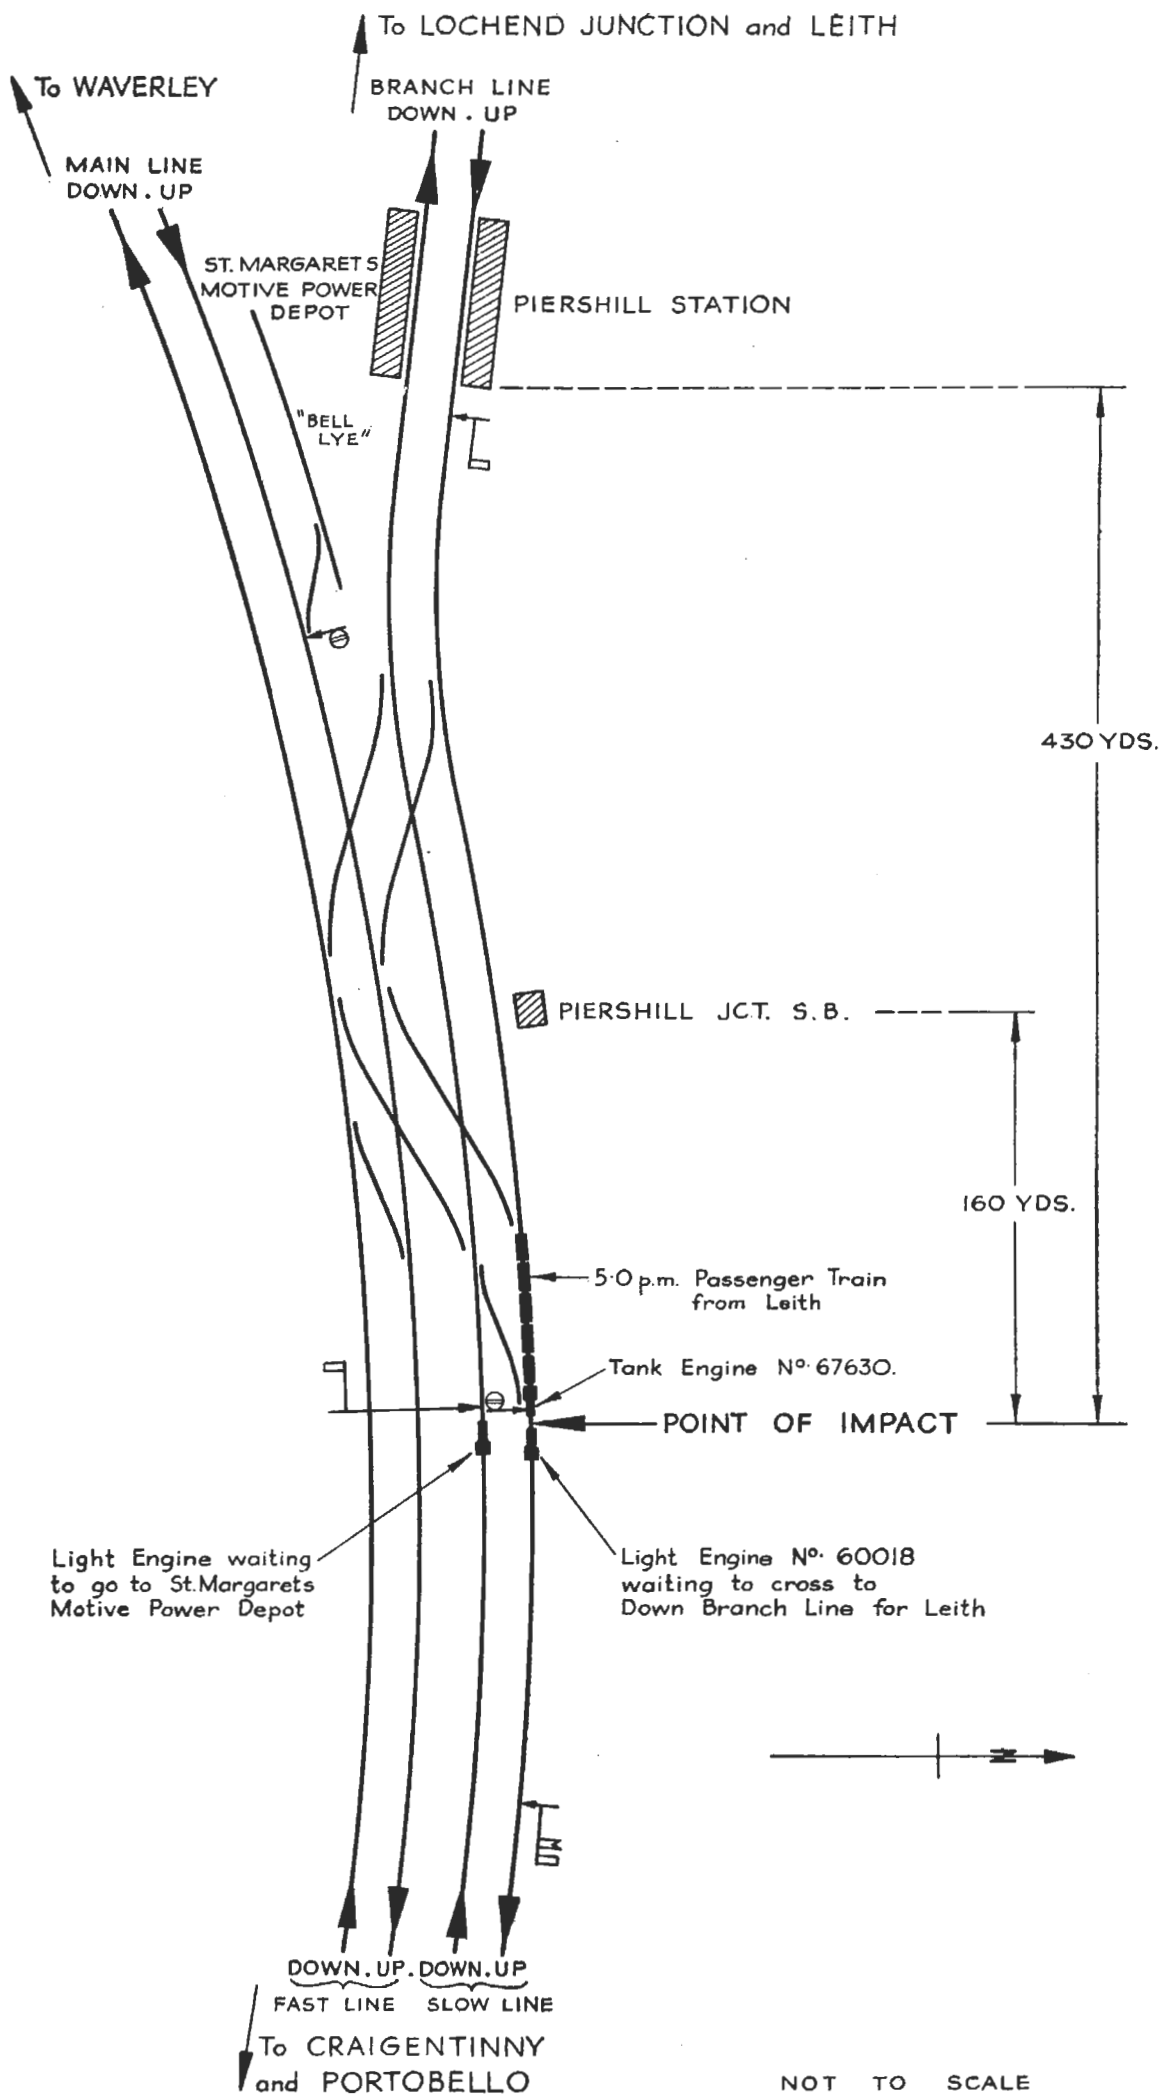
A sketch of Piershill Junction is given on page 3. For clarity, only the signals mentioned in the text are shown.

The mistakes which the signalman made were that he failed to send the "Blocking back inside Home signal" to Lochend Junction, and that he omitted to put collars on his Up Main to Slow, and Up Branch to Slow Home signal levers. Thus, when he forgot the light engine, there was nothing to prevent a train being offered from Lochend Junction, or to prevent him accepting and pulling off the signals for it.

It is satisfactory to report that track circuiting, which would have prevented this accident, will shortly be installed at Piershill Junction.
