RAILWAY ACCIDENTS

REPORT ON THE COLLISION

15th April 1957

PORTSMOUTH

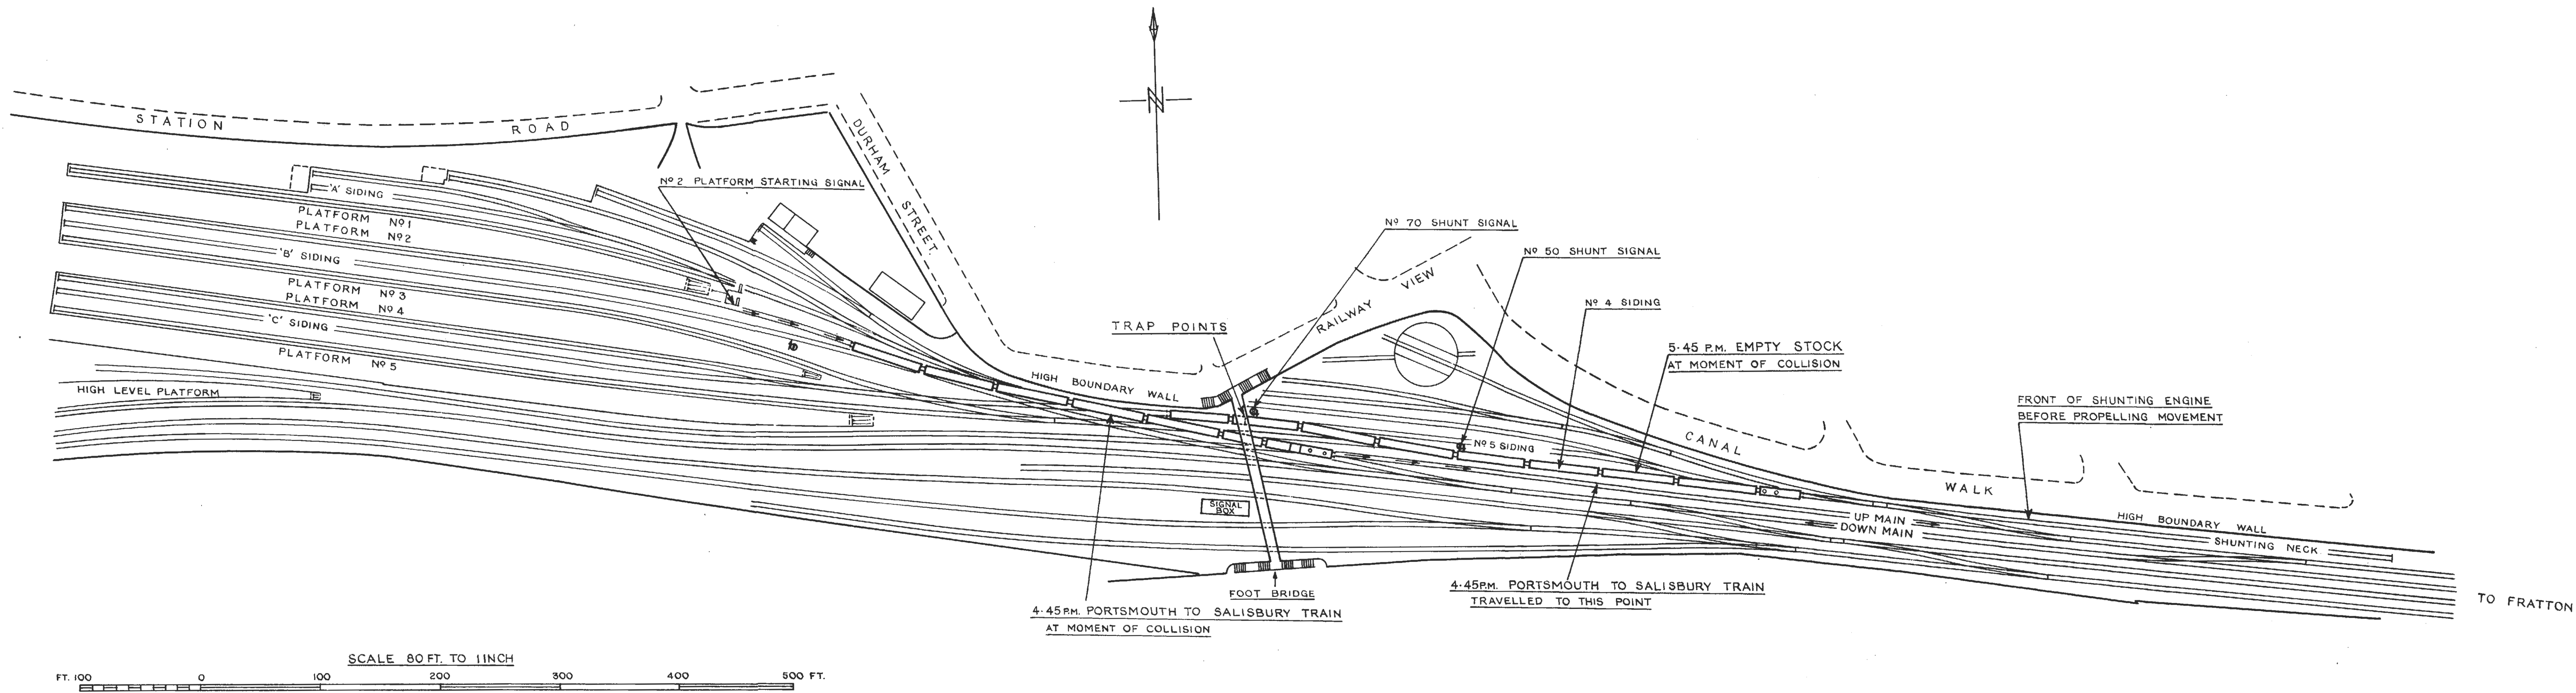
COLLISION AT PORTSMOUTH AND SOUTHSEA, 15TH APRIL 1957

3. With reference to the plan, there are five terminal platforms (Nos. 1 to 5) at Portsmouth and Southsea station, and the Up and Down through lines to Portsmouth Harbour are served by a high level island platform. The running signals are semaphores except on the high level lines where colour light signals have been installed, and the shunt signals are of the disc type.

4. The route followed by the passenger train from No. 2 platform is marked by arrows on the plan and the approximate position of this train and of the set of empty coaches at the moment of impact has been shown. "B" siding, in which the empty stock set had been standing before it was drawn forward over No. 5 siding into No. 4 siding and towards the shunting neck, is between Nos. 2 and 3 platform lines.

5. The shunting neck is in prolongation of No. 4 siding but is offset from the alignment of it towards the Up Main line on account of the high brick boundary wall on the north side. As a consequence of this kink in the alignment of the shunting neck, Nos. 50 and 70 shunt signals, which are provided on Nos. 4 and 5 sidings respectively to control shunting movements towards the station, cannot be seen from the north side of an engine standing in the neck at the head of a set of vehicles, and the shunter cannot be seen from the other side of the engine unless he stands away from the siding and on or near the Up Main line. The trap points on No. 5 siding, on which the leading coaches of the shunting movement became derailed, are immediately ahead of No. 70 shunt signal.

26. There would have been no room for the misunderstanding if the driver could have seen the shunting signal before he began to propel. Every such movement past No. 50 shunt signal crosses the outgoing route from platforms 1 to 4, and many of the movements cross the incoming main line as well, and I am sure that the driver would not have begun to propel if he had seen the ground signal at danger. As already mentioned the view of this signal when propelling is very short indeed owing to the track alignment, and there is no doubt that the risk of a collision of this kind would be very much less if a better site could be found for the signal where it could always be seen from the shunting neck, or if this is not possible, a repeater were to be provided.

27. The trap points were too close to the outgoing line to prevent the collision. When they were originally laid it was necessary to have as much siding accommodation as possible in the very restricted yard where the engine turntable is situated, but I understand that with the advent of electrification the reduction in accommodation which would be entailed if the points were moved can be accepted.

28. In spite of the difficult conditions under which the frequent shunting movements are controlled here, I am informed that no accident has occurred on this account for a great many years. In view, however, of the circumstances which were brought to notice on this occasion, it is intended to abolish No. 5 siding and to resite the catch points where they will be effective. The shunting signal is also to be moved to a better position, and a repeater will be added if it is found to be necessary.
