RAILWAY ACCIDENT

Report on the Collision that occurred on 15th December 1971 at Portsmouth & Southsea Station

IN THE
SOUTHERN REGION
BRITISH RAILWAYS

COLLISION AT PORTSMOUTH HIGH-LEVEL STATION

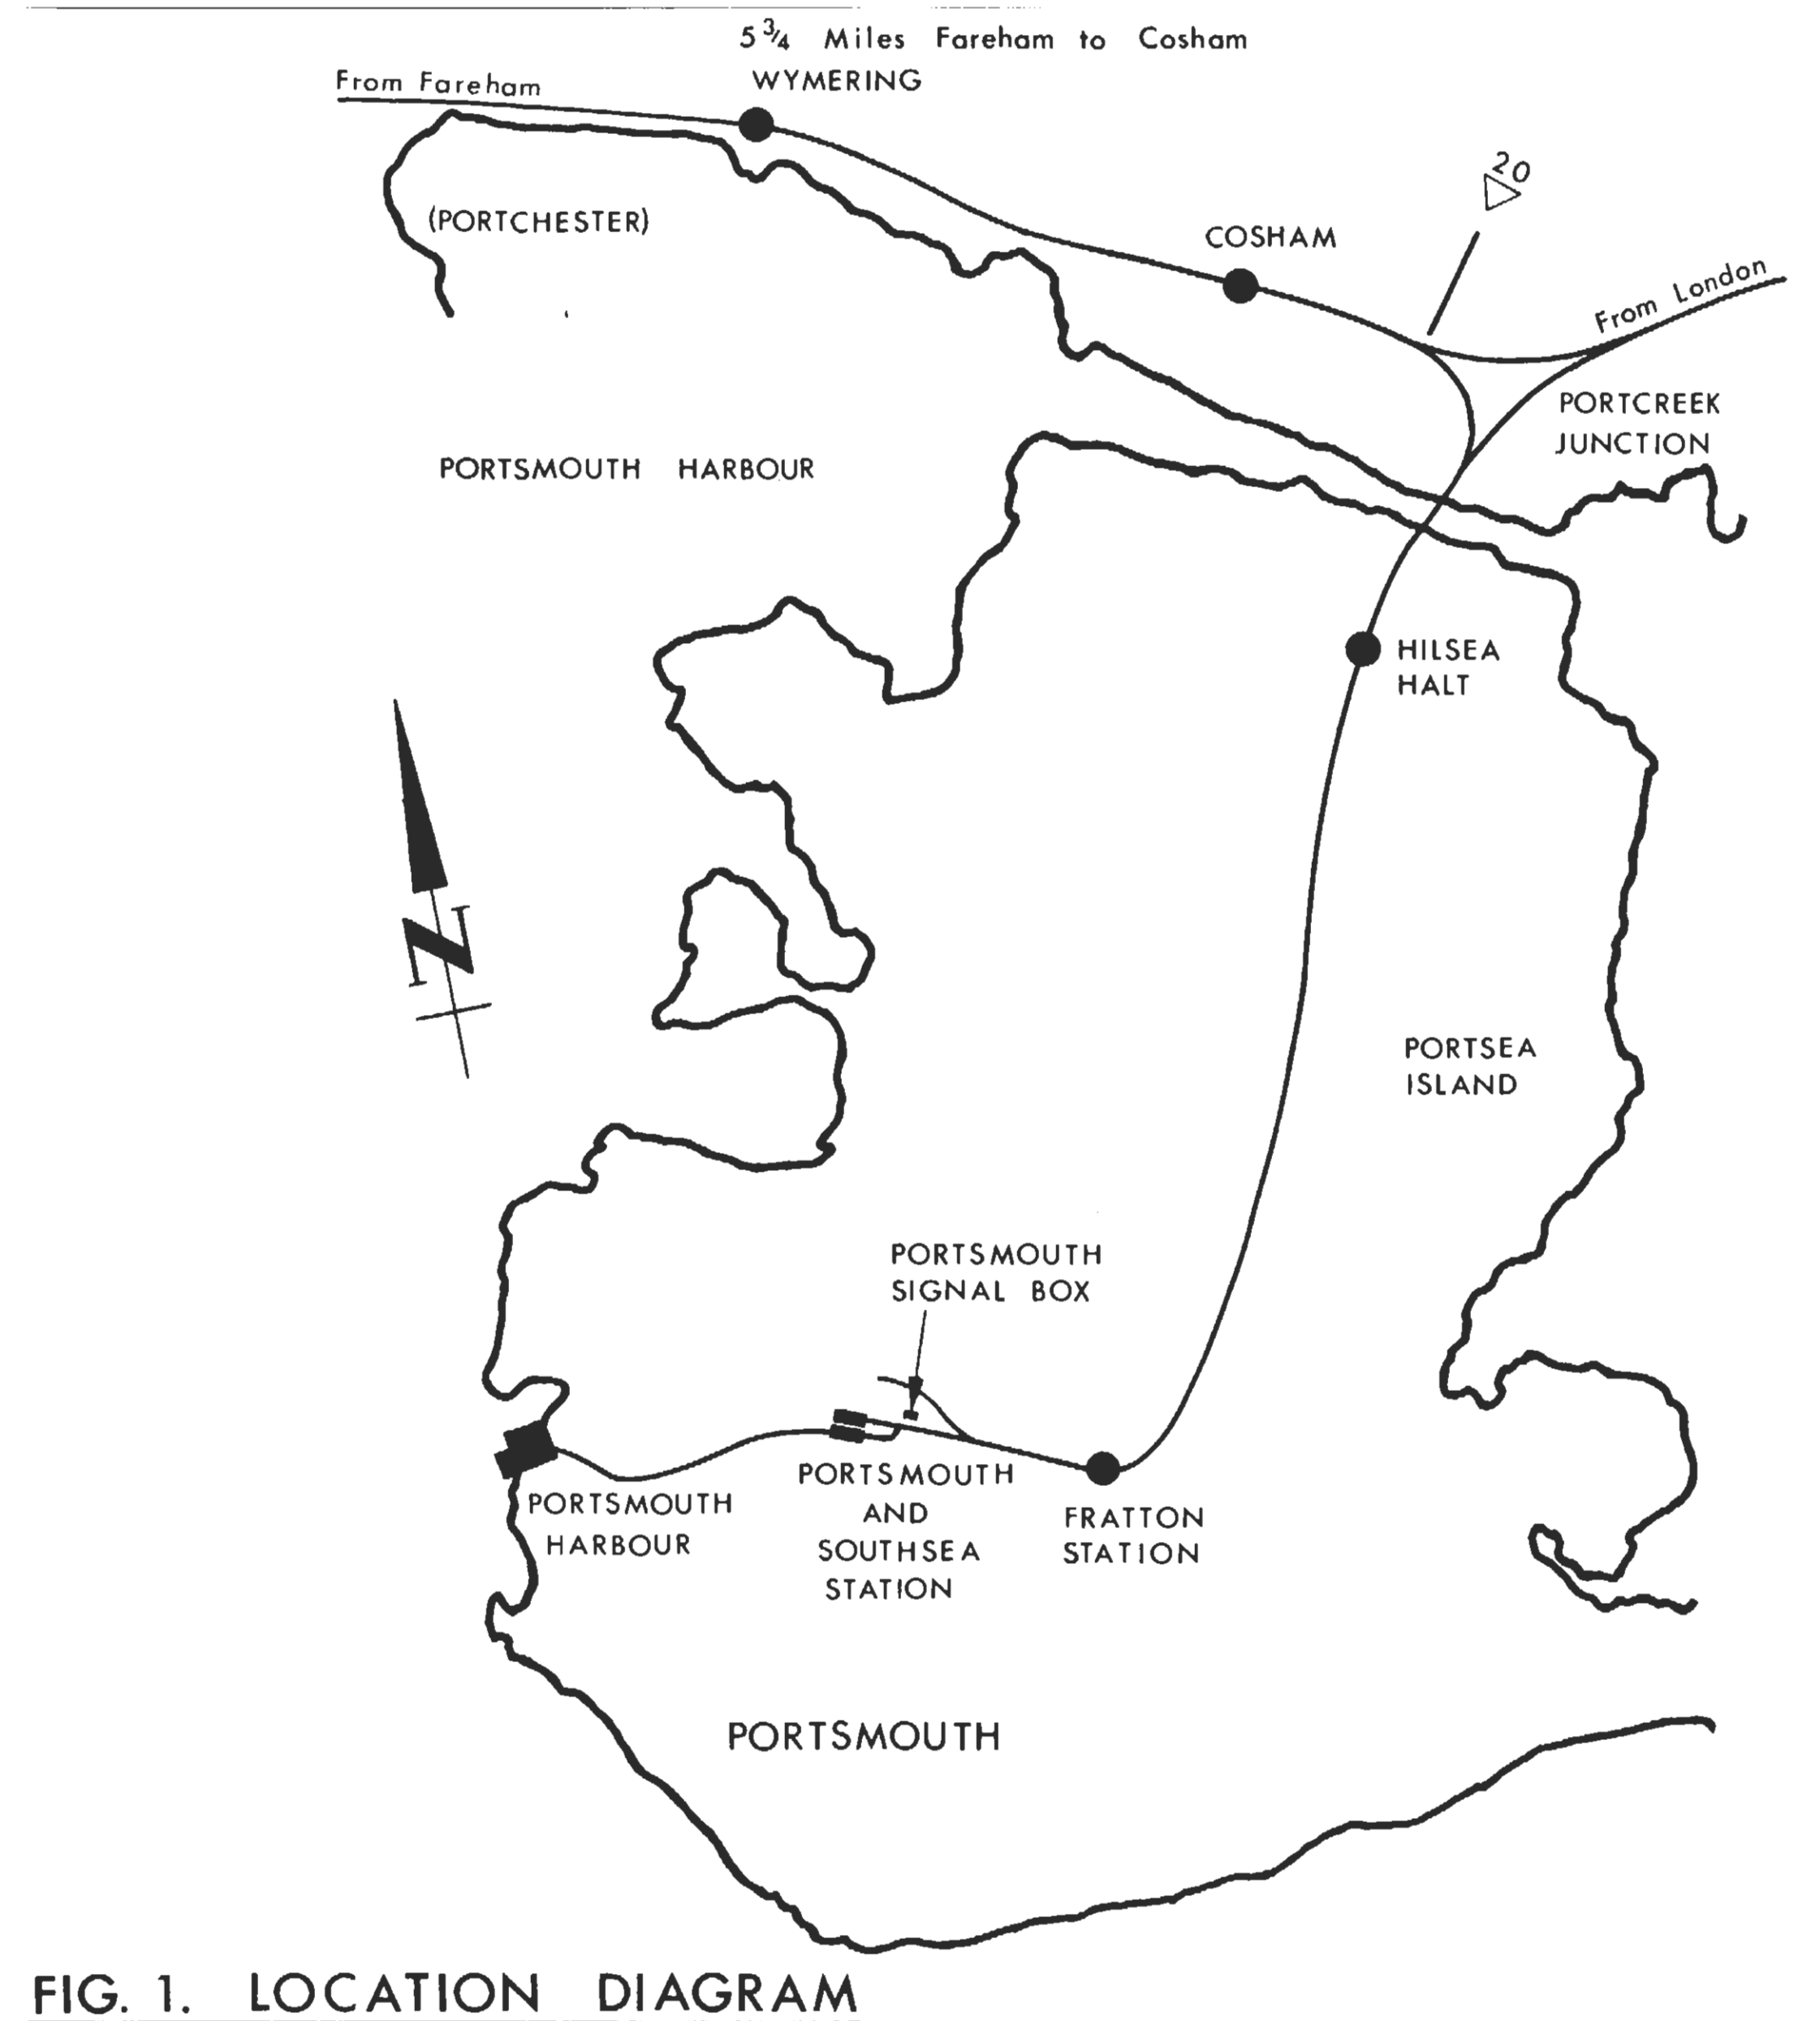
FIG. 1. LOCATION DIAGRAM

1. The site is illustrated in figure 1 at the end of this report. The Cardiff train was routed via Fareham and Cosham and through the 20 mph curve onto the Main London to Portsmouth line at Portcreek Junction. The maximum line speed to Fratton is thereafter 85 mph, but a 30 mph restriction applies for 1,080 yards through Fratton Station which is on a right hand curve, and through a left hand curve under Somers Road Bridge some 400 yards past the station. Between Fratton and Portsmouth & Southsea Stations, which are about 1,200 yards apart, there are four tracks in a cutting with brick retaining walls. The Up & Down Main lines lie to the north, and on their Down side there is a Down Relief line and an Up & Down Carriage line known as the 'Back Road'. Portsmouth signalbox lies 350 yards beyond Somers Road bridge on the north side of the lines, and 50 yards beyond it and under a footbridge the lines for Portsmouth Harbour station via Portsmouth & Southsea High Level Station diverge from those entering the Low Level terminus. The Down Main line approaching the High Level station curves first left and then right and rises at a gradient of 1 in 61 reducing to 1 in 400 before the start of the single island platform. A 20 mph permanent speed restriction applies from a point 53 yards before the platform end, so that an unrestricted section of line some 480 yards long remains between the end of the Fratton restriction and this restriction. The High Level station is roofed from 30 yards from the platform end. The line entering the Down platform curves left and the first view of a 4-car train standing in it is from near signal No. WA 448, at a range of about 100 yards.
