RAILWAY ACCIDENT

**Report on the Collision that
occurred on 27th April 1980
at Portsmouth Harbour**

IN THE
SOUTHERN REGION
BRITISH RAILWAYS

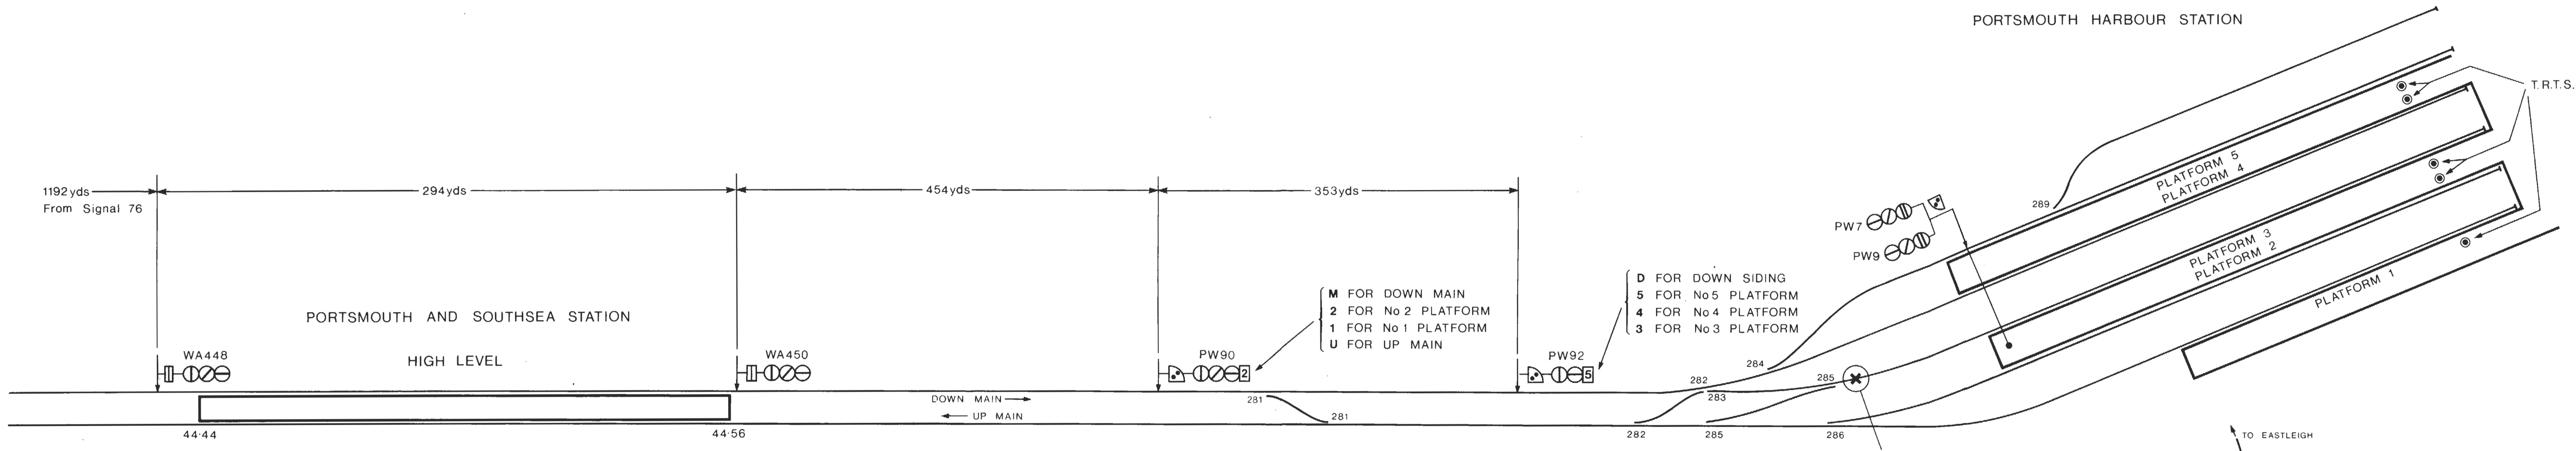
Fig. 1 GENERAL SITE PLAN SHOWING SIGNALLING, TRACK LAYOUT AND SITE OF COLLISION
NOT TO SCALE

In November 1979 British Railways Standard Signalling Principle No. 33 was implemented and both Signals PW 90 and 92 were altered to give only a single Yellow aspect for movements up to the buffer stops of Nos 1 and 2 Platforms and Nos 3–5 Platforms respectively. Signal PW 92 can no longer display a Green aspect in any situation and the AWS track equipment for this signal was altered to a permanent magnet only. Signal PW 90 displays a Green aspect with an 'M' indicator when the route is set from Signal PW 92 to the buffer stops of Nos 3–5 platforms. A single Yellow aspect at Signal PW 90 is displayed when the route is set to Signal PW 92 only, or to the buffer stops of Nos 1 or 2 platforms. A signalling diagram of the area is at Figure 1 at the back of this Report.

13. When the route was set for train 2P42 from No. 3 Platform to the Up Main line via No. 285 points reversed, Signal PW 7 cleared to a proceed aspect. The train departed at 10.05. As it pulled out of the station and its front passed over No. 285 crossover, train 2P17 passed Signal PW 92 at Danger and was routed by No. 238 points reversed on a conflicting course with it, the sidelong collision initially occurring about 420 ft beyond Signal PW 92.

52. The immediate cause of this collision was the passing of Signal PW 92 at Danger by the 08.20 Waterloo–Portsmouth Harbour train, 2P17, driven by Driver Hole.

57. In order to reduce the possibility of a collision, however, in the event of Signal PW 92 being passed at Danger, certain alterations have been made to the signalling at Portsmouth Harbour. In particular, the Starting Signals PW 5 and PW 7 at the London ends of Nos. 4 and 3 Platforms now have their aspects restored to Danger by the occupation of track circuits NE and NF respectively. The controls have also been altered so that No. 3 Platform Starting Signal, PW 7, requires No. 283 points to be in the "normal" position before it will clear, thus giving additional overrun protection. I am satisfied that these arrangements will improve safety in the event of further incidents of this nature.
