RAILWAY ACCIDENTS

REPORT ON THE COLLISION
which occurred on
25th January 1954 at
SHEFFIELD, VICTORIA, STATION
in the
EASTERN REGION
BRITISH RAILWAYS

30th April, 1954.

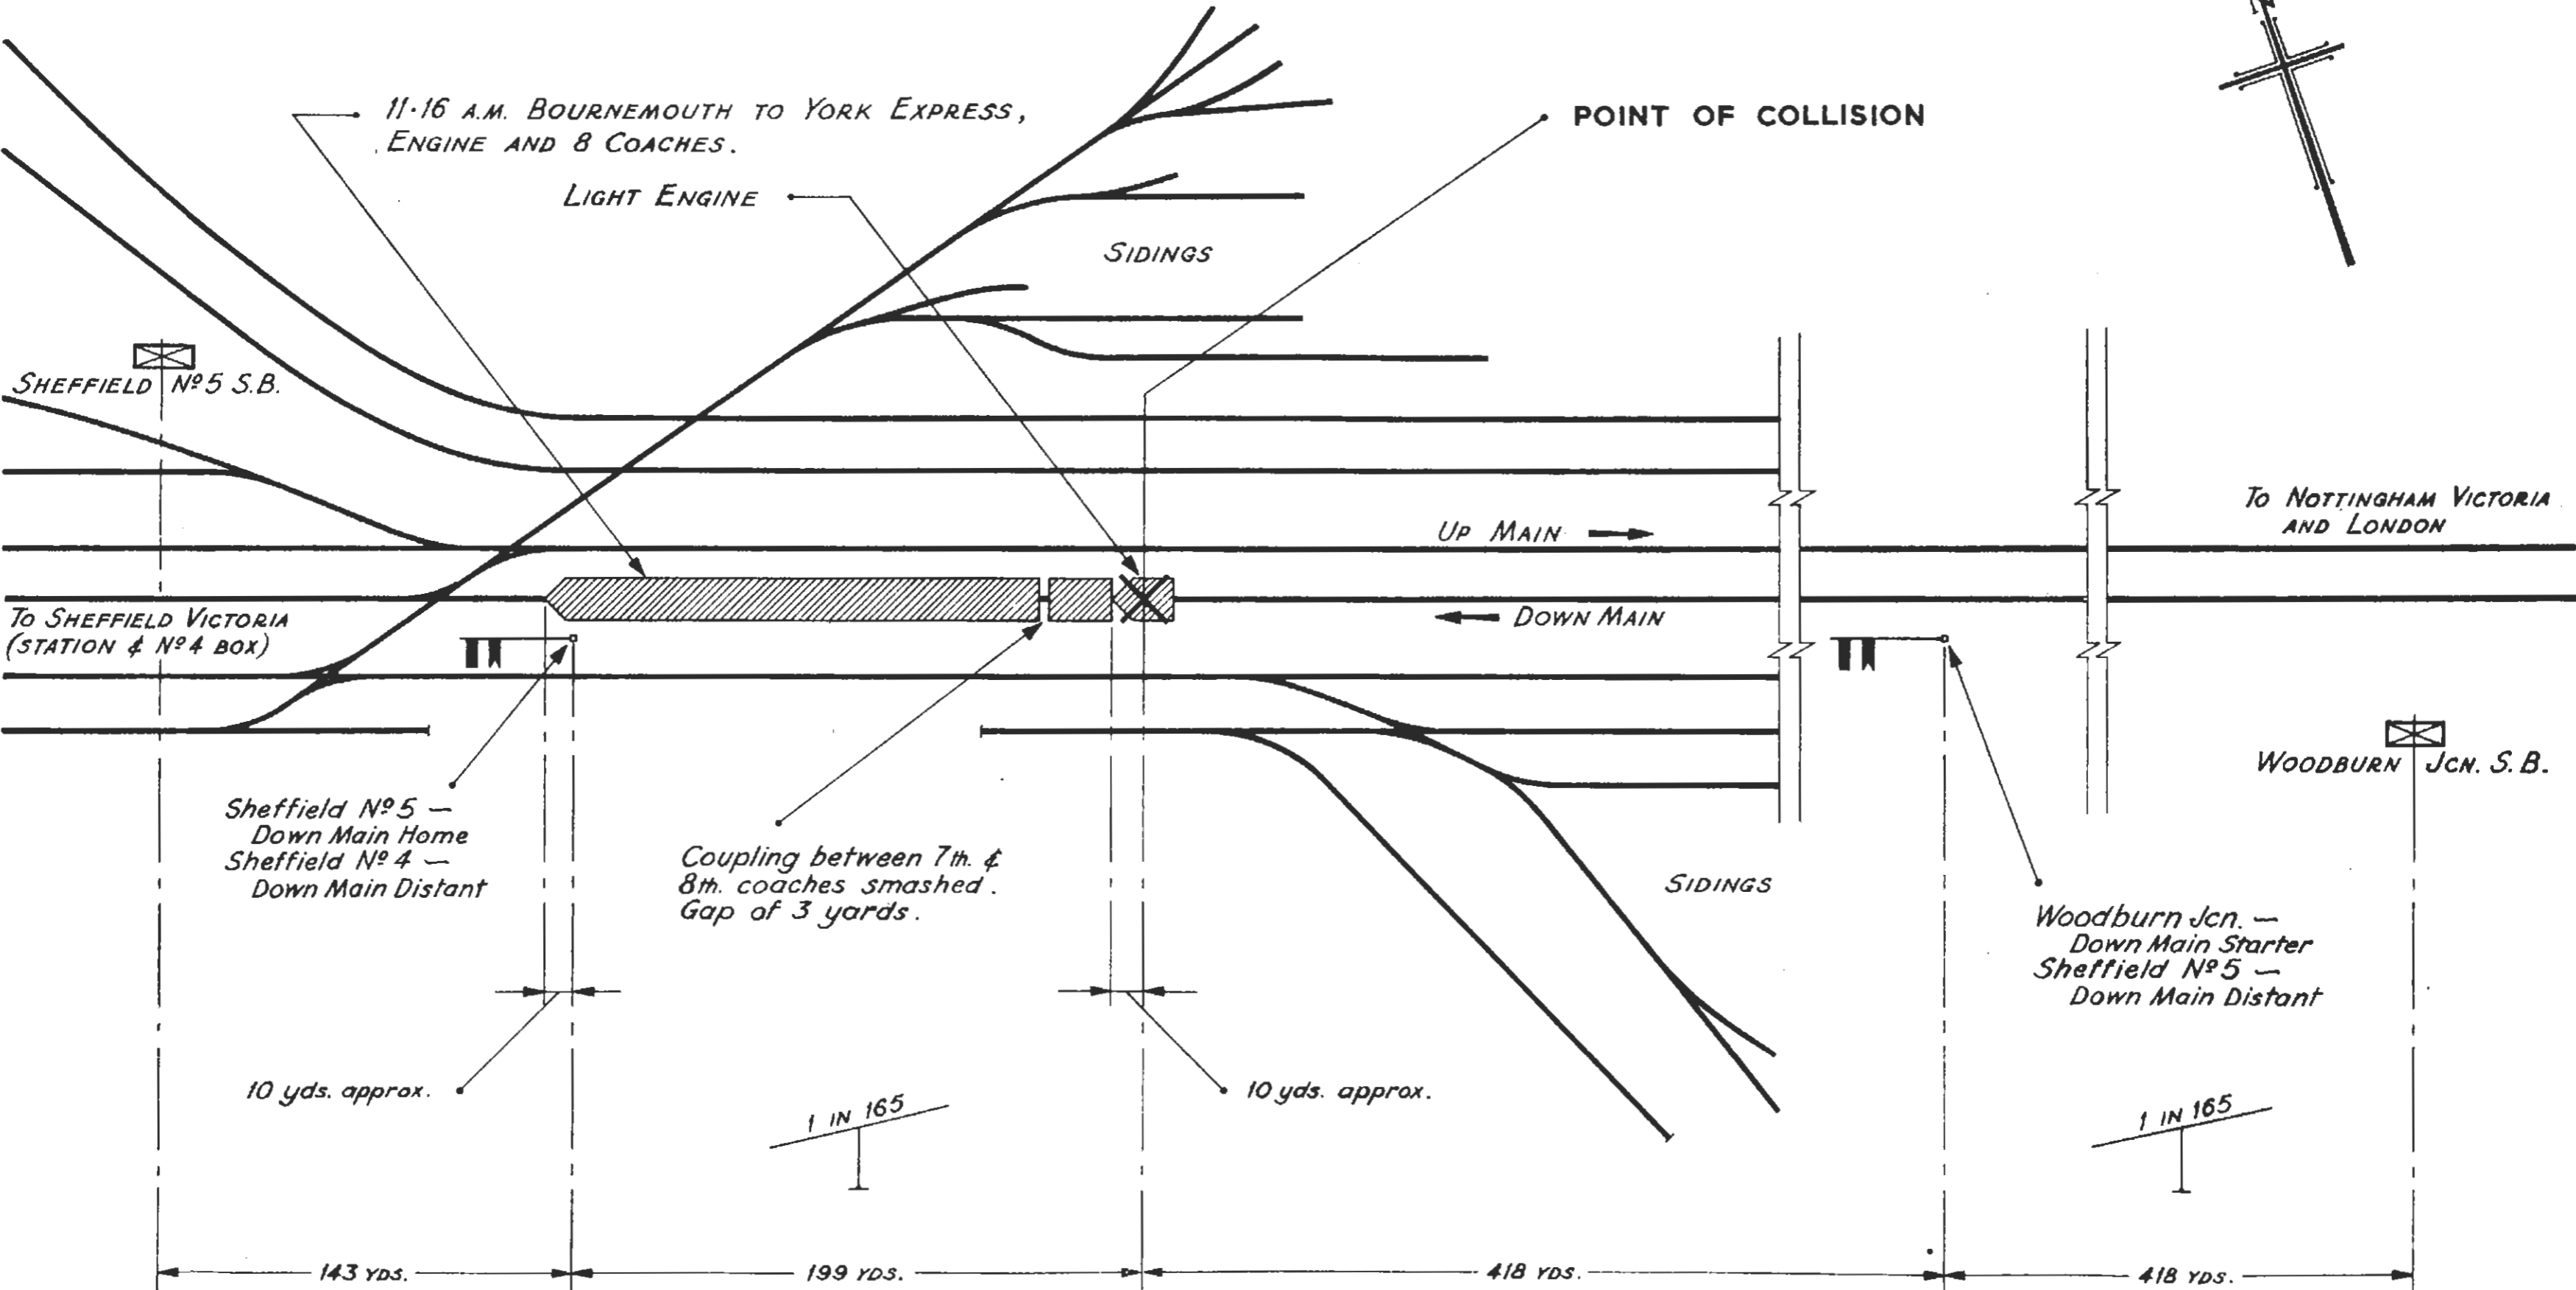
The sketch opposite shows the essential features of the layout, the position of the signal boxes concerned, Woodburn Junction and Sheffield No. 5, and the signals. Train working is by three position block instruments. The section signals are released by "Line clear" on the block instruments. The lines are not track circuited.
