MINISTRY OF TRANSPORT AND
CIVIL AVIATION

REPORT ON THE COLLISION

17th February 1959

SLADE GREEN and DARTFORD

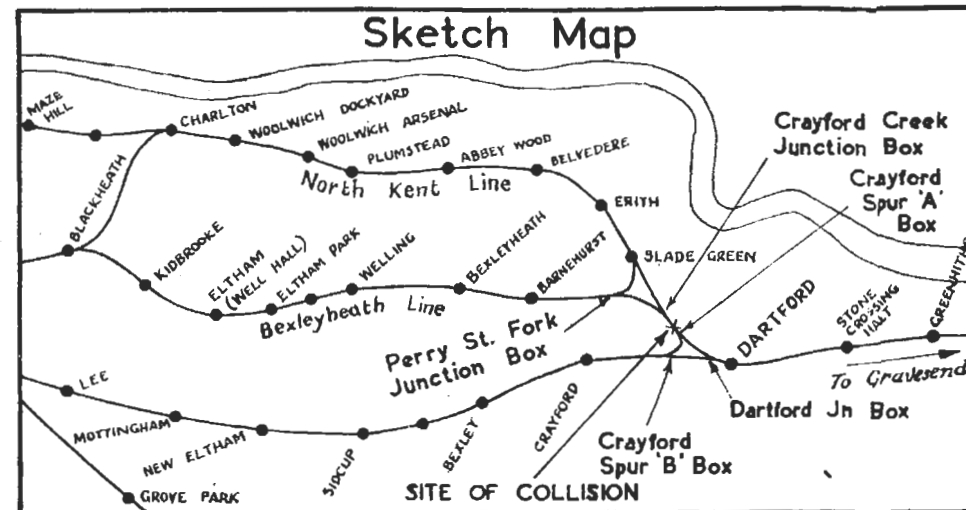
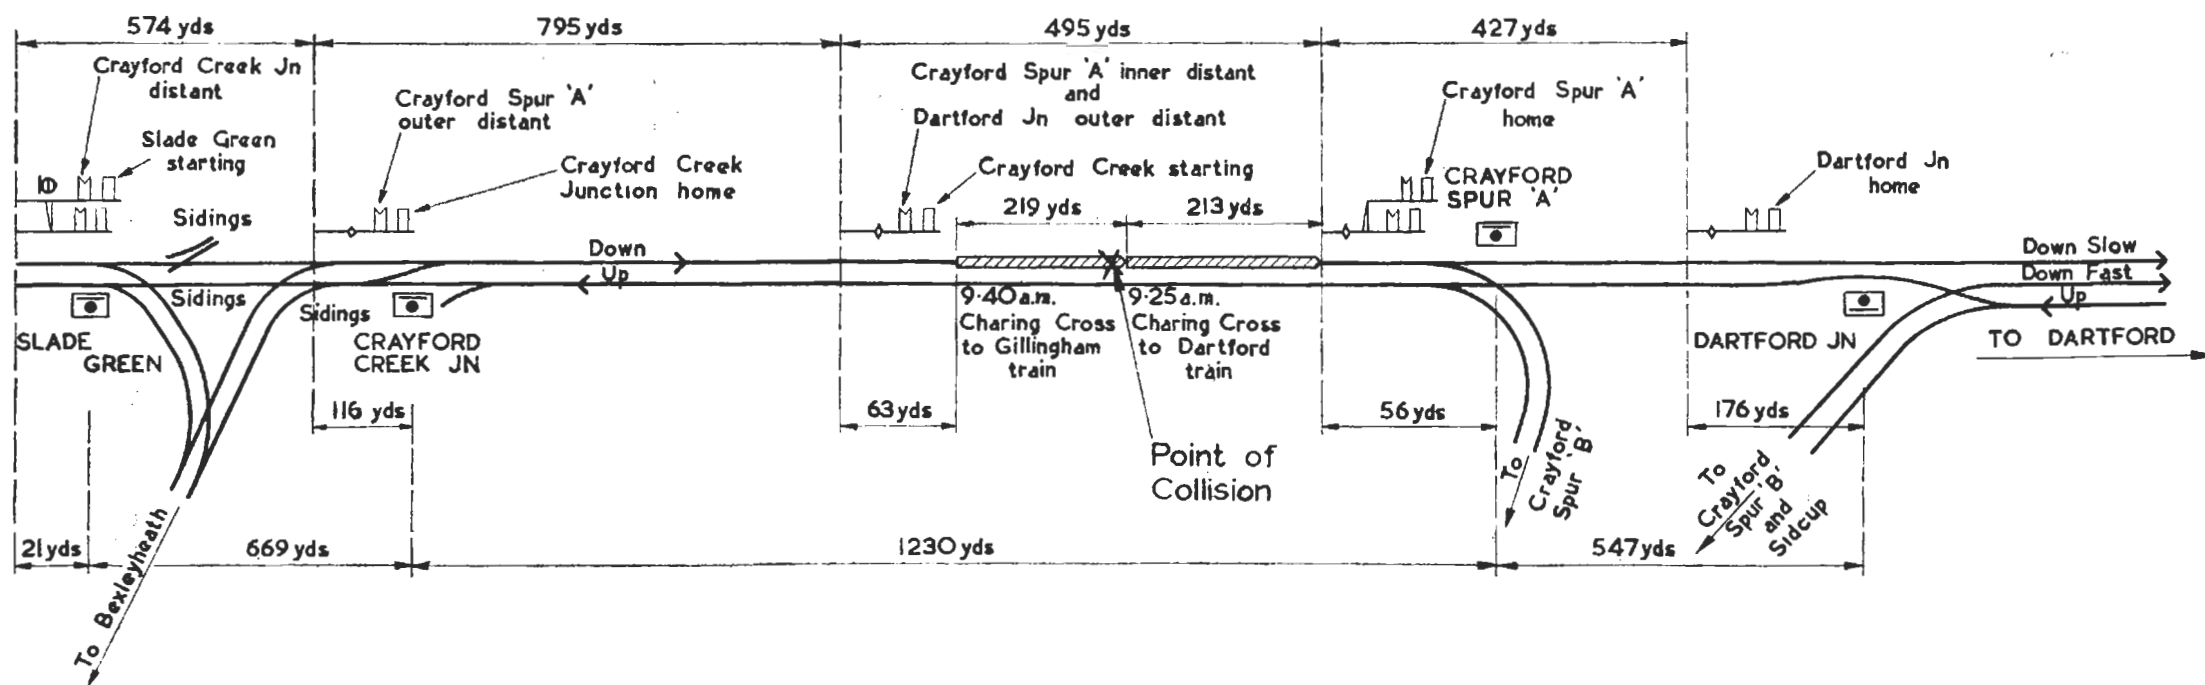
LINE DIAGRAM (Not to Scale)

1. A sketch map of the railway in the area of the accident and a dimensioned diagram to illustrate the position of the trains and the relevant signal boxes and Down line signals, are shown on the facing page.

3. The signals are upper quadrant semaphores. The Down homes at Crayford Spur "A" box are 56 yards from it towards London and they are not provided with a berth track circuit; they comprise the signal for the spur line on the post with the Crayford Spur "B" fixed distant signal below it, and the North Kent signal above the Dartford Junction distant signal on a bracket arm at a higher level to the left. The Down line signals on the approach to Crayford Spur "A" Down home signal are as shown on the diagram.

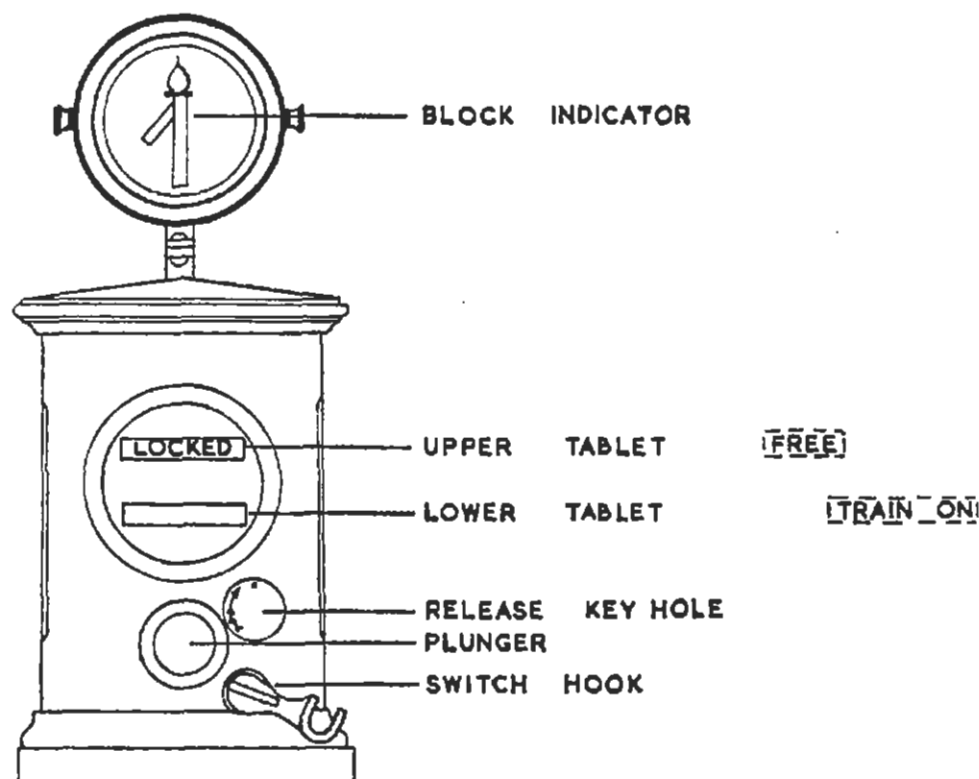
SYKES' THREE-WIRE, TWO-POSITION, LOCK AND BLOCK INSTRUMENT.

5. A feature of relevance to the circumstances of this accident is the working of the two-position Block Indicator: this has the appearance of a miniature semaphore arm in a case on top of the instrument which controls the section signal. The semaphore arm is normally lowered; it rises to the horizontal position when the plunger at the signal box ahead is pressed to release the lock on the section signal lever. The electrical circuit through the plunger to the indicator is so designed that the indicator arm will rise when the plunger is operated to cause the "Train on" tablet to show in the box ahead even if the electrical circuit is made so briefly that the heavier electrical lock on the section signal lever in the box in rear does not have time to operate. This can happen if the plunger is not pressed firmly. The circuit is then disconnected and the lock cannot be freed until the system has been made normal by a release in the signal box ahead.

42. This uncertainty can be overcome by an improved indicator which has separate positions for Normal, Line Clear, and for Train on Line or Line Blocked; it is placed at Line Clear when the plunger is operated, and moved to the Train on Line position when the switch hook is placed over the plunger. It therefore helps the signalman in the box in rear much more than the two-position instrument, and it is natural to expect that he will pay attention to it, especially in a busy box when he is making a number of train movements successively without pause. I am sure that Miller would habitually have paid closer attention to three-position instruments if they had been installed at Crayford Creek Junction, and he might not then have forgotten to send the Train Entering Section message and have jumped to the wrong conclusion which gave rise to this accident.
