## LONDON AND NORTH EASTERN RAILWAY.

MINISTRY OF TRANSPORT,  
Metropole Buildings,  
Northumberland Avenue,  
London, W.C.2.

13th July, 1937.

I have the honour to report, for the information of the Minister of Transport, in accordance with the Order of 16th February, 1937, the result of my Inquiry into the circumstances of the accident which occurred about 12.45 p.m. on 15th February at Sleaford North Junction, on the Lincoln-Spalding line of the London and North Eastern Railway.

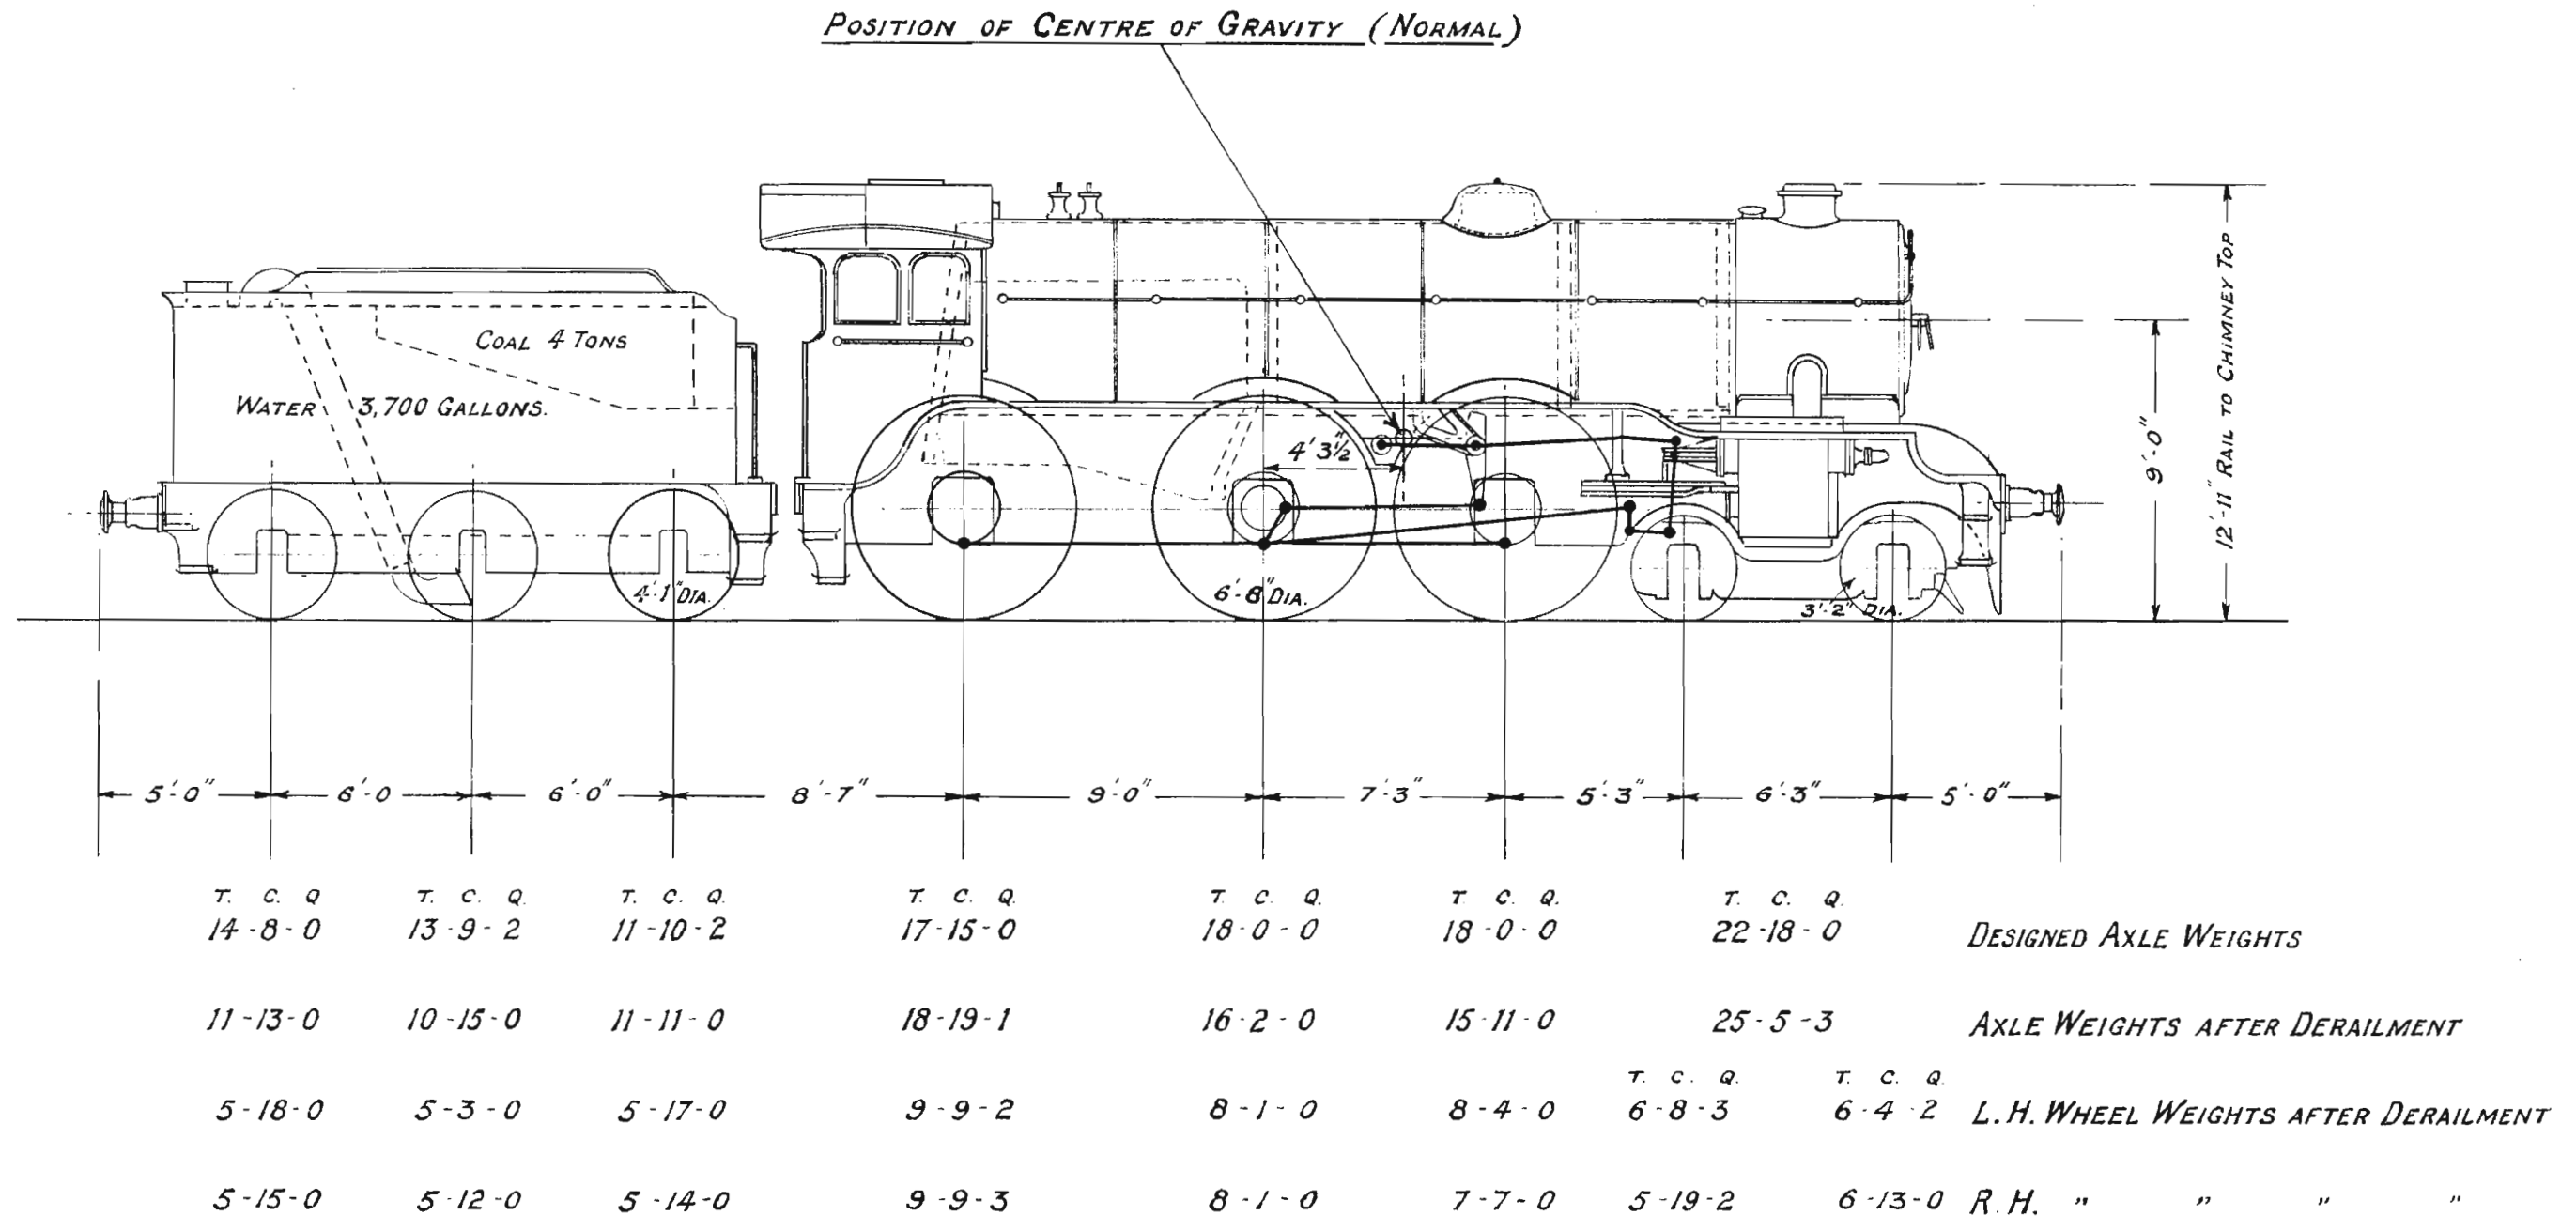
# L. N. E. R. ENGINE N<sup>o</sup> 2829 "NAWORTH CASTLE"

The drawing attached indicates general dimensions and designed axle weights, together with actual weights on individual wheels as weighed after the derailment, the engine having been hauled dead from Sleaford to Doncaster Works. The engine had been weighed and adjusted to diagram weights in June, 1936.

or other defects which would have had any material bearing on the derailment. The one point referred to above is the weights on the various wheels, which were appreciably different from the designed weights, in particular on the wheels of the leading coupled axle.

It must be recognised that these differences may to some extent have been due to the derailment, and may not have been in existence previously, but I think it is reasonably probable that uneven distribution of weight may have had some bearing on the derailment, as explained in more detail below.
