RAILWAY ACCIDENT

Report on the Collision that occurred on 11th January 1967 at St. Anne's Park, Bristol

IN THE
WESTERN REGION
BRITISH RAILWAYS

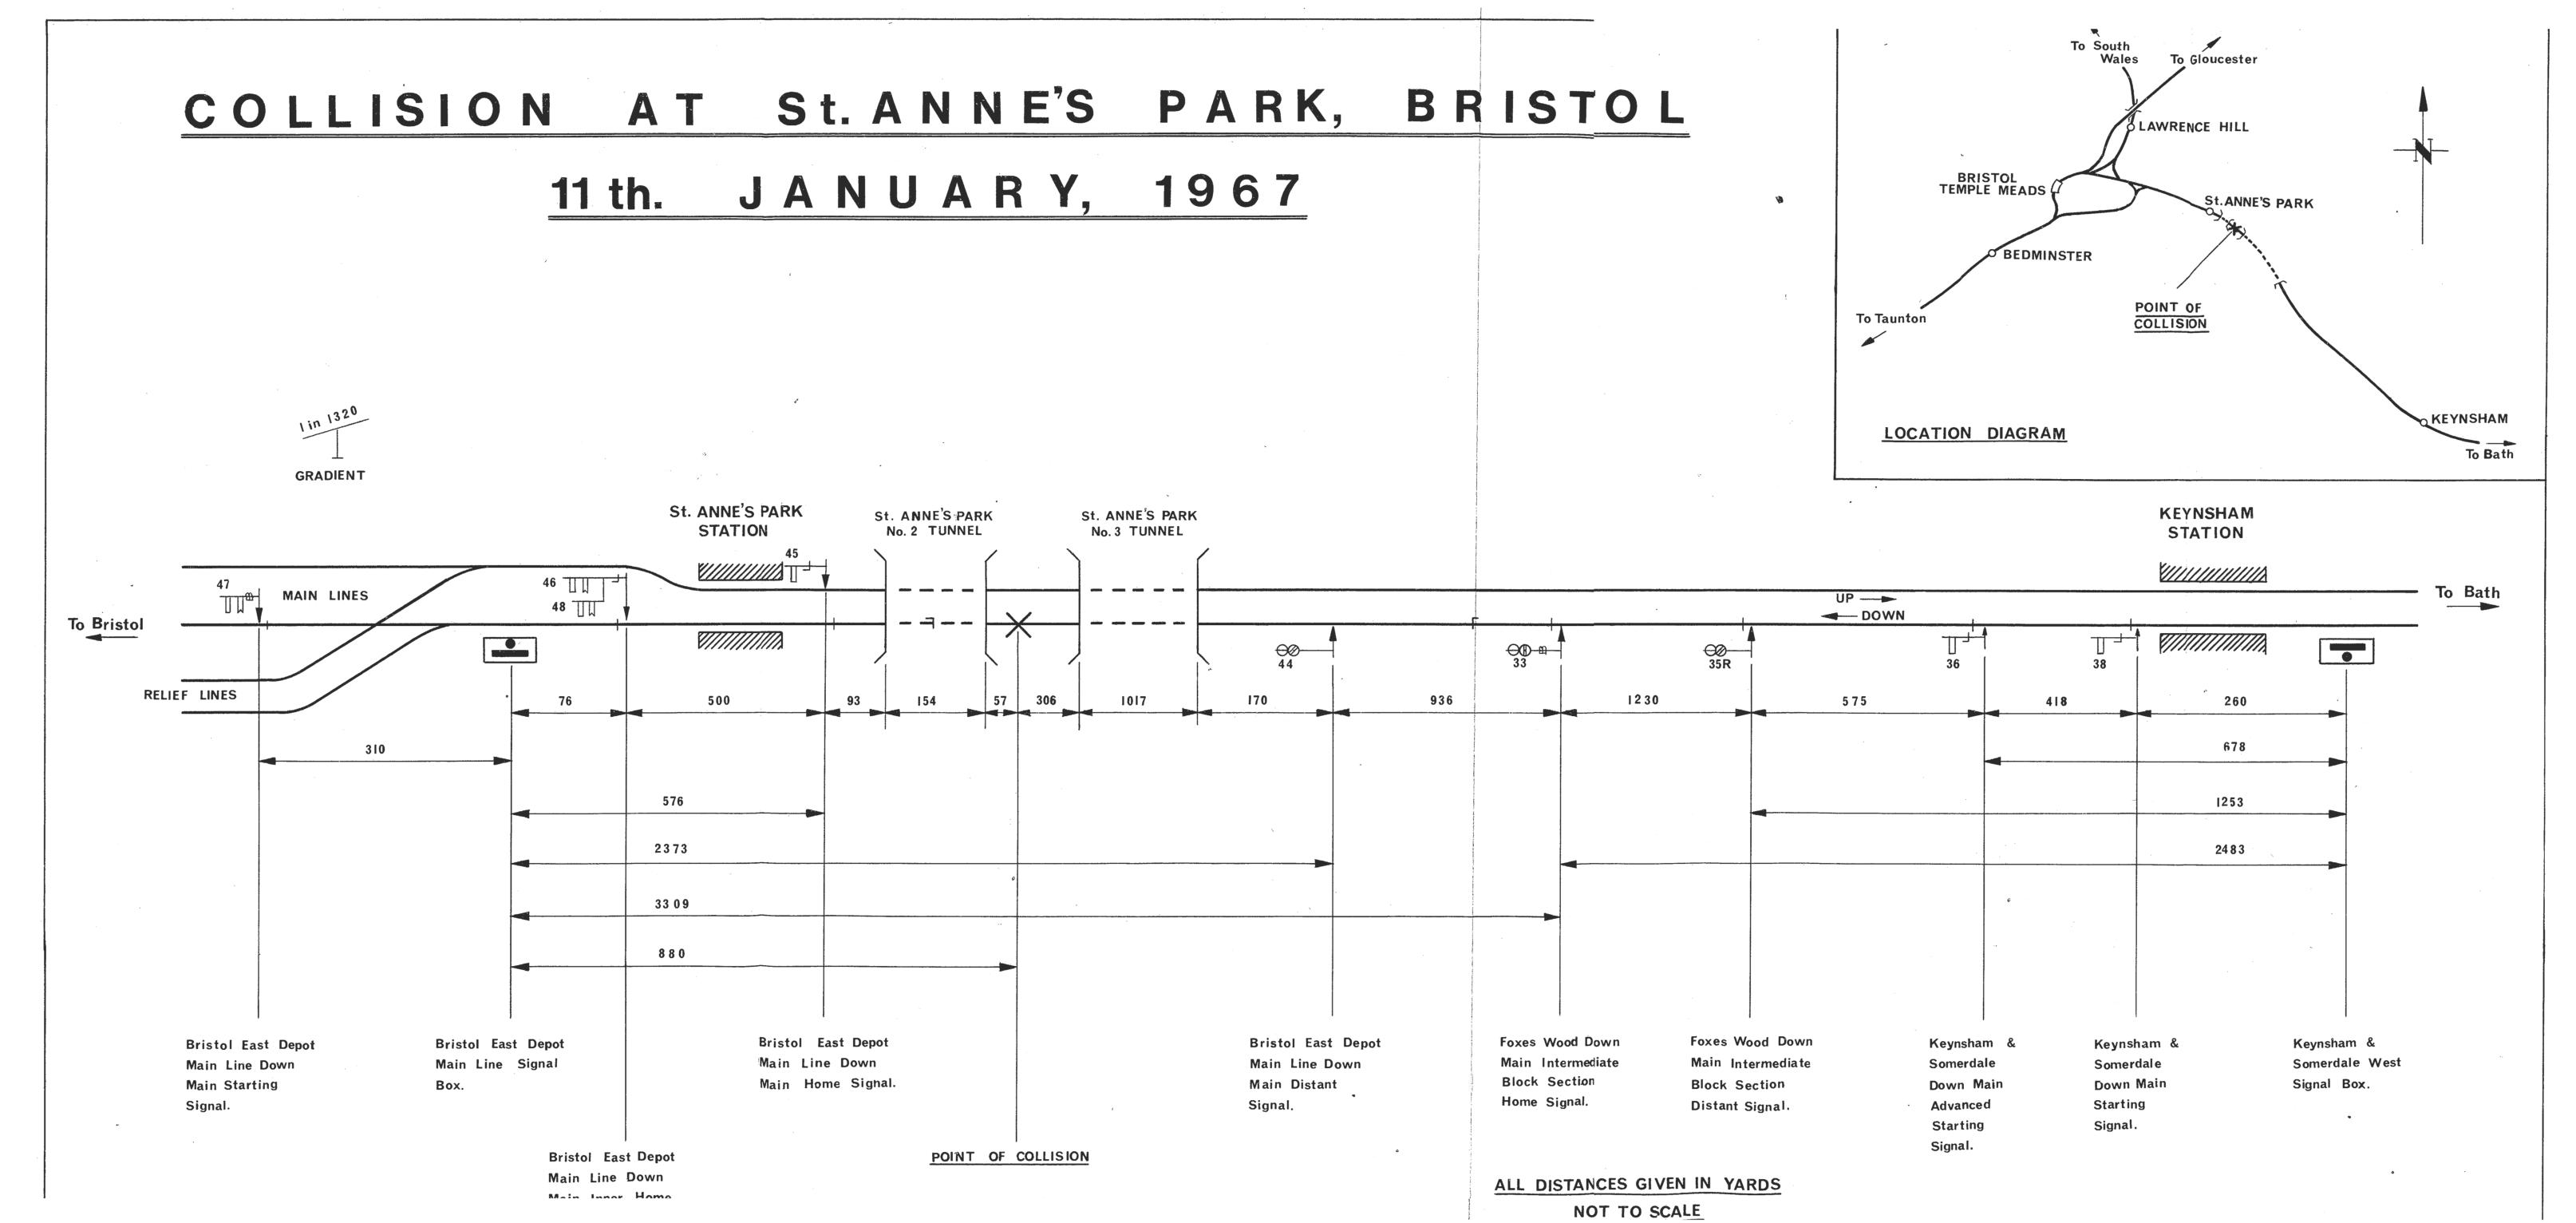
- 2. The signalling in the area is on the absolute block system and the adjacent signalboxes are Keynsham and Somerdale West, $2\frac{3}{4}$ miles away in the Up direction, and Bristol East Depot Main Line, $\frac{1}{2}$ mile in the Down direction. The locations of the relevant signals on the Down line are shown in the attached plan.
