MINISTRY OF TRANSPORT

REPORT ON THE COLLISION

9th June 1951 at

STOBCROSS

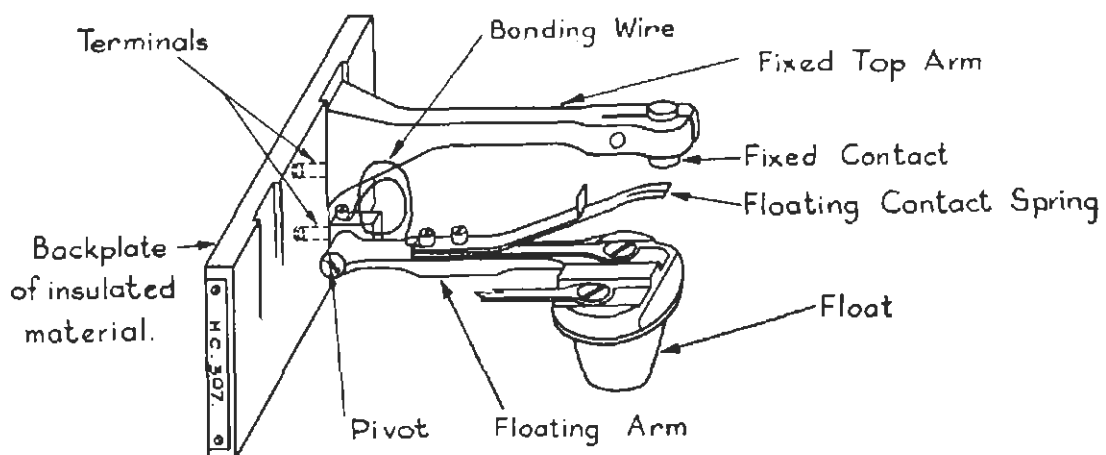
The following sketch illustrates part of the contact unit :—

In this unit a contact spring on a floating arm attached to the float is placed centrally below a fixed top arm. The floating contact spring is connected to a terminal on the back plate by means of an uninsulated and coiled stainless steel bonding wire. The fixed and floating arms are of metal and are varnished. In the particular unit in use it was found that the bonding wire, which should have a horizontal clearance of $\frac{3}{16}$ inch from the fixed top arm, had become displaced and was making intermittent contact with it. The varnish of the top arm was chafed. As a result, the circuit through the treadle occasionally remained closed for long periods after the passage of trains.

Whyte could not explain how the bonding wire had become displaced as he was certain that he had not touched it ; he suggested that it might have been received in that condition. He said that in that case he might not have noticed the defect as the negative circuit tests had not caused him to look for any fault, and he had not been instructed to watch specially for any displacement of the wire.

It has not been possible to establish exactly when the defect started in the treadle. I have seen that treadles, after being overhauled in the workshops in Crewe, are tested most carefully before being sent to the Regions, and I consider it very unlikely that the treadle was despatched in a defective condition, as suggested by Lineman Whyte. I accept his statement that he did not open the cover of the contact chamber when he installed the treadle, and I can only conclude that the bonding wire was displaced by him when he subsequently examined the contact chamber in May. If that was the case, the fault was not present when Mr. McCulloch should have tested the circuit.

The intermittent nature of the fault was due possibly to vibration set up by trains and overhead traffic on the made up ground verging on the docks, and it would account for the negative readings when the original electrical leakage tests were made.

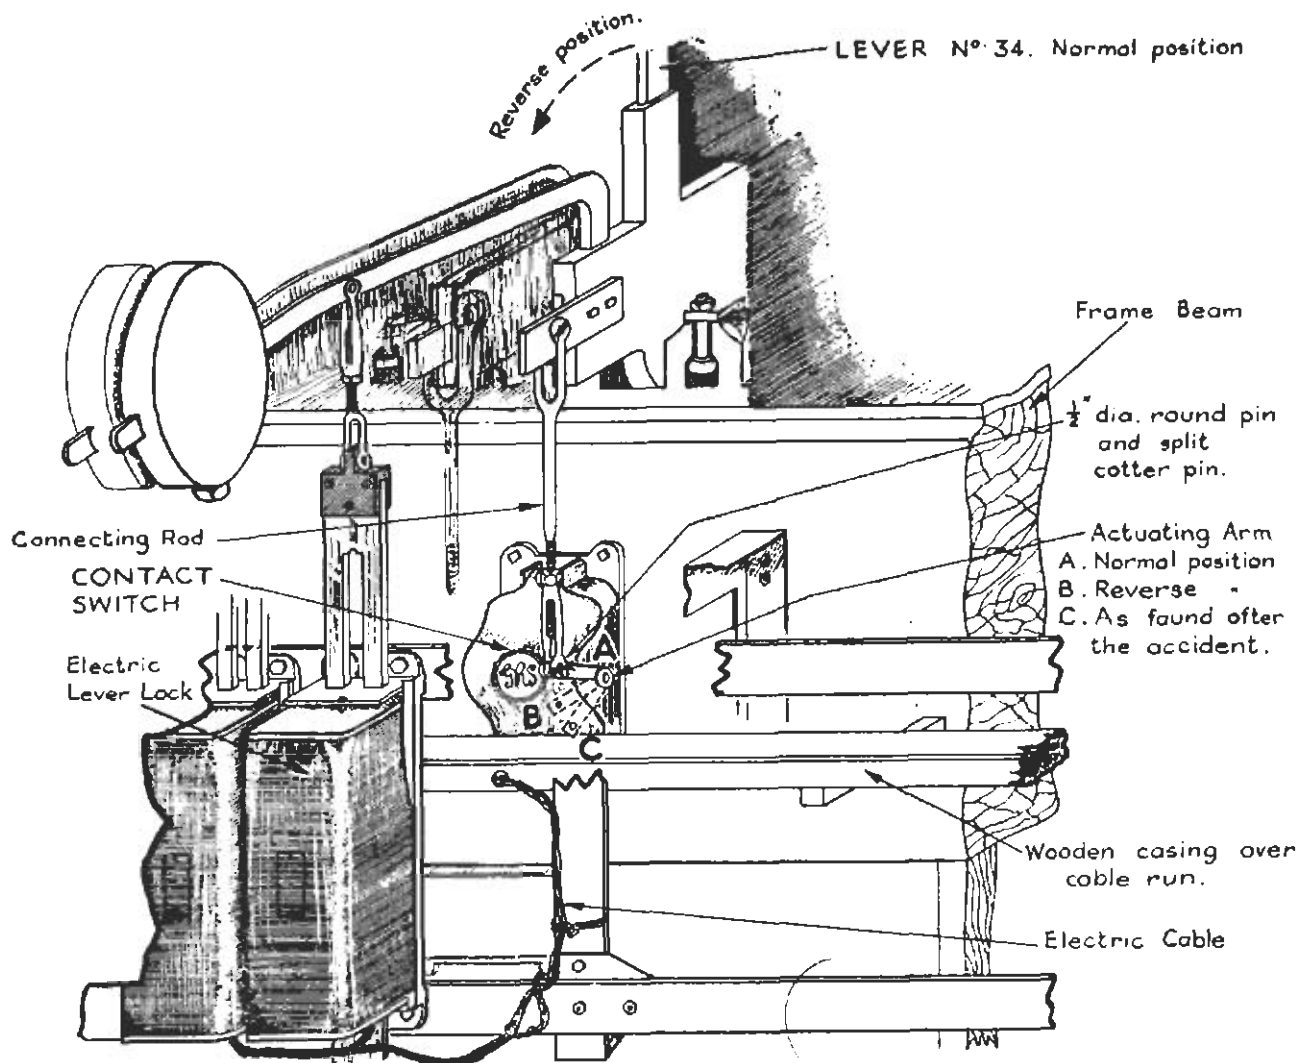
12. The contact switch under the lever of home signal No. 34, illustrated on page 4, is of the rotary type and it was manufactured by the General Railway Signalling Company. The actuating arm of the switch is connected by a rod to the tail of the lever. The connecting rod and the arm are held in position by means of a $\frac{1}{2}$ -inch turned round pin which is secured by a split cotter pin. The circuit is broken when the lever is normal and the arm is in the raised position (A) and "made up" when the lever is pulled and the arm in the lowered position (B) which is about 20° below the horizontal. If the switch arm becomes disconnected, it should fall to a greater angle to the horizontal, and the circuit again should be broken. In the switch in question, the actuating arm was found disconnected (in position C) but the wooden casing of a cable run below the arm had prevented it from falling sufficiently for the circuit to be broken. A round pin of the correct size was found on the earth and ash floor of the box below the switch, and a complete split cotter pin about a foot away from it. The round pin and the split pin were not rusted and they appeared to be those which had joined the actuating arm of the switch and the connecting rod, and to have become recently displaced. The split pin was $\frac{1}{8}$ inch diameter. One of its jaws was straight while the other was only slightly opened, and the pin could be placed without difficulty in the hole of the round pin. The correct size of split pin for the round pin is $\frac{5}{32}$ inch diameter.

The following sketch illustrates the contact switch :—

Continuing his evidence, Whyte said that on Sunday morning he examined, again in Mr. Baldwin's presence, the electrical locking under the frame and found the actuating arm of the contact switch disconnected and lying on the wooden casing.

Regarding the failure of the contact switch, I have no doubt that the split cotter pin found on the floor of the box was that from the round pin which held the switch arm to the connecting rod, and it is probable that it had fallen out only a short time before the accident. Neither Inspector McCulloch nor Lineman Whyte had noticed that the jaws of the pin were not properly opened, nor that it was too small. Mr. McCulloch had also overlooked six other undersized pins which were found in use in the same frame after the accident. I was informed that, following the accident at Glasgow Cross in 1949, special instructions regarding the maintenance of the signalling and electrical equipment on the low level lines were issued. Among other things, inspectors were required to check all split pins carefully. In spite of that Mr. McCulloch signed a certificate after his detailed examination in January 1951, that the frame in the Stobcross box was in good order.
