MINISTRY OF TRANSPORT

REPORT ON THE COLLISION

25th August 1962

TORQUAY

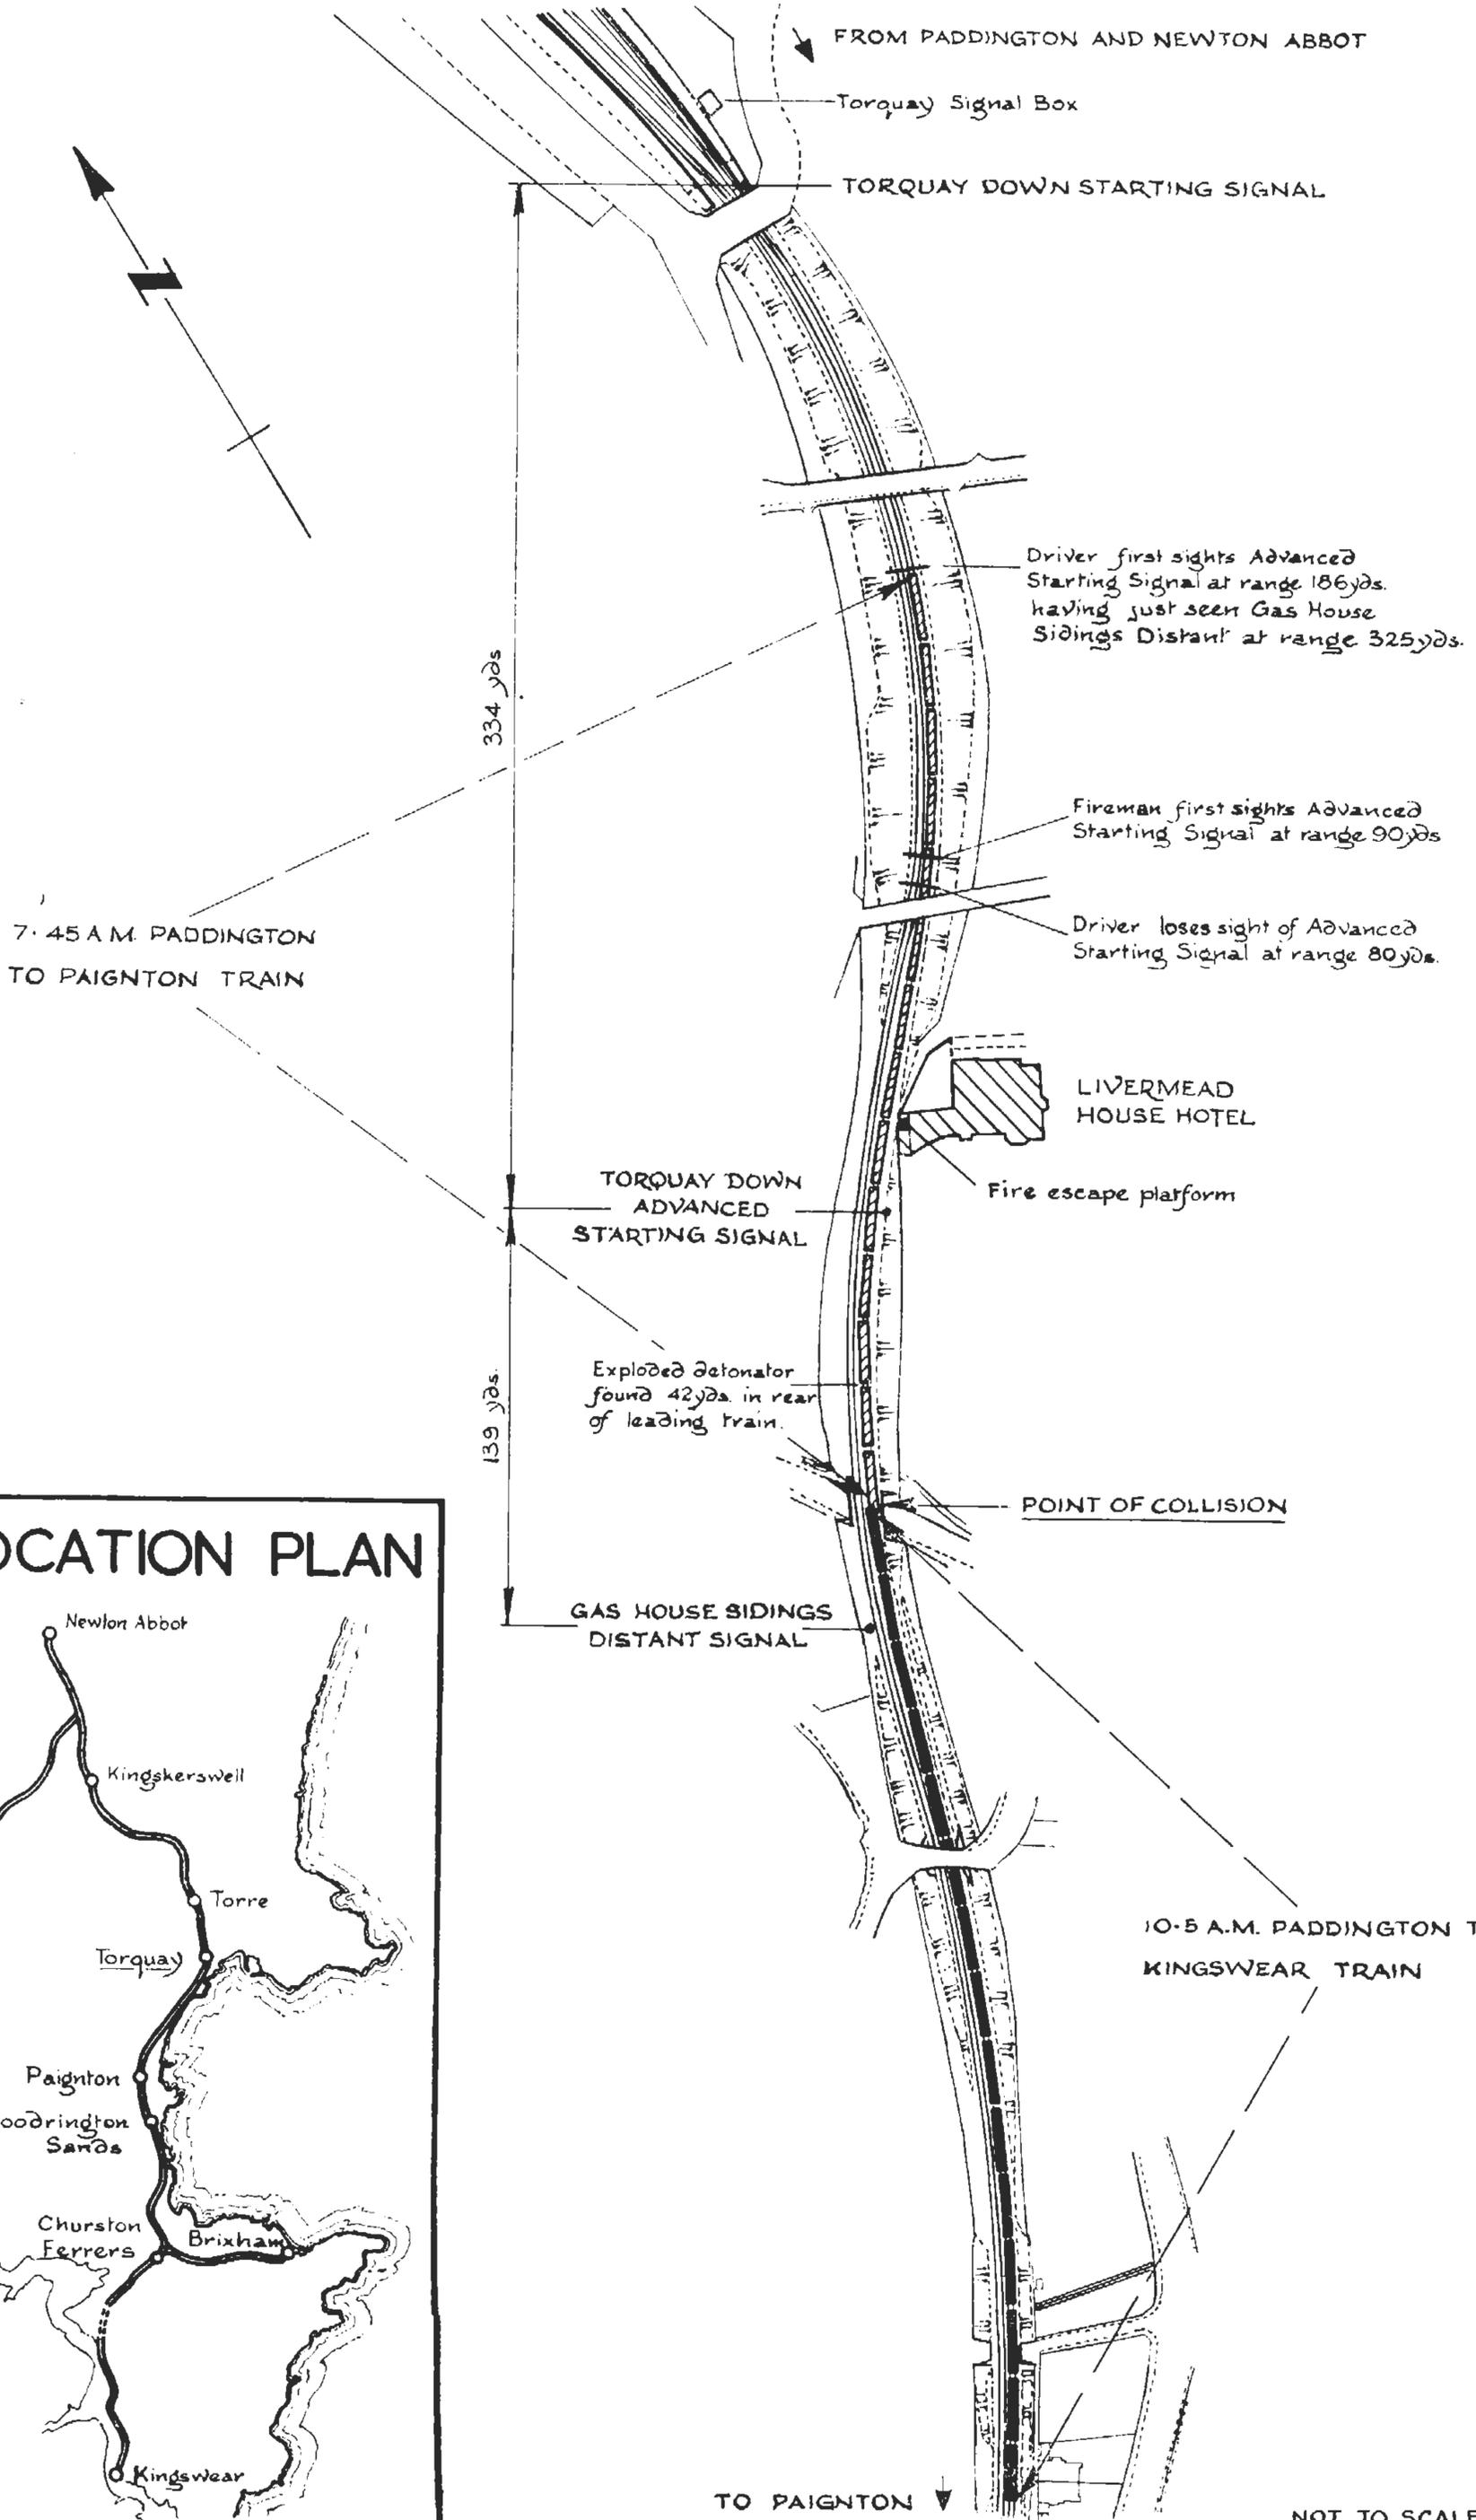
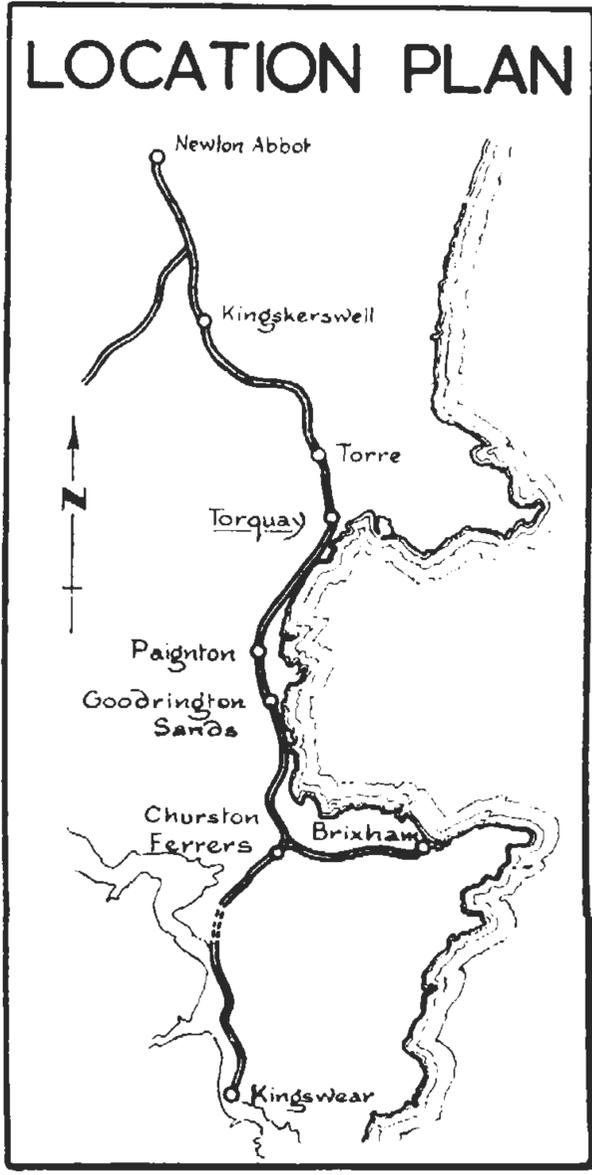
2. The diagram shows the layout at the scene of the collision, the Down line signals and the points at which they come into and pass out of the view of the men on the footplate of a Hall class engine, the approximate point of impact, and the positions of the trains after the accident. The Torquay Starting and Advanced Starting signals and the Gas House Siding Distant signal are all lower quadrant semaphores. The arm and light of the Advanced Starting signal are both repeated in the Torquay signalbox.
