MINISTRY OF TRANSPORT

REPORT on the COLLISION

22nd November 1962

VICTORIA and ST. JAMES'S PARK
STATIONS

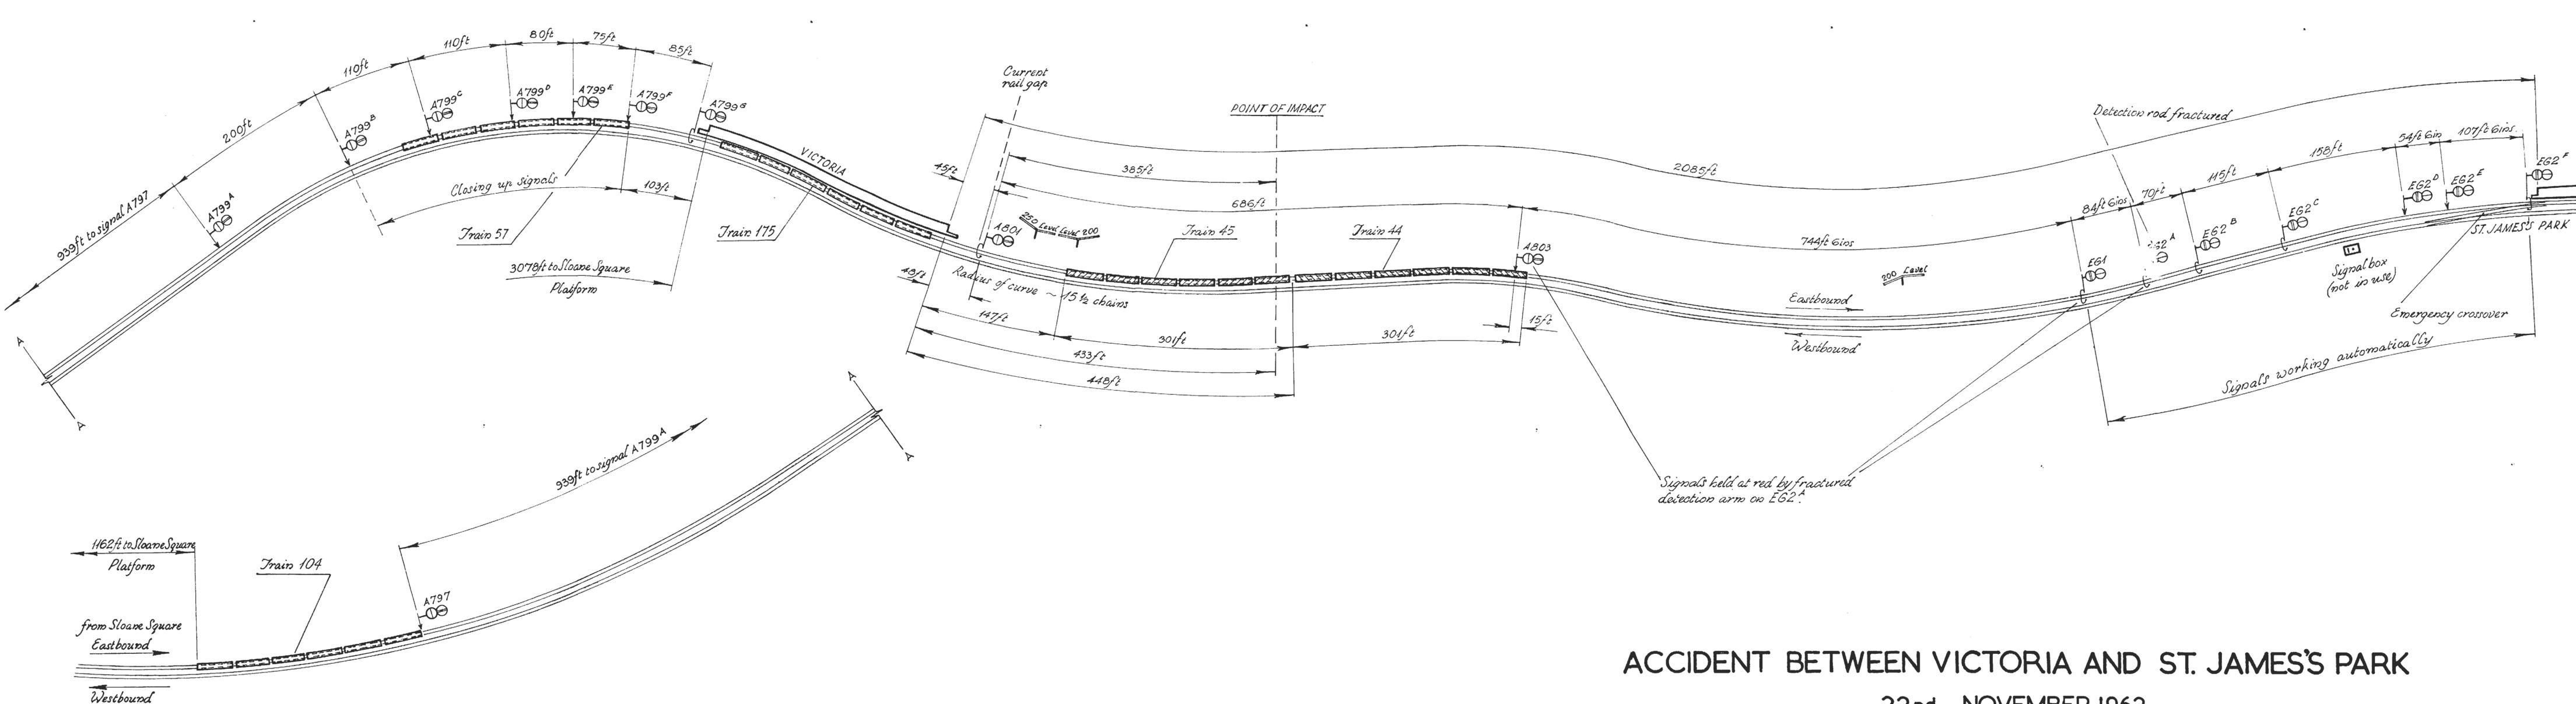
ACCIDENT BETWEEN VICTORIA AND ST. JAMES'S PARK

2. The diagram shows the signalling of the eastbound line between South Kensington and St. James's Park. The line is track circuited throughout and the signals are controlled by the track circuits. All the signals work automatically except that those with the prefix "EG" on the approach side of St. James's Park can be controlled to Danger from a signalbox at that station when an emergency crossover between the eastbound and westbound lines is required to be used. At the time of the accident, however, the signalbox was closed and all the signals were working automatically. There are no telephones at these signals.

4. The signals are of the two-aspect type and each is equipped with a train stop which is raised when the signal is at Danger. If the signal is passed at Danger the train stop engages with the trip cock on a train, which automatically applies the brakes. The correct operation of a train stop is proved in the circuits of the signal concerned and of certain approach signals. The train stop at signal no. EG2A had failed due to the fracture of its detection arm, and that signal and also signals no. EG1 and A803 were therefore held at Danger.
