RAILWAY ACCIDENT

Report on the Collision that occurred on 5th December 1969 at Waterloo Station

IN THE
SOUTHERN REGION
BRITISH RAILWAYS

7th August 1970.

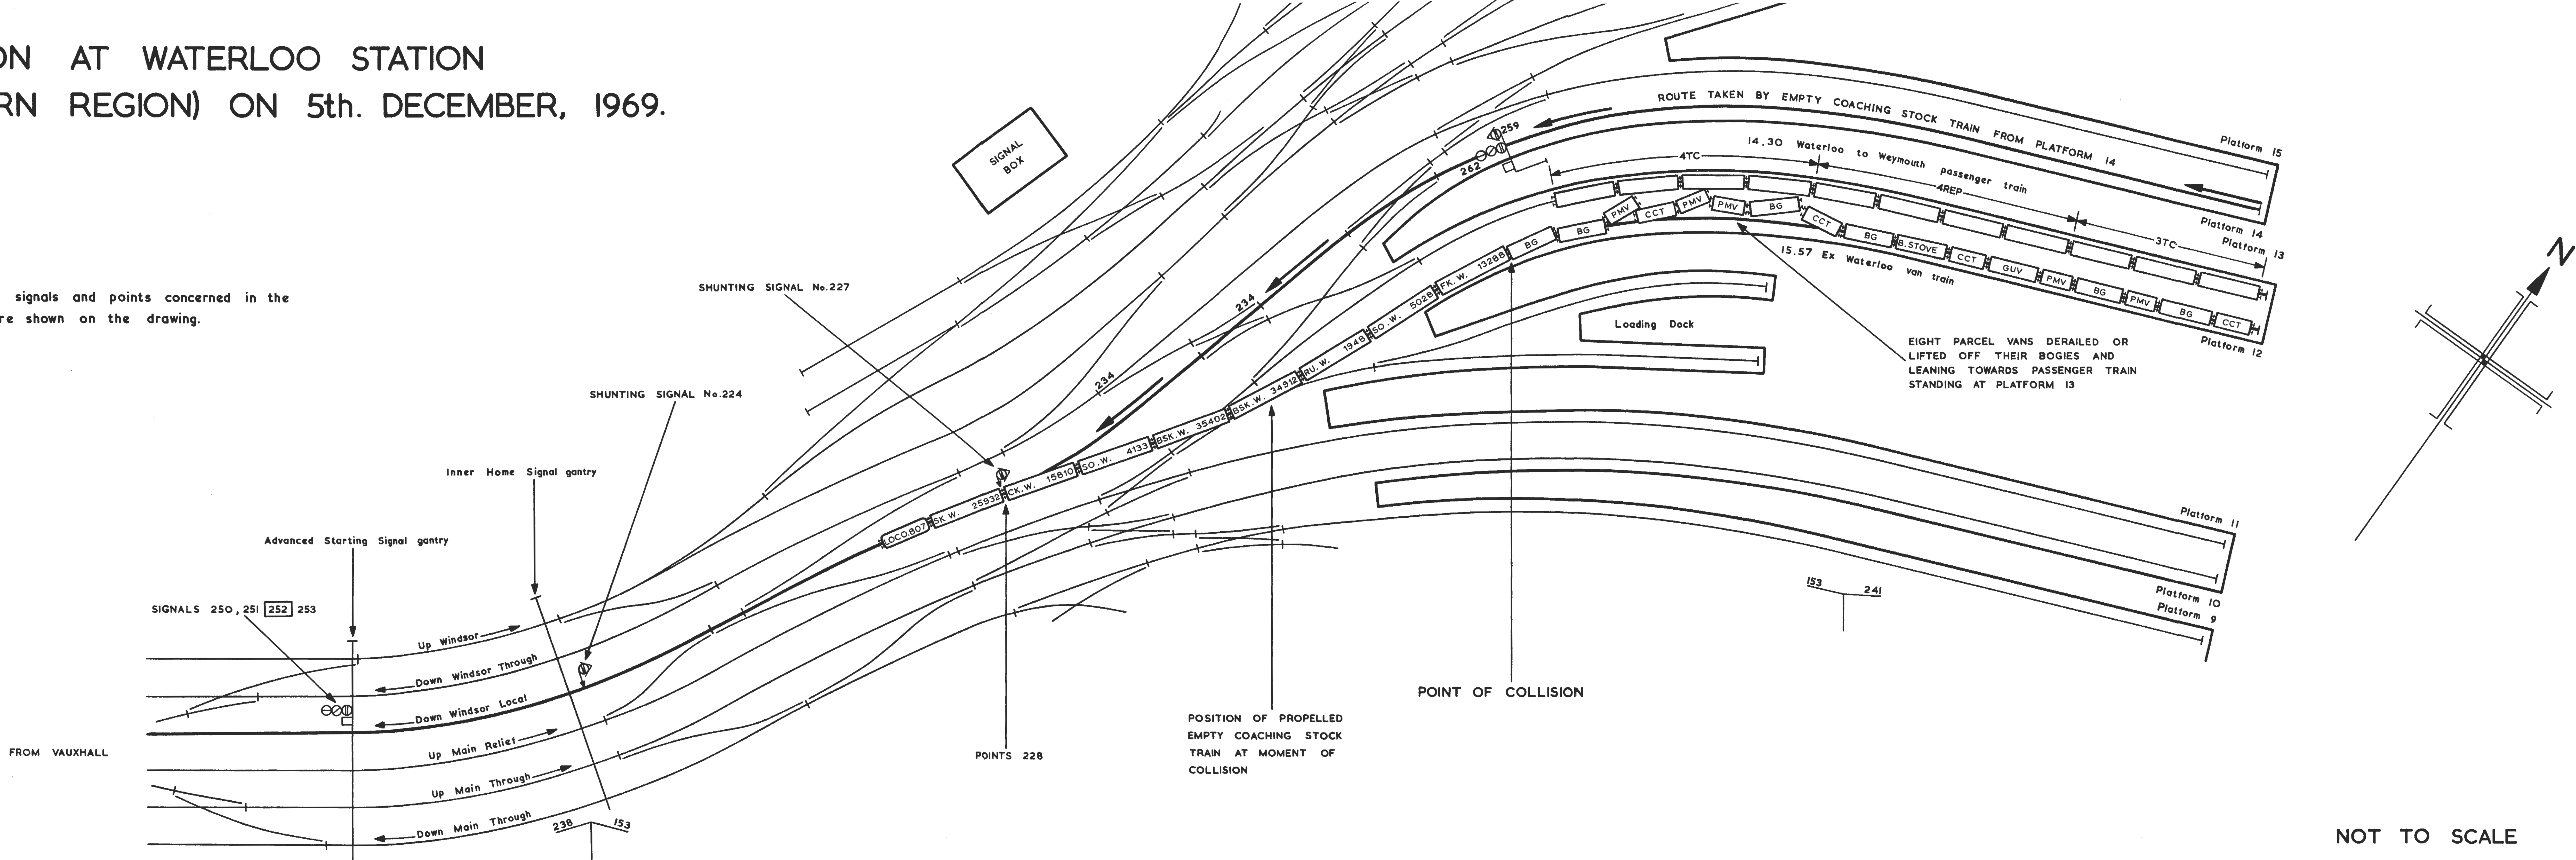
COLLISION AT WATERLOO STATION
(SOUTHERN REGION) ON 5th. DECEMBER, 1969.

1. Waterloo Station is the London terminus of the South Western Division of the Southern Region and it has 21 platforms. Between Vauxhall, approximately one mile to the south, and Waterloo there are four Up and four Down lines. Those concerned in this accident are the Down Windsor Through, Down Windsor Local, Up Main Relief, and Up Main Through lines. Approaching the terminus the lines are sharply curved and those leading to Platforms 12, 13, and 14 take a long left hand curve, the latter part of which is of 17 chains radius, followed by a short right hand curve of 12 chains radius before curving left and right again into the station. Details of the layout and the position of relevant signals and other features are shown on the Plan at the back of the Report.

30. Sighting tests made after the accident with a train similar in composition to the empty stock train involved in the collision were described by *Mr. W. O. J. Willmott*, Divisional Movements Manager, South Western Division. The result of these tests may be summarised as follows and should be read in conjunction with the plan at the back of the report:

- a. From the locomotive (second man's side)—Signal 224 visible from the commencement of the propelling movement. Signal 227 not seen until approximately 33 ft away.

- b. From the second vehicle from the propelling locomotive (C. K. W 15810)—Signal 224 and the locomotive visible from the left hand side of the coach. Signal 227 not visible at the start of the propelling movement.

- c. From the fourth vehicle from the propelling Locomotive (B.S.K. W 35402)—Signal 224 level with the left hand side of the coach at the start of the propelling movement. Signal 227 visible from the right hand side of the coach. The locomotive visible from the left hand side of the coach.

- d. From the Seventh vehicle from the propelling locomotive (T.S.O. W 5028)—Signals 224 and 227 both visible (224 reverse side only), but the locomotive not in view.

- e. From the leading vehicle (F.K. W 13288)—Signal 227 only seen.
