MINISTRY OF TRANSPORT

REPORT ON THE COLLISION

4th November 1959

WEST SLEEKBURN

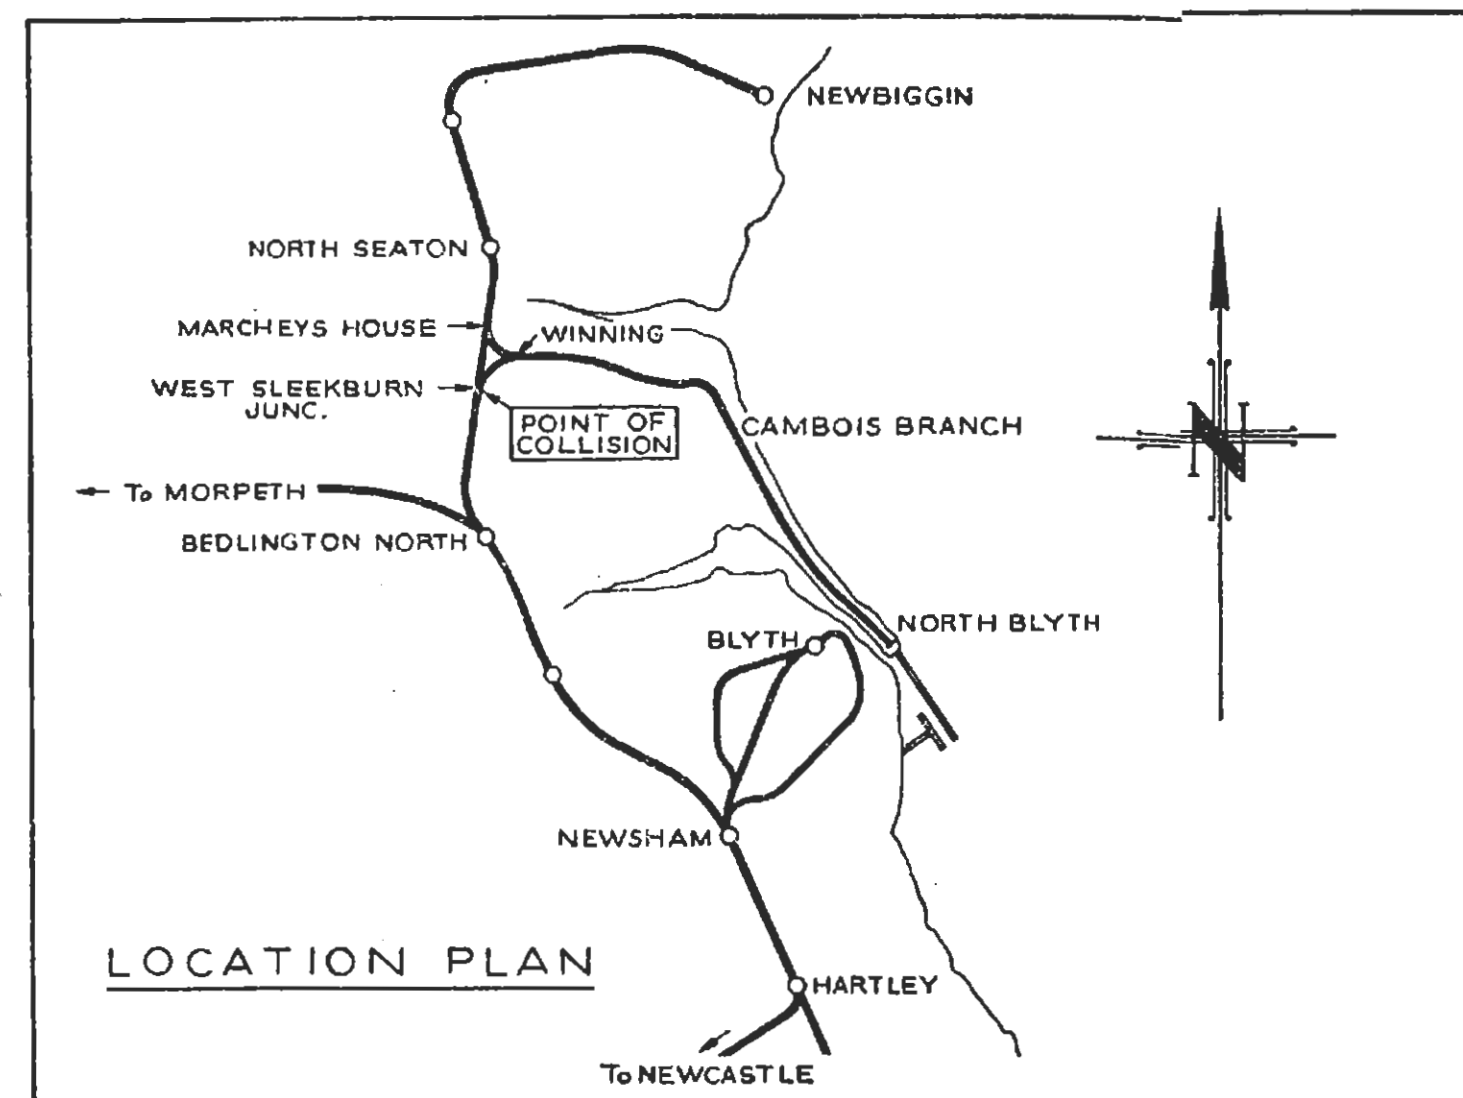
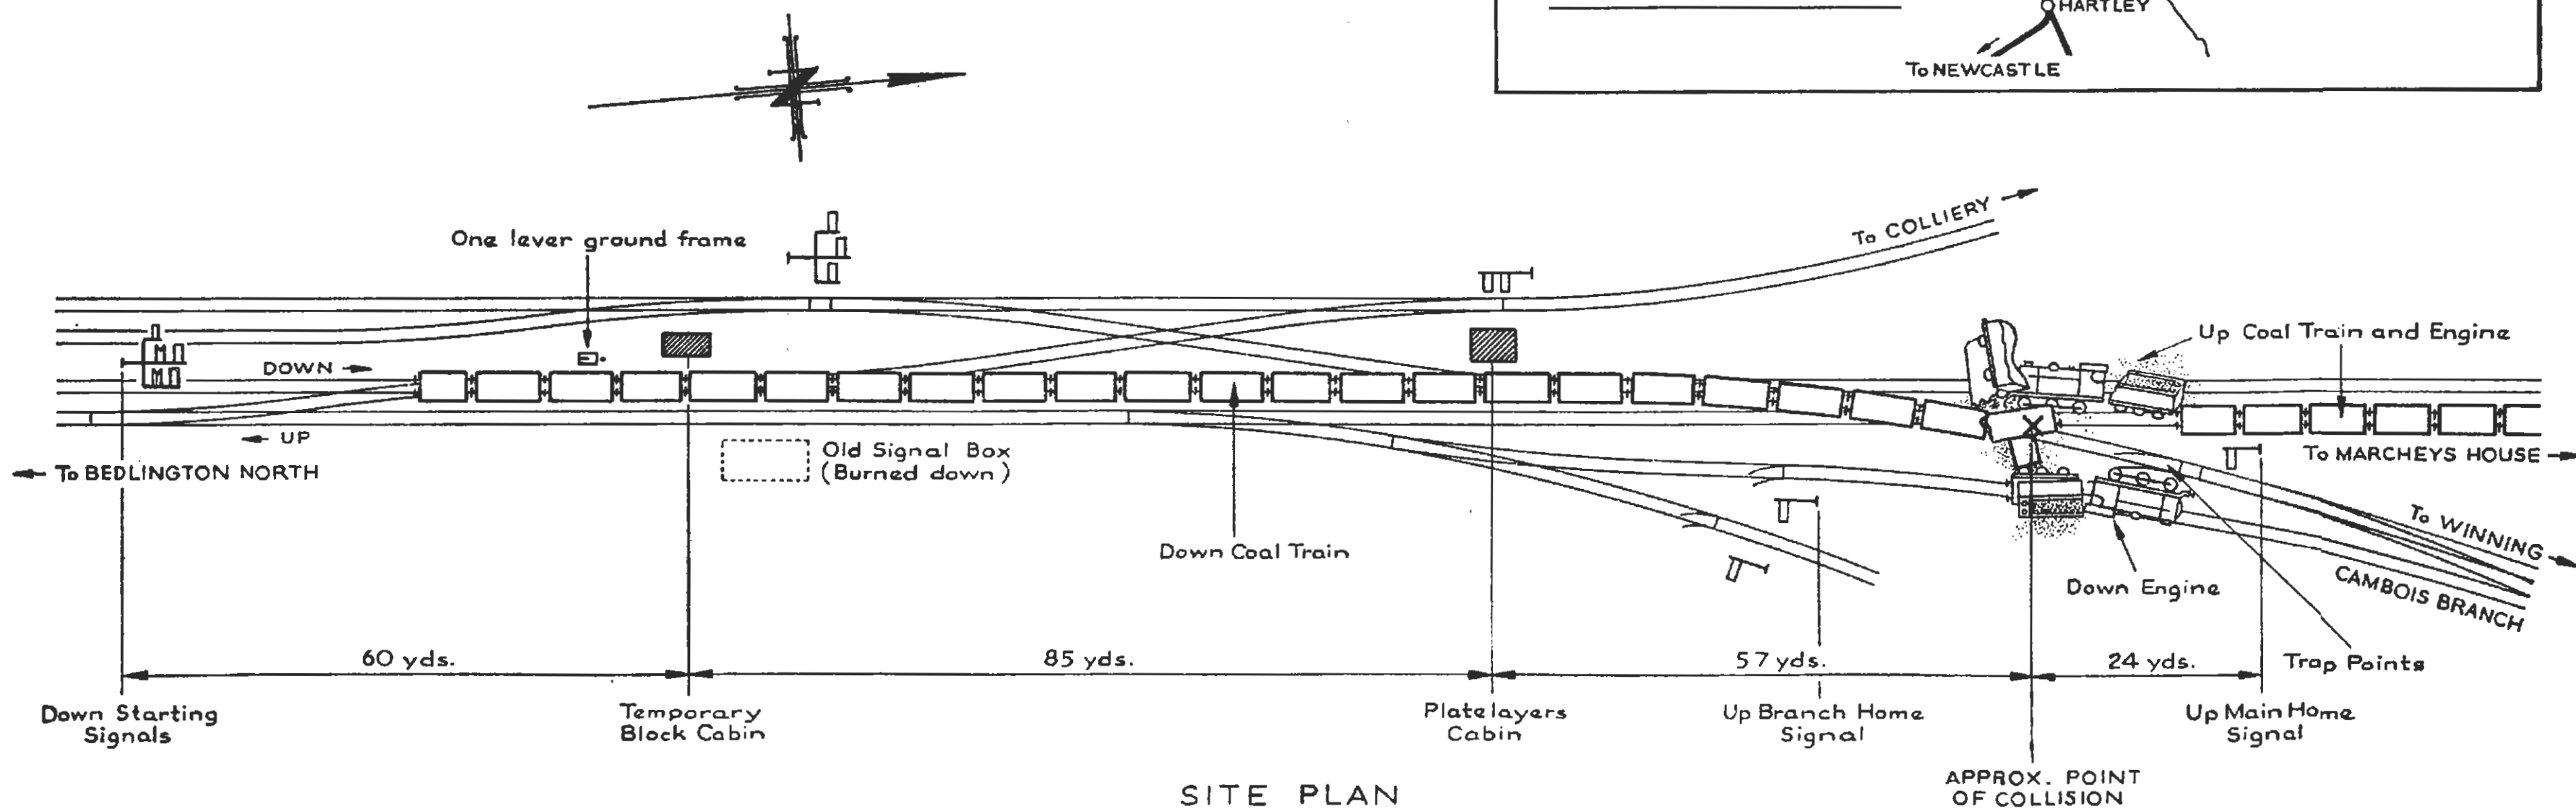
SITE PLAN
SCALE: 66 FEET TO 1 INCH

3. As will be seen from the location plan and drawing on the facing page, the double track line from Newcastle to Newbiggin runs North in the Down direction past West Sleekburn where there is a double line junction, facing in the Down direction, to the Cambois branch. This is a goods line which runs eastwards to the coal jetties at North Blyth. The relevant signal boxes, proceeding towards Newbiggin, and their distances from each other are as follows :

4. The alignment is straight through West Sleekburn which is in a shallow valley between Bedlington and Marcheys House. In the Up direction, from Marcheys House, the gradient falls at about 1 in 400 for $\frac{1}{2}$ mile and it then steepens to 1 in 92½ over a short distance before it eases to 1 in 140 at the junction. It is, however, shown as 1 in 250 throughout this length in the records. The increase in the gradient is ascribed to a gradual subsidence of the land over coal workings in the area of the junction.

8. West Sleekburn Up home signal (the one passed at danger by the Up train) protects the junction and is only 18 yards from the fouling point at the diamond crossing. As already indicated, it is near the bottom of the falling gradient in the Up direction from Marcheys House, and there is no outer home signal. In the Down direction the starting signals for the main line and to the branch are on a bracketted post about 60 yards on the approach side of the block cabin, and the home signal is 204 yards on the approach side of the starting signals. There are also signals leading to and from colliery sidings on both sides of the line which are not relevant to the circumstances of this accident. A few weeks before the accident the Down home signal, which is some distance from the cabin, had been connected to a single lever frame near the cabin to avoid the need for a hand signalman at the signal.
