**REPORT ON THE COLLISION**  
which occurred on  
13th May 1950 at  
**WHITEHOUSE WEST JUNCTION**  
Nr. Preston  
in the  
**LONDON MIDLAND REGION**  
**BRITISH RAILWAYS**

Collision at Whitehouse West Junction, Preston

13th May, 1950

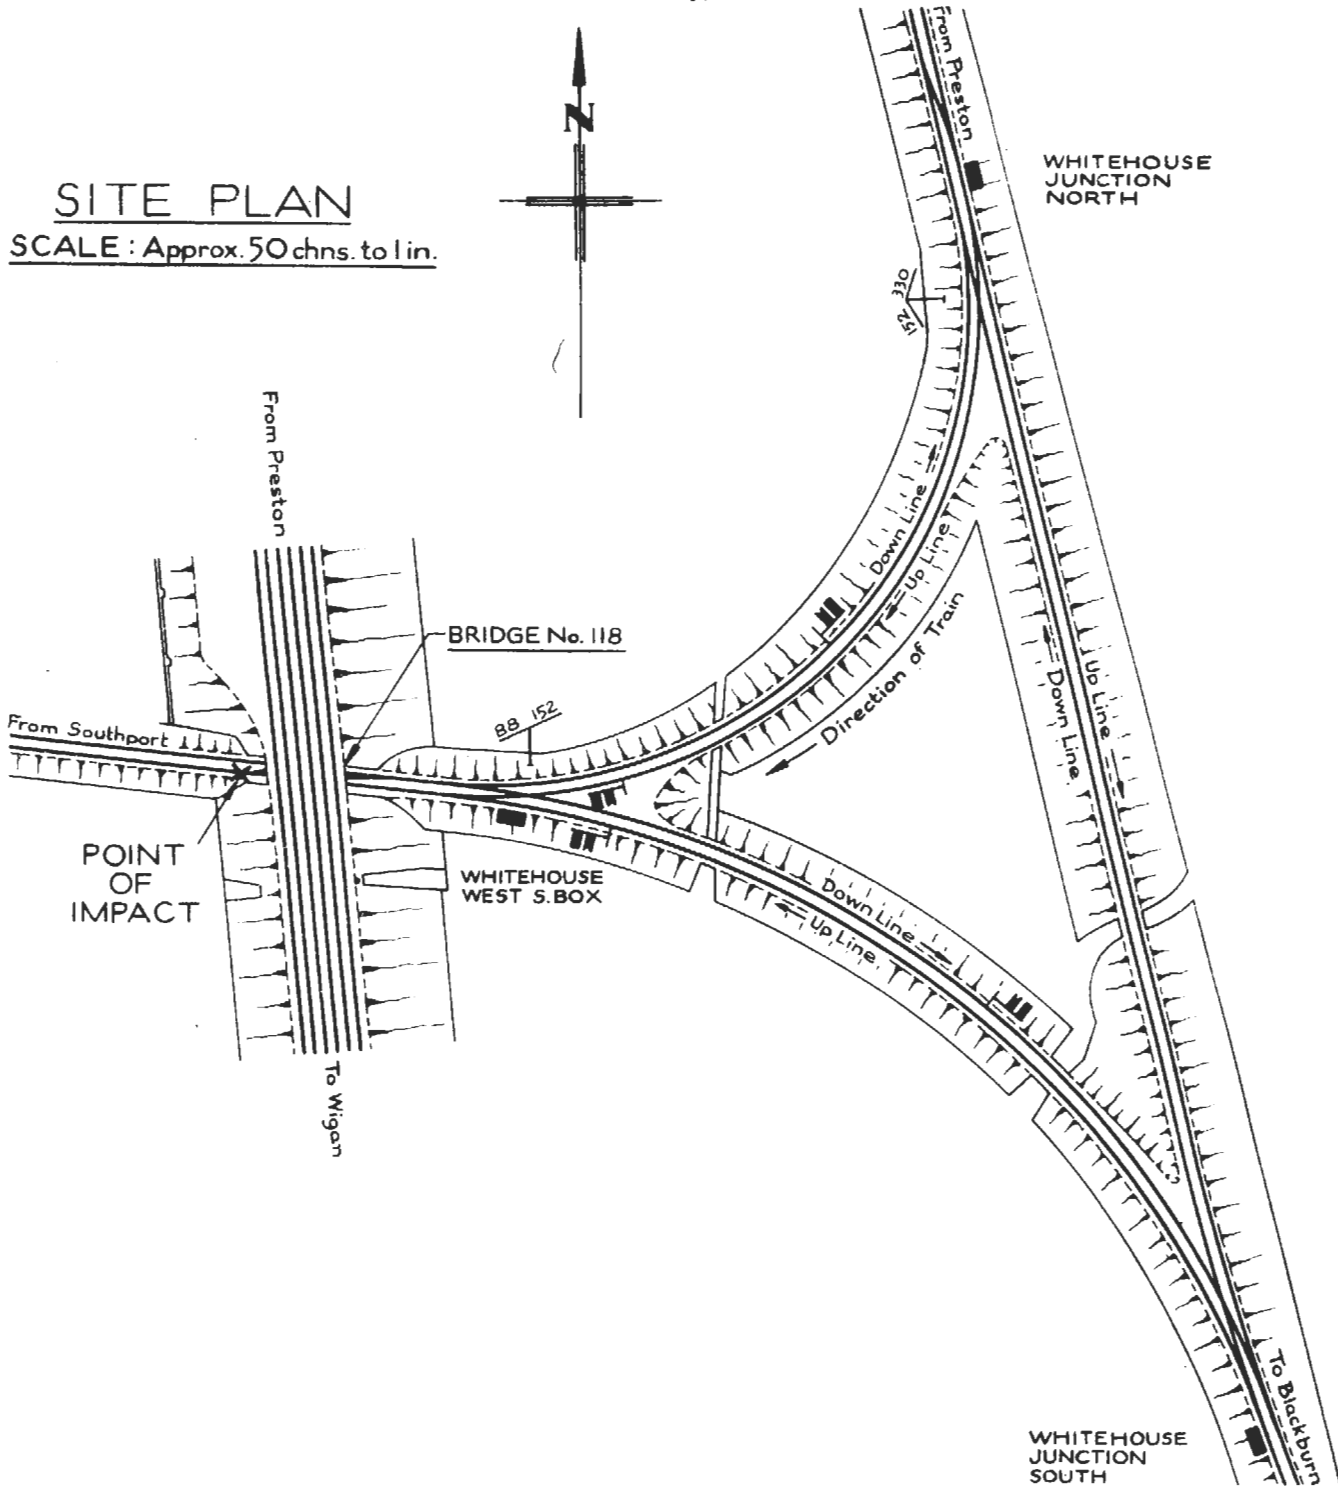
## SITE PLAN

1. The double line from Preston to Blackburn runs South through Whitehouse North and South Junctions as indicated on the diagram. The Southport route diverges to the right at the first-named junction and passes round a 12 chain curve to Whitehouse West Junction, where it is joined by a loop (known as the Fork line) from Whitehouse South, thus forming a triangle which is used for turning engines. The gradient from the North Junction falls at 1 in 152 to a point nearly opposite the West box, where it changes to 1 in 80 and then to level at the crossover trailing points. The formation at the West Junction is on a 20 feet embankment, and at the west end there is a 75 feet long overbridge carrying six railway tracks, including the main lines to the North via Preston. A 20 m.p.h. speed restriction is imposed through the Whitehouse North and West diverging junctions.

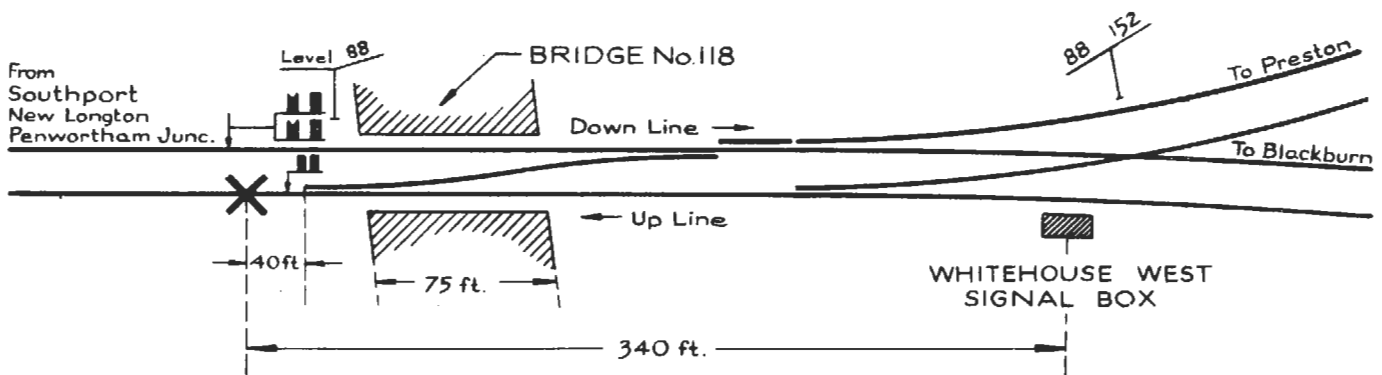
## ENLARGED PLAN

POINT OF IMPACT

The 10.20 p.m. Up Passenger train from Preston to Southport was travelling under clear signals at about 20 m.p.h., when it collided with a stationary light engine, which had been waiting for over 10 minutes at the west end of the junction to cross to the Down line.
