# RAILWAY ACCIDENT

**Report on the Collision  
that occurred on  
12th October 1972  
at Wimbledon Station**

IN THE  
SOUTHERN REGION  
BRITISH RAILWAYS

# COLLISION AT WIMBLEDON

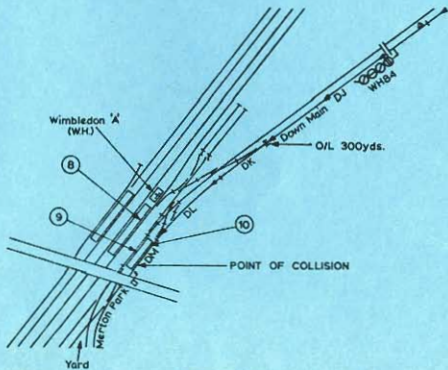
Location Diagram

1. The goods train's route approaches Streatham Junction, which lies 3 miles east of Wimbledon, from Balham on the Down Local Line as shown in the diagram opposite. Its route diverges left-handed climbing steeply onto the Down Local Spur and then curves right-handed over the main lines to connect with the Tulse Hill lines, which also pass over the main lines, beyond the two bridges and opposite Streatham Junction signal box (BC). The route then immediately diverges right-handed onto the Down Wimbledon line (called the Down Streatham Junction line in Wimbledon signal box). The Down local line from Balham has 4-aspect colour light signals. That protecting the turnout onto the Down Local Spur is equipped with a standard British Railways junction indicator (a line of five lunar white lights) controlled by lever BC 77 in Streatham Junction signal box and is 'approach-controlled' when reading to 3-aspect colour light signal BC 37 on the Down Local Spur which protects the trailing connection with the Tulse Hill line. A 4-aspect colour light signal with a right-handed junction indicator controlled by lever BC 32, signals trains to a fully automatic 2-aspect colour light signal CA 248 on the Down Wimbledon line situated 543 yards ahead of signal BC 32. There is an emergency trailing crossover, which is kept normally clipped and padlocked out of use, 354 yards on the approach side of signal CA 248.
