MINISTRY OF TRANSPORT & CIVIL AVIATION

REPORT ON THE COLLISION

which occurred on
23rd December 1955

WOKING

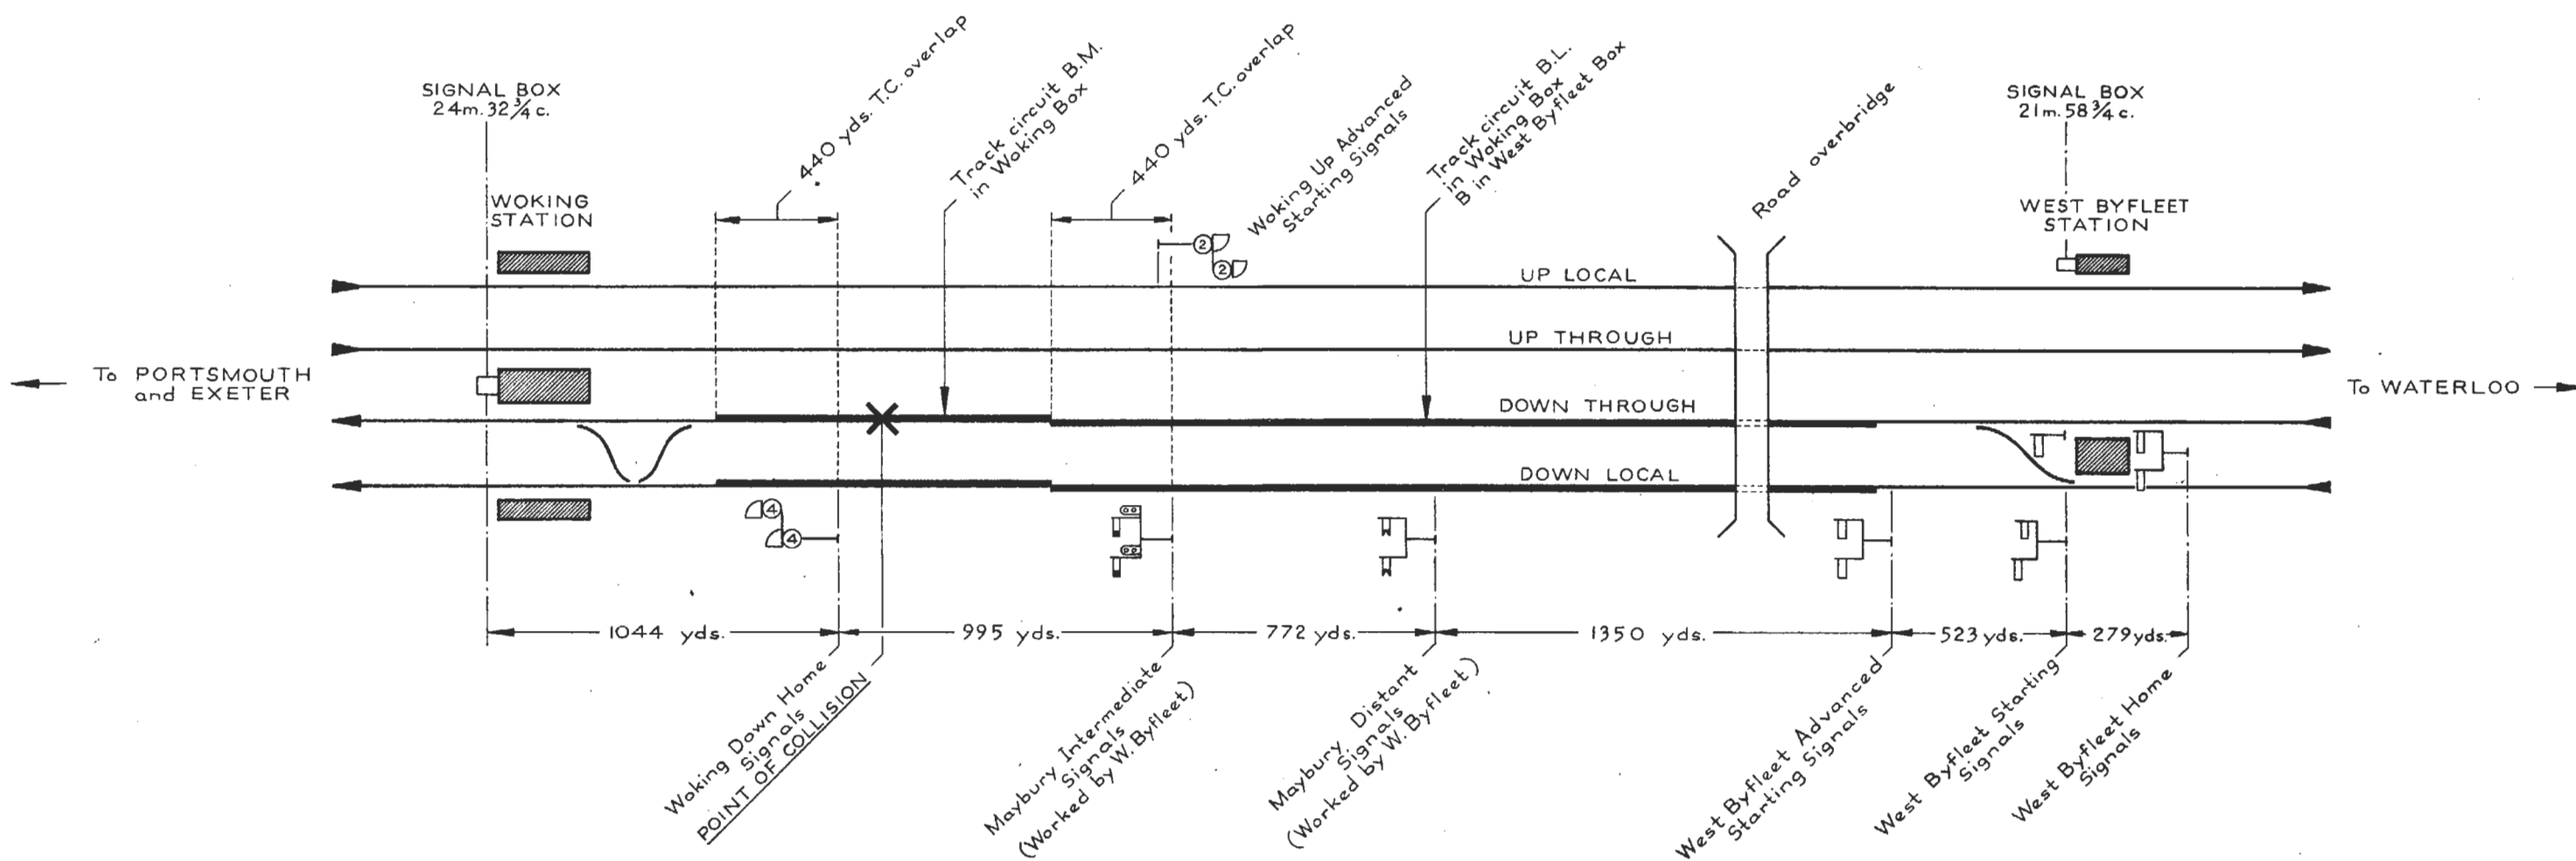
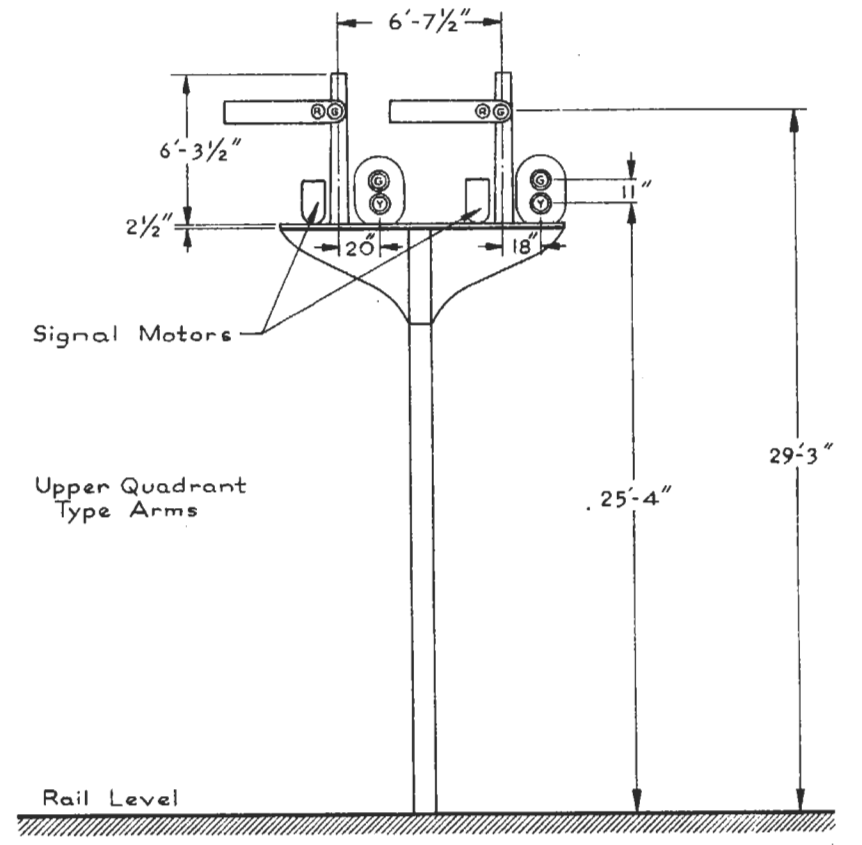
MAYBURY INTERMEDIATE SIGNALS

3. As will be seen from the drawing the two semaphore stop arms are mounted on a bracket above a single post, with the approach colour lights just below them. The semaphore signal lights are electric but their intensity is equivalent to that of a well trimmed oil lamp, and is much less than that of the approach colour lights.

30. Driver Hopkins has had long service with the Railway and his record is very good ; I can only assume that, despite his evidence to the contrary, he missed the Maybury Distant signal and overlooked the semaphore red light of the Through line Intermediate signal when he saw the brilliant yellow aspect under the Local line signal, which he must have misread as applying to the Through line.

34. I made a number of journeys on a locomotive by night in clear weather between West Byfleet and Woking to examine the visibility of the Maybury Intermediate Down Through signal at danger when the Down Local signal was clear with a yellow approach colour light beneath, and I noted that the yellow light tended to overpower the dimmer semaphore signal red light close by. I was assured by most of the drivers to whom I spoke that they had no serious problem in picking out the red light of the Through line semaphore signal in these circumstances, but there is no doubt that this could be difficult under adverse weather conditions.

35. The amount of light which should be provided in the semaphore signal lamp at locations such as this has been carefully considered in the past by the Railway, but the view has been held that the normal intensity should be maintained. I suggest, however, that this matter might be considered further and the disparity between the amount of light shown by the semaphore signal lamp and the approach colour light reduced. I think also that if the approach lights under the Local line signal were to the left of the post instead of to the right as at present, the additional distance of about 3 ft. between these lights and the Through line signal might make a big reduction in the overpowering effect of the yellow aspect. Unless there are serious technical difficulties I recommend that a trial be made with this alteration.
